Manhole Inspection Report

Date:	03/28/2018	Weather:		Coding:	RZMACP
MH#:	M-507-073	Owner:	NA	Len. Surveyed:	8.3
P.O.#:		Surveyor:	John Kuglmaier	Rim to Invert:	8.9
Customer:		Cert. #:	U-1215-07002349	Wall Material:	Concrete (reinforced)

Street:	Csokasy Ct	Project:	Hobart, IN
City:	Hobart, IN	GPS Northing:	0.0
Location:		GPS Easting:	0.0
Drain Area:	Southwest	GPS Accuracy:	Nearest Meter
Cover Shape:	Circular	Evidence of Surcharge:	No
Cover Size:	22.5	Potential for Runoff:	None
Comments:

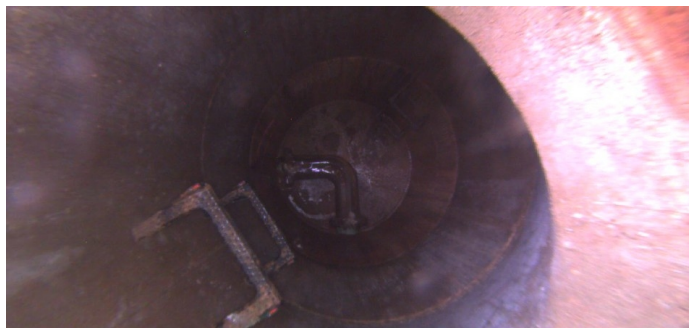
Code: **MGP**
Description: **General Photo**

Distance (ft): **.0**
Structural Grade: **0**
O&M Grade: **0**
Clock Start/From:
Clock To:
1st Value:
2nd Value:
Value Percent:
Step: **NO**
Remarks:

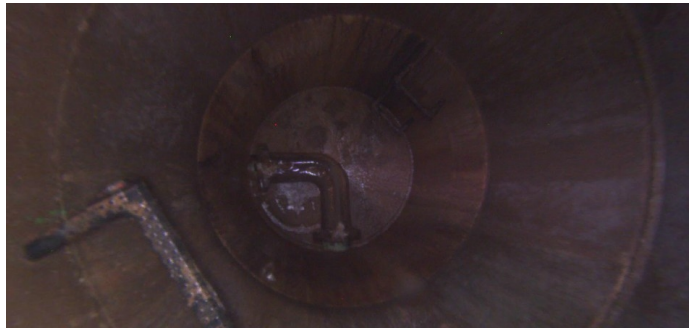
Code: **IS**
Description: **Infil Stain**

Distance (ft): **1.7**
Structural Grade: **0**
O&M Grade: **0**
Clock Start/From: **12**
Clock To: **12**
1st Value:
2nd Value:
Value Percent:
Step: **NO**
Remarks:

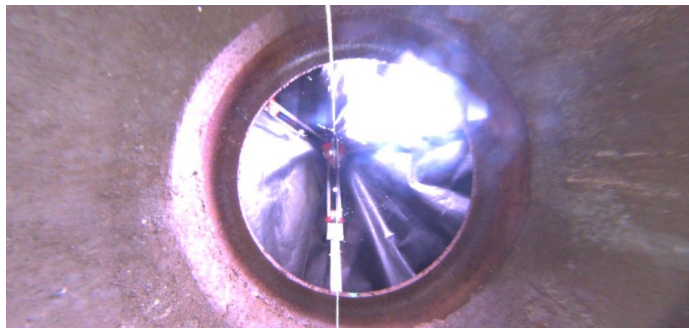
Code: **MGP**
Description: **General Photo**

Distance (ft): **2.4**
Structural Grade: **0**
O&M Grade: **0**
Clock Start/From:
Clock To:
1st Value:
2nd Value:
Value Percent:
Step: **NO**
Remarks:

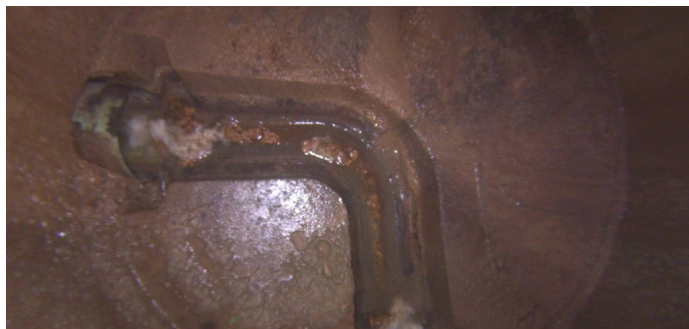
Code: **MGO**
Description: **General Observation**

Distance (ft): **6.5**
Structural Grade: **0**
O&M Grade: **0**
Clock Start/From:
Clock To:
1st Value:
2nd Value:
Value Percent:
Step: **NO**
Remarks: **Ins. Comp.**
