Manhole Inspection Report

Date:	04/25/2018	Weather:		Coding:	RZMACP
MH#:	M-507-075	Owner:	NA	Len. Surveyed:	5.7
P.O.#:		Surveyor:	John Kuglmaier	Rim to Invert:	5.9
Customer:		Cert. #:	U-1215-07002349	Wall Material:	Concrete (reinforced)

Street:	North of 11th St. 338' East of Colora	Project:	Hobart, IN
City:	Hobart, IN	GPS Northing:	2901238.539
Location:		GPS Easting:	2901238.539
Drain Area:	Southwest	GPS Accuracy:	Sub-Meter
Cover Shape:	Circular	Evidence of Surcharge:	Yes
Cover Size:	22.5	Potential for Runoff:	None
Comments:

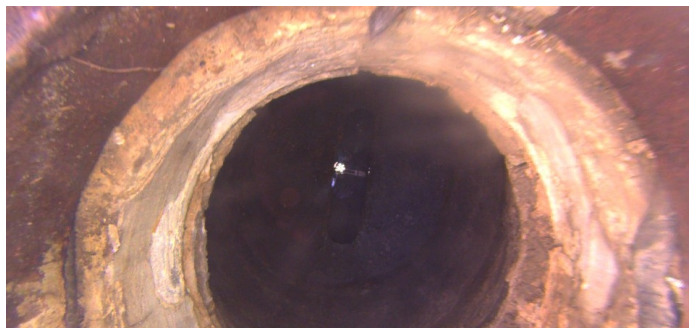
Code: **MGP**
 Description: **General Photo**

Distance (ft): **.0**
 Structural Grade: **0**
 O&M Grade: **0**
 Clock Start/From:
 Clock To:
 1st Value:
 2nd Value:
 Value Percent:
 Step: **NO**
 Remarks:

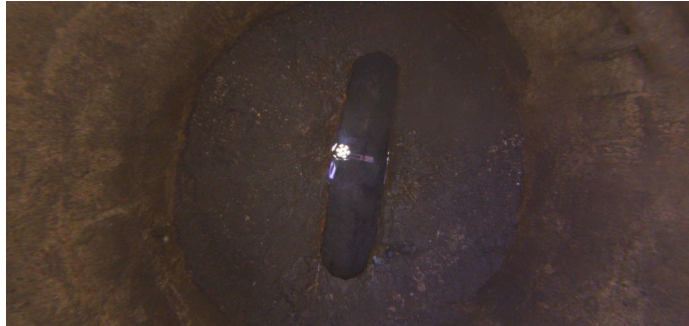
Code: **DSF**
Description: **Deposits Settled Fine**

Distance (ft): **2.5**
Structural Grade: **0**
O&M Grade: **3**
Clock Start/From: **12**
Clock To: **12**
1st Value:
2nd Value:
Value Percent: **15.000**
Step: **NO**
Remarks:

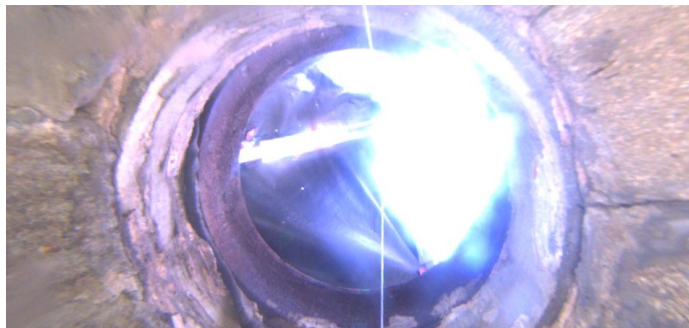
Code: **MGP**
Description: **General Photo**

Distance (ft): **2.7**
Structural Grade: **0**
O&M Grade: **0**
Clock Start/From:
Clock To:
1st Value:
2nd Value:
Value Percent:
Step: **NO**
Remarks:

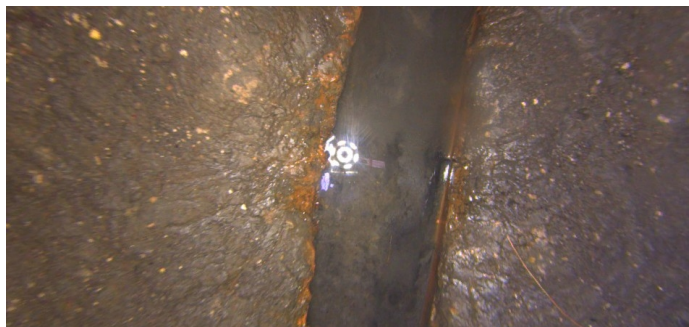
Code: **MGO**
Description: **General Observation**

Distance (ft): **4.6**
Structural Grade: **0**
O&M Grade: **0**
Clock Start/From:
Clock To:
1st Value:
2nd Value:
Value Percent:
Step: **NO**
Remarks: **Ins. Comp.**
