Manhole Inspection Report

Date:	03/28/2018	Weather:		Coding:	RZMACP
MH#:	M-507-081	Owner:	NA	Len. Surveyed:	9.7
P.O.#:		Surveyor:	John Kuglmaier	Rim to Invert:	10.1
Customer:		Cert. #:	U-1215-07002349	Wall Material:	Concrete (reinforced)

Street:	Virginia St. 550' North of Csokasy Ln.	Project:	Hobart, IN
City:	Hobart, IN	GPS Northing:	0.0
Location:		GPS Easting:	0.0
Drain Area:	Southwest	GPS Accuracy:	Nearest Meter
Cover Shape:	Circular	Evidence of Surcharge:	No
Cover Size:	22.5	Potential for Runoff:	None
Comments:

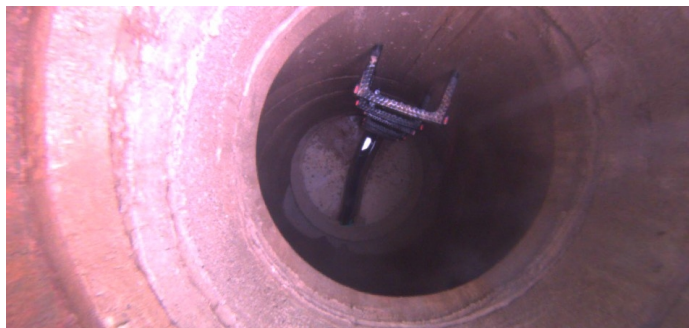
Code: **MGP**
Description: **General Photo**

Distance (ft): **.0**
Structural Grade: **0**
O&M Grade: **0**
Clock Start/From:
Clock To:
1st Value:
2nd Value:
Value Percent:
Step: **NO**
Remarks:

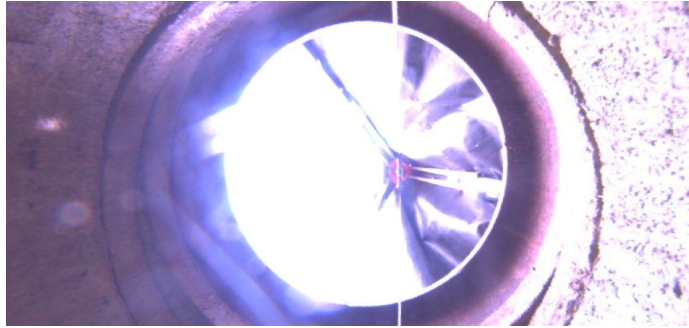
Code: **MGP**
Description: **General Photo**

Distance (ft): **2.3**
Structural Grade: **0**
O&M Grade: **0**
Clock Start/From:
Clock To:
1st Value:
2nd Value:
Value Percent:
Step: **NO**
Remarks:

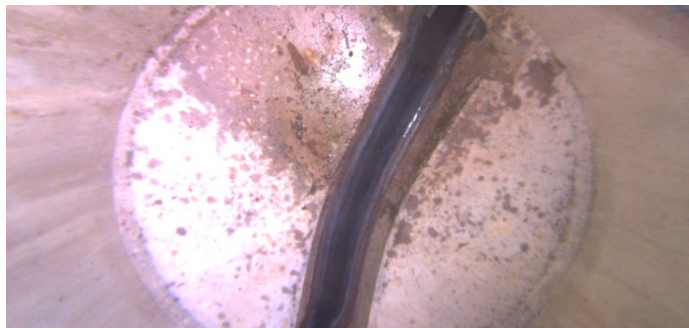
Code: **MGO**
Description: **General Observation**

Distance (ft): **7.7**
Structural Grade: **0**
O&M Grade: **0**
Clock Start/From:
Clock To:
1st Value:
2nd Value:
Value Percent:
Step: **NO**
Remarks: **Ins. Comp.**
