Manhole Inspection Report

Date:	04/24/2018	Weather:		Coding:	RZMACP
MH#:	M-507-083	Owner:	NA	Len. Surveyed:	5.2
P.O.#:		Surveyor:	John Kuglmaier	Rim to Invert:	5.4
Customer:		Cert. #:	U-1215-07002349	Wall Material:	Concrete (reinforced)

Street:	On 10th Pl. 171' West of Colorado St	Project:	Hobart, IN
City:	Hobart, IN	GPS Northing:	2900612.946
Location:		GPS Easting:	2900612.946
Drain Area:	Southwest	GPS Accuracy:	Sub-Meter
Cover Shape:	Circular	Evidence of Surcharge:	No
Cover Size:	22.5	Potential for Runoff:	None
Comments:

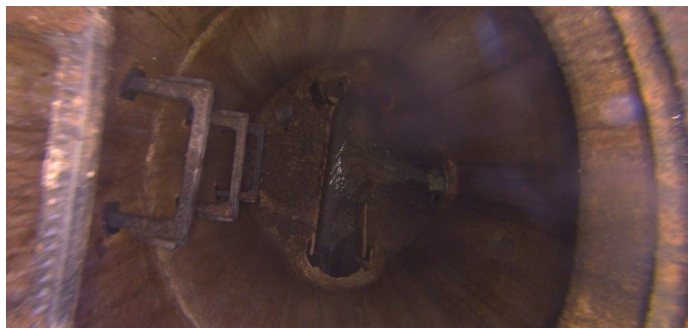
Code: **MGP**
Description: **General Photo**

Distance (ft): **.0**
Structural Grade: **0**
O&M Grade: **0**
Clock Start/From:
Clock To:
1st Value:
2nd Value:
Value Percent:
Step: **NO**
Remarks:

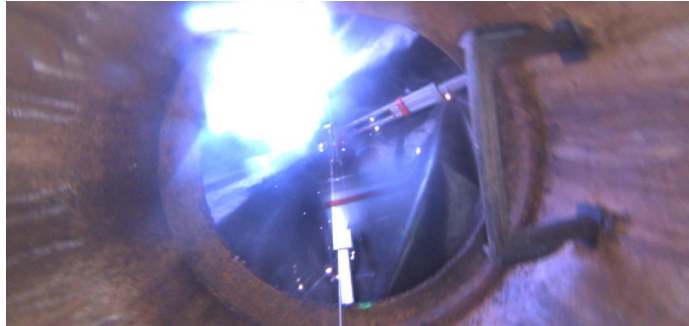
Code: **MGP**
Description: **General Photo**

Distance (ft): **2.1**
Structural Grade: **0**
O&M Grade: **0**
Clock Start/From:
Clock To:
1st Value:
2nd Value:
Value Percent:
Step: **NO**
Remarks:

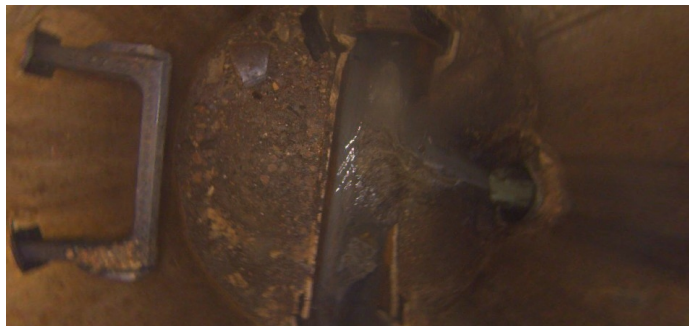
Code: **DAZ**
Description: **Deposits Attached Other**

Distance (ft): **2.5**
Structural Grade: **0**
O&M Grade: **2**
Clock Start/From: **12**
Clock To: **12**
1st Value:
2nd Value:
Value Percent: **5.000**
Step: **NO**
Remarks: **Mixed materials**

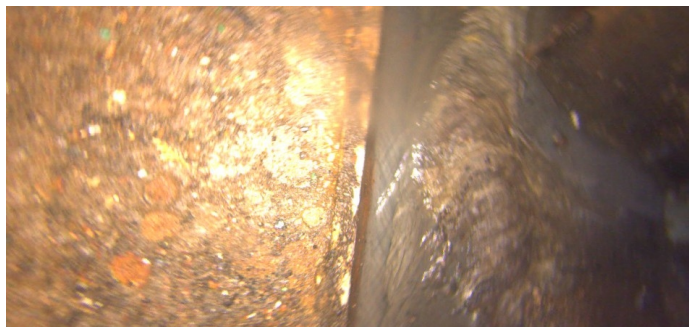
Code: **MGO**
Description: **General Observation**

Distance (ft): **4.6**
Structural Grade: **0**
O&M Grade: **0**
Clock Start/From:
Clock To:
1st Value:
2nd Value:
Value Percent:
Step: **NO**
Remarks: **Ins. Comp.**
