Manhole Inspection Report

Date:	04/24/2018	Weather:		Coding:	RZMACP
MH#:	M-507-084	Owner:	NA	Len. Surveyed:	6.0
P.O.#:		Surveyor:	John Kuglmaier	Rim to Invert:	6.5
Customer:		Cert. #:	U-1215-07002349	Wall Material:	Concrete (reinforced)

Street:	10th Pl. and Colorado St.	Project:	Hobart, IN
City:	Hobart, IN	GPS Northing:	41.52098846
Location:		GPS Easting:	-87.27307129
Drain Area:	Southwest	GPS Accuracy:	Nearest Meter
Cover Shape:	Circular	Evidence of Surcharge:	No
Cover Size:	22.5	Potential for Runoff:	None
Comments:

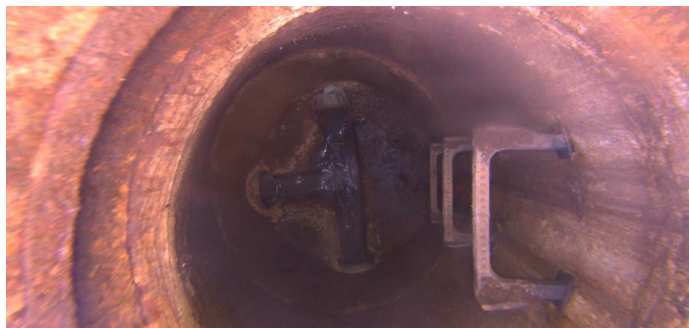
Code: **MGP**
Description: **General Photo**

Distance (ft): **.0**
Structural Grade: **0**
O&M Grade: **0**
Clock Start/From:
Clock To:
1st Value:
2nd Value:
Value Percent:
Step: **NO**
Remarks:

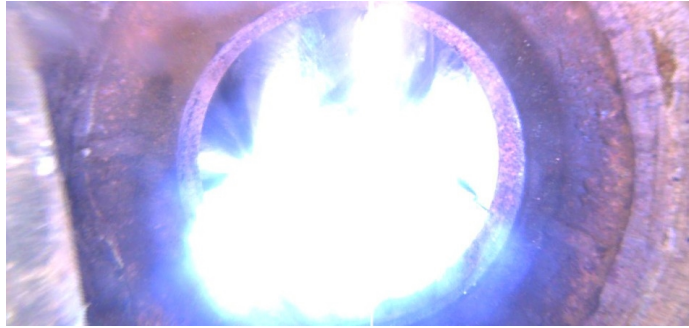
Code: **MGP**
Description: **General Photo**

Distance (ft): **2.2**
Structural Grade: **0**
O&M Grade: **0**
Clock Start/From:
Clock To:
1st Value:
2nd Value:
Value Percent:
Step: **NO**
Remarks:

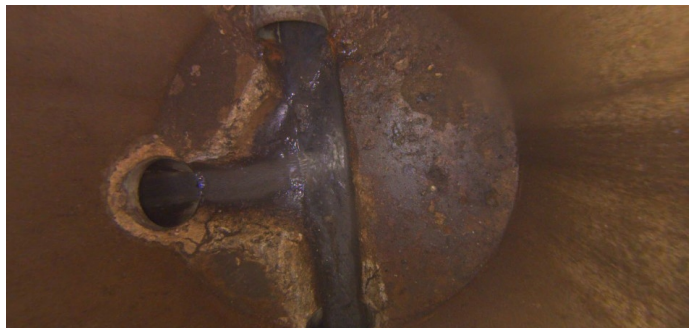
Code: **DSF**
Description: **Deposits Settled Fine**

Distance (ft): **3.4**
Structural Grade: **0**
O&M Grade: **2**
Clock Start/From: **12**
Clock To: **12**
1st Value:
2nd Value:
Value Percent: **5.000**
Step: **NO**
Remarks:

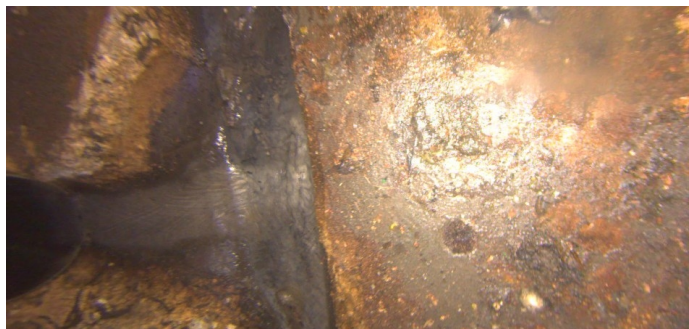
Code: **MGO**
Description: **General Observation**

Distance (ft): **5.2**
Structural Grade: **0**
O&M Grade: **0**
Clock Start/From:
Clock To:
1st Value:
2nd Value:
Value Percent:
Step: **NO**
Remarks: **Ins. Comp.**
