Manhole Inspection Report

Date:	04/24/2018	Weather:		Coding:	RZMACP
MH#:	M-507-085	Owner:	NA	Len. Surveyed:	4.7
P.O.#:		Surveyor:	John Kuglmaier	Rim to Invert:	4.9
Customer:		Cert. #:	U-1215-07002349	Wall Material:	Concrete (reinforced)

Street:	On Colorado St. 165' South of 10th P	Project:	Hobart, IN
City:	Hobart, IN	GPS Northing:	2900781.082
Location:		GPS Easting:	2900781.082
Drain Area:	Southwest	GPS Accuracy:	Sub-Meter
Cover Shape:	Circular	Evidence of Surcharge:	No
Cover Size:	22.5	Potential for Runoff:	None
Comments:

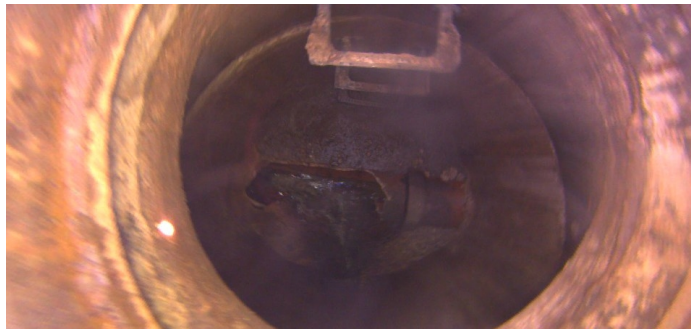
Code: **MGP**
Description: **General Photo**

Distance (ft): **.0**
Structural Grade: **0**
O&M Grade: **0**
Clock Start/From:
Clock To:
1st Value:
2nd Value:
Value Percent:
Step: **NO**
Remarks:

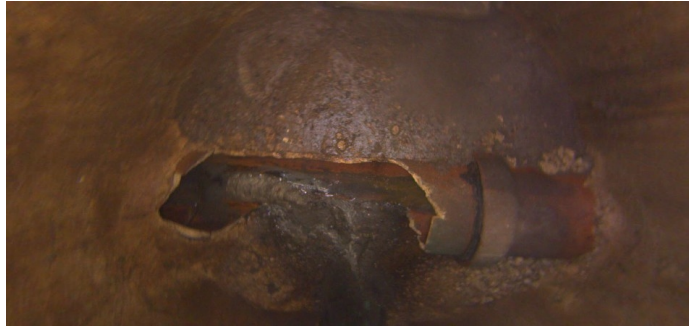
Code: **DSF**
Description: **Deposits Settled Fine**

Distance (ft): **2.5**
Structural Grade: **0**
O&M Grade: **2**
Clock Start/From: **12**
Clock To: **12**
1st Value:
2nd Value:
Value Percent: **5.000**
Step: **NO**
Remarks:

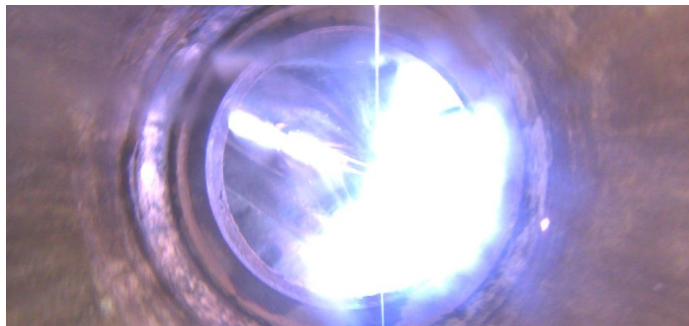
Code: **MGP**
Description: **General Photo**

Distance (ft): **2.5**
Structural Grade: **0**
O&M Grade: **0**
Clock Start/From:
Clock To:
1st Value:
2nd Value:
Value Percent:
Step: **NO**
Remarks:

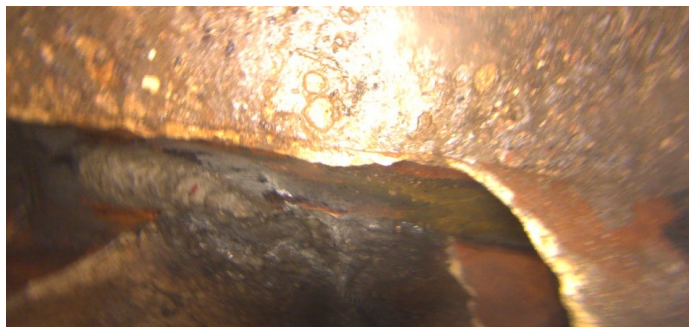
Code: **MGO**
Description: **General Observation**

Distance (ft): **4.0**
Structural Grade: **0**
O&M Grade: **0**
Clock Start/From:
Clock To:
1st Value:
2nd Value:
Value Percent:
Step: **NO**
Remarks: **Ins. Comp.**
