Manhole Inspection Report

Date:	04/25/2018	Weather:		Coding:	RZMACP
MH#:	M-507-087	Owner:	NA	Len. Surveyed:	8.0
P.O.#:		Surveyor:	John Kuglmaier	Rim to Invert:	8.7
Customer:		Cert. #:	U-1215-07002349	Wall Material:	Concrete (reinforced)

Street:	Virginia St. and 10th Pl. To the West.	Project:	Hobart, IN
City:	Hobart, IN	GPS Northing:	2901176.234
Location:		GPS Easting:	2901176.234
Drain Area:	Southwest	GPS Accuracy:	Sub-Meter
Cover Shape:	Circular	Evidence of Surcharge:	No
Cover Size:	22.5	Potential for Runoff:	None
Comments:

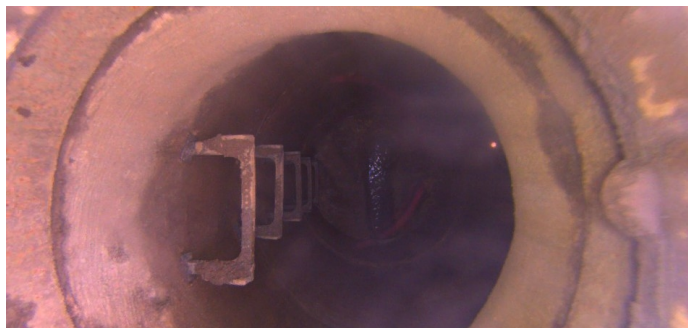
Code: **MGP**
Description: **General Photo**

Distance (ft): **.0**
Structural Grade: **0**
O&M Grade: **0**
Clock Start/From:
Clock To:
1st Value:
2nd Value:
Value Percent:
Step: **NO**
Remarks:

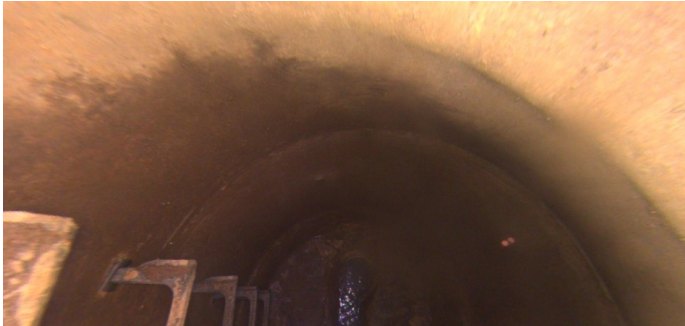
Code:	IS
Description:	Infil Stain

Distance (ft):	1.1
Structural Grade:	0
O&M Grade:	0
Clock Start/From:	12
Clock To:	12
1st Value:	
2nd Value:	
Value Percent:	
Step:	NO
Remarks:

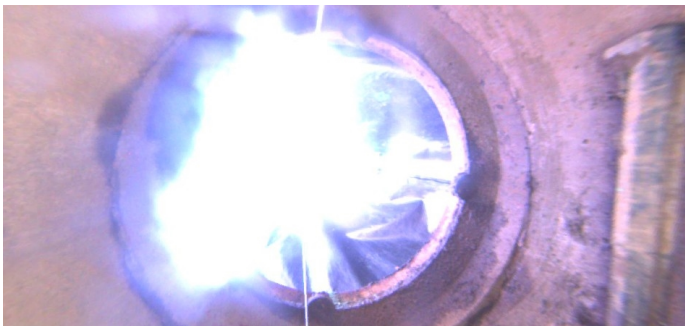
Code:	MGP
Description:	General Photo

Distance (ft):	2.5
Structural Grade:	0
O&M Grade:	0
Clock Start/From:	
Clock To:	
1st Value:	
2nd Value:	
Value Percent:	
Step:	NO
Remarks:

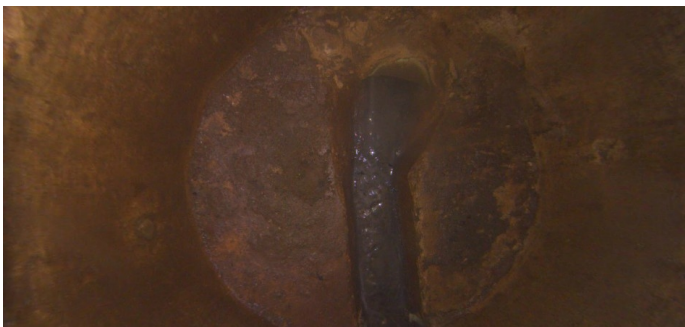
Code:	DSF
Description:	Deposits Settled Fine

Distance (ft):	5.4
Structural Grade:	0
O&M Grade:	2
Clock Start/From:	12
Clock To:	12
1st Value:	
2nd Value:	
Value Percent:	5.000
Step:	NO
Remarks:

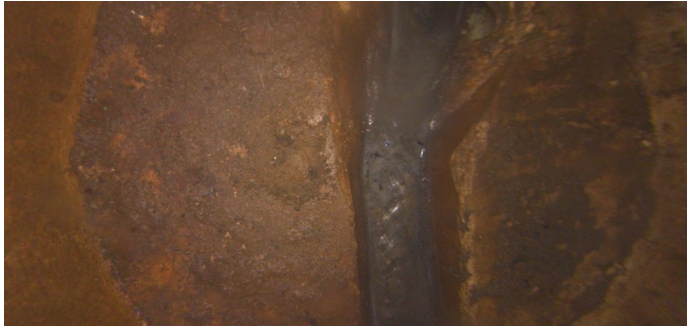
Code:	MGO
Description:	General Observation
Distance (ft):	6.8
Structural Grade:	0
O&M Grade:	0
Clock Start/From:	
Clock To:	
1st Value:	
2nd Value:	
Value Percent:	
Step:	NO
Remarks:	Ins. Comp.
