Manhole Inspection Report

Date:	04/05/2018	Weather:		Coding:	RZMACP
MH#:	M-507-092	Owner:	NA	Len. Surveyed:	5.2
P.O.#:		Surveyor:	John Kuglmaier	Rim to Invert:	5.9
Customer:		Cert. #:	U-1215-07002349	Wall Material:	Concrete (reinforced)

Street:	14th St. and Wisconsin St. The North	Project:	Hobart, IN
City:	Hobart, IN	GPS Northing:	0.0
Location:		GPS Easting:	0.0
Drain Area:	Southwest	GPS Accuracy:	Nearest Meter
Cover Shape:	Circular	Evidence of Surcharge:	No
Cover Size:	22.5	Potential for Runoff:	None
Comments:

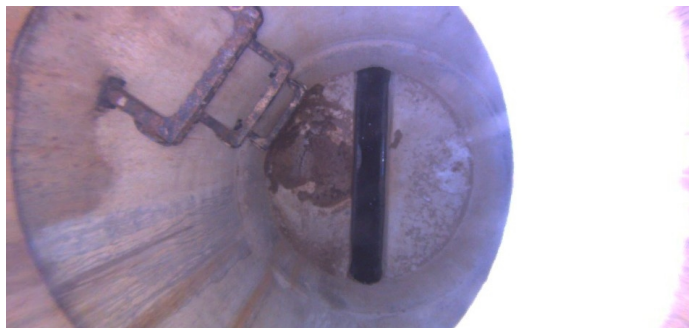
Code: **MGP**
Description: **General Photo**

Distance (ft): **.0**
Structural Grade: **0**
O&M Grade: **0**
Clock Start/From:
Clock To:
1st Value:
2nd Value:
Value Percent:
Step: **NO**
Remarks:

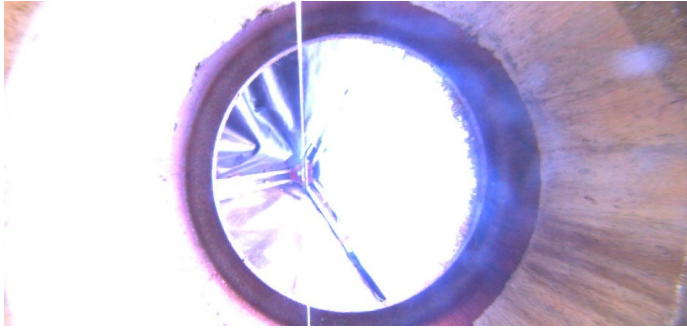
Code: **MGP**
Description: **General Photo**

Distance (ft): **2.4**
Structural Grade: **0**
O&M Grade: **0**
Clock Start/From:
Clock To:
1st Value:
2nd Value:
Value Percent:
Step: **NO**
Remarks:

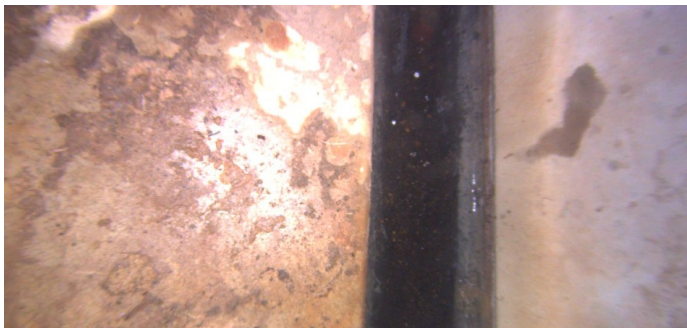
Code: **MGO**
Description: **General Observation**

Distance (ft): **4.6**
Structural Grade: **0**
O&M Grade: **0**
Clock Start/From:
Clock To:
1st Value:
2nd Value:
Value Percent:
Step: **NO**
Remarks: **Ins. Comp.**
