Manhole Inspection Report

Date:	04/24/2018	Weather:		Coding:	RZMACP
MH#:	M-507-095	Owner:	NA	Len. Surveyed:	3.7
P.O.#:		Surveyor:	John Kuglmaier	Rim to Invert:	4.1
Customer:		Cert. #:	U-1215-07002349	Wall Material:	Concrete (reinforced)

Street:	On 10th St. 449' West of Decatur St.	Project:	Hobart, IN
City:	Hobart, IN	GPS Northing:	2899669.182
Location:		GPS Easting:	2899669.182
Drain Area:	Southwest	GPS Accuracy:	Sub-Meter
Cover Shape:	Circular	Evidence of Surcharge:	No
Cover Size:	22.5	Potential for Runoff:	None
Comments:

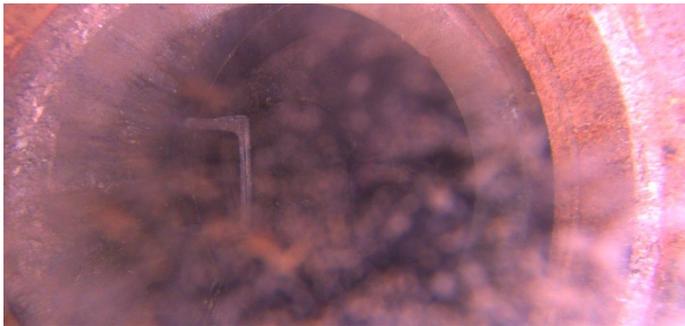
Code: **MGP**
Description: **General Photo**

Distance (ft): **.0**
Structural Grade: **0**
O&M Grade: **0**
Clock Start/From:
Clock To:
1st Value:
2nd Value:
Value Percent:
Step: **NO**
Remarks:

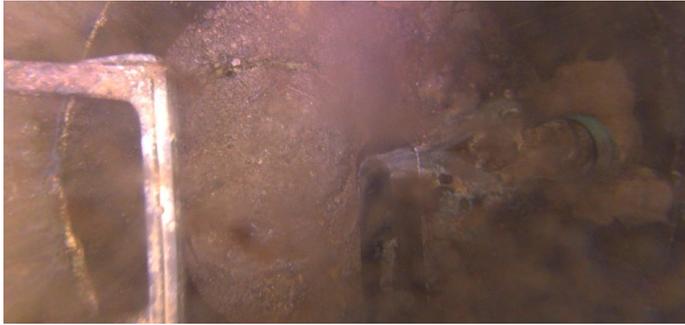
Code: **DAZ**
Description: **Deposits Attached Other**

Distance (ft): **1.3**
Structural Grade: **0**
O&M Grade: **2**
Clock Start/From: **12**
Clock To: **12**
1st Value:
2nd Value:
Value Percent: **10.000**
Step: **NO**
Remarks: **Mixed materials**

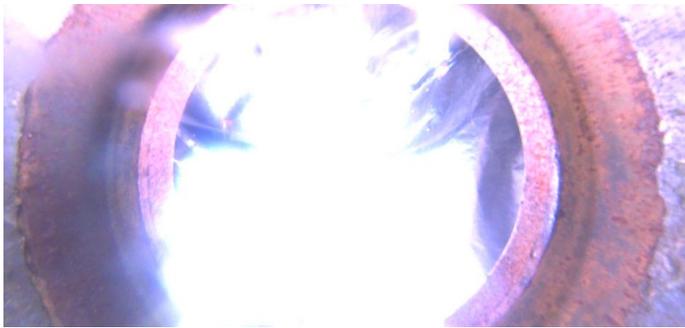
Code: **MGP**
Description: **General Photo**

Distance (ft): **2.1**
Structural Grade: **0**
O&M Grade: **0**
Clock Start/From:
Clock To:
1st Value:
2nd Value:
Value Percent:
Step: **NO**
Remarks:
