Manhole Inspection Report

Date:	04/24/2018	Weather:		Coding:	RZMACP
MH#:	M-507-097	Owner:	NA	Len. Surveyed:	5.4
P.O.#:		Surveyor:	John Kuglmaier	Rim to Invert:	9.0
Customer:		Cert. #:	U-1215-07002349	Wall Material:	Concrete (reinforced)

Street:	304' Northwest of 10th Pl. And Deca	Project:	Hobart, IN
City:	Hobart, IN	GPS Northing:	41.52122116
Location:		GPS Easting:	-87.27655029
Drain Area:	Southwest	GPS Accuracy:	Nearest Meter
Cover Shape:	Circular	Evidence of Surcharge:	No
Cover Size:	22.5	Potential for Runoff:	None
Comments:

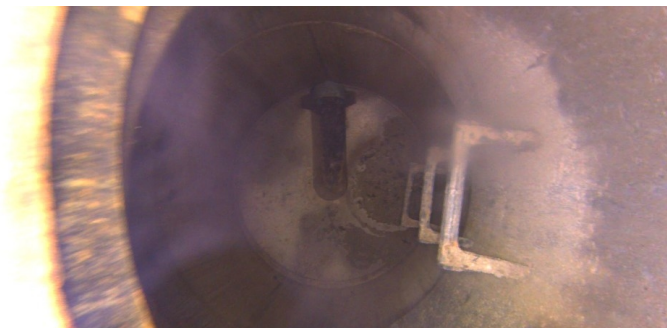
Code: **MGP**
Description: **General Photo**

Distance (ft): **.0**
Structural Grade: **0**
O&M Grade: **0**
Clock Start/From:
Clock To:
1st Value:
2nd Value:
Value Percent:
Step: **NO**
Remarks:

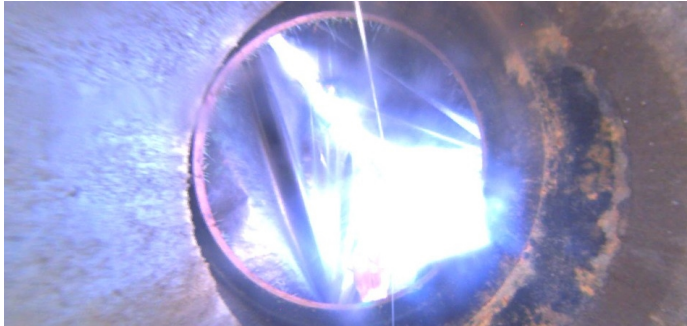
Code:	MGP
Description:	General Photo
Distance (ft):	2.1
Structural Grade:	0
O&M Grade:	0
Clock Start/From:	
Clock To:	
1st Value:	
2nd Value:	
Value Percent:	
Step:	NO
Remarks:

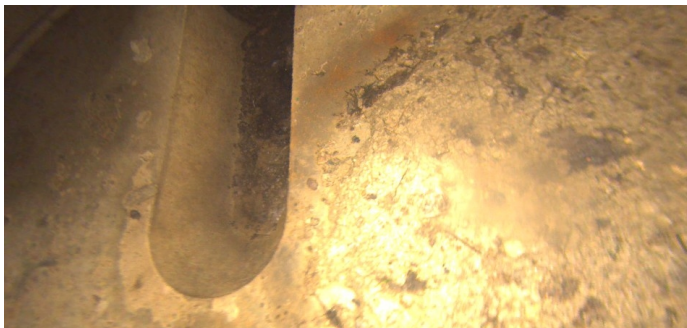
Code:	MGO
Description:	General Observation
Distance (ft):	4.6
Structural Grade:	0
O&M Grade:	0
Clock Start/From:	
Clock To:	
1st Value:	
2nd Value:	
Value Percent:	
Step:	NO
Remarks:	Ins. Comp.
