# Manhole Inspection Report

Date:	<b>04/24/2018</b>	Weather:		Coding:	<b>RZMACP</b>
MH#:	<b>M-507-098</b>	Owner:	<b>NA</b>	Len. Surveyed:	<b>5.8</b>
P.O.#:		Surveyor:	<b>John Kuglmaier</b>	Rim to Invert:	<b>6.2</b>
Customer:		Cert. #:	<b>U-1215-07002349</b>	Wall Material:	<b>Concrete (reinforced)</b>

Street:	<b>304' Southwest of 10th Pl. And Deca</b>	Project:	<b>Hobart, IN</b>
City:	<b>Hobart, IN</b>	GPS Northing:	<b>41.52041626</b>
Location:		GPS Easting:	<b>-87.27629089</b>
Drain Area:	<b>Southwest</b>	GPS Accuracy:	<b>Nearest Meter</b>
Cover Shape:	<b>Circular</b>	Evidence of Surcharge:	<b>No</b>
Cover Size:	<b>22.5</b>	Potential for Runoff:	<b>None</b>
Comments:

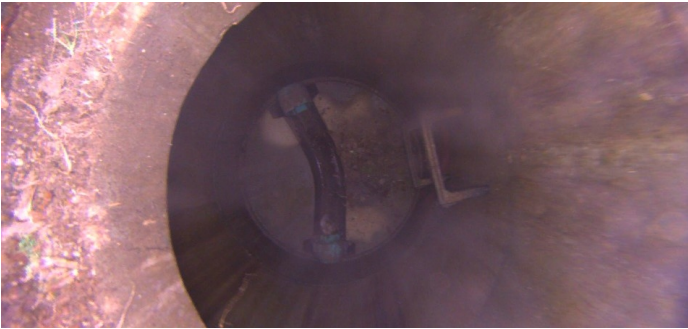
Code:

MGP

Description:

General Photo

Distance (ft):

.0

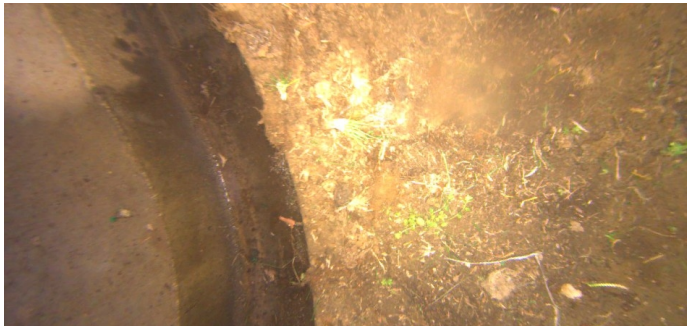
Code:	<b>MGO</b>
Description:	<b>General Observation</b>
Distance (ft):	<b>5.0</b>
Structural Grade:	<b>0</b>
O&M Grade:	<b>0</b>
Clock Start/From:	
Clock To:	
1st Value:	
2nd Value:	
Value Percent:	
Step:	<b>NO</b>
Remarks:	<b>Ins. Comp.</b>
