Manhole Inspection Report

Date:	03/27/2018	Weather:		Coding:	RZMACP
MH#:	M-507-099	Owner:	NA	Len. Surveyed:	5.3
P.O.#:		Surveyor:	John Kuglmaier	Rim to Invert:	6.0
Customer:		Cert. #:	U-1215-07002349	Wall Material:	Concrete (reinforced)

Street:	225' Northwest of Decatur St. and C	Project:	Hobart, IN
City:	Hobart, IN	GPS Northing:	0.0
Location:		GPS Easting:	0.0
Drain Area:	Southwest	GPS Accuracy:	Nearest Meter
Cover Shape:	Circular	Evidence of Surcharge:	No
Cover Size:	22.5	Potential for Runoff:	None
Comments:

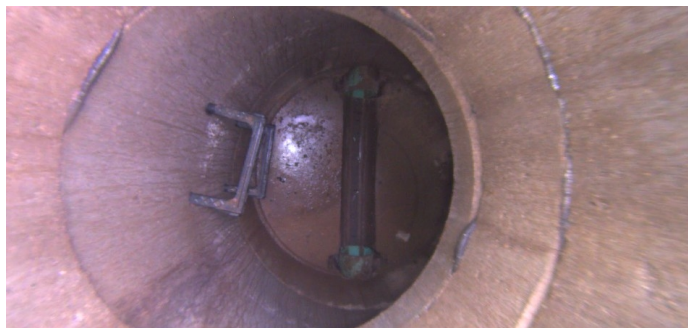
Code: **MGP**
Description: **General Photo**

Distance (ft): **.0**
Structural Grade: **0**
O&M Grade: **0**
Clock Start/From:
Clock To:
1st Value:
2nd Value:
Value Percent:
Step: **NO**
Remarks:

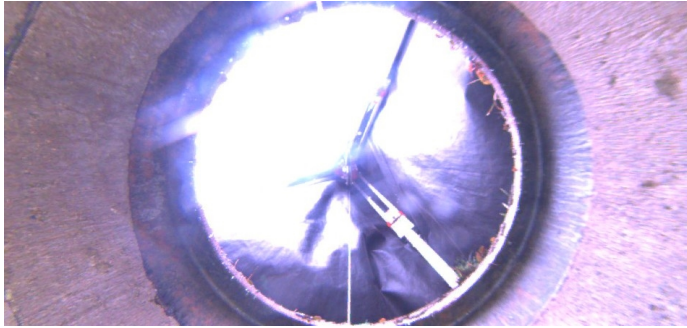
Code: **MGP**
Description: **General Photo**

Distance (ft): **1.9**
Structural Grade: **0**
O&M Grade: **0**
Clock Start/From:
Clock To:
1st Value:
2nd Value:
Value Percent:
Step: **NO**
Remarks:

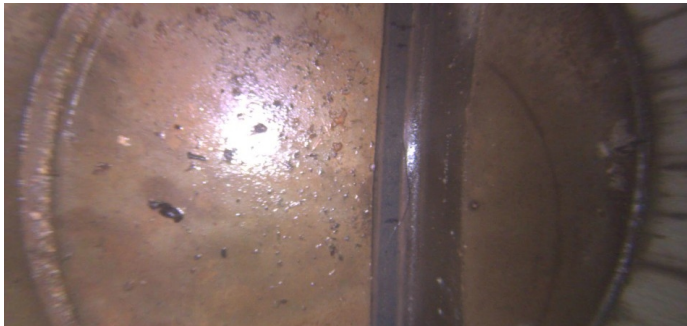
Code: **MGO**
Description: **General Observation**

Distance (ft): **3.8**
Structural Grade: **0**
O&M Grade: **0**
Clock Start/From:
Clock To:
1st Value:
2nd Value:
Value Percent:
Step: **NO**
Remarks: **Ins. Comp.**
