Manhole Inspection Report

Date:	03/27/2018	Weather:		Coding:	RZMACP
MH#:	M-507-100	Owner:	NA	Len. Surveyed:	4.1
P.O.#:		Surveyor:	John Kuglmaier	Rim to Invert:	5.0
Customer:		Cert. #:	U-1215-07002349	Wall Material:	Concrete (reinforced)

Street:	153' West of Decatur St. and Csokas	Project:	Hobart, IN
City:	Hobart, IN	GPS Northing:	0.0
Location:		GPS Easting:	0.0
Drain Area:	Southwest	GPS Accuracy:	Nearest Meter
Cover Shape:	Circular	Evidence of Surcharge:	No
Cover Size:	22.5	Potential for Runoff:	None
Comments:

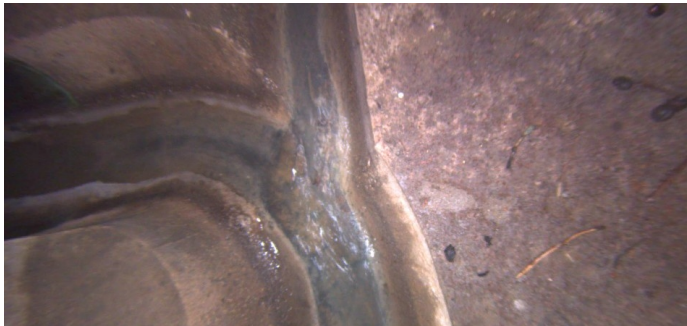
Code: **MGP**
Description: **General Photo**

Distance (ft): **1.7**
Structural Grade: **0**
O&M Grade: **0**
Clock Start/From:
Clock To:
1st Value:
2nd Value:
Value Percent:
Step: **NO**
Remarks:
