Manhole Inspection Report

Date:	04/05/2018	Weather:		Coding:	RZMACP
MH#:	M-508-001	Owner:	NA	Len. Surveyed:	5.7
P.O.#:		Surveyor:	John Kuglmaier	Rim to Invert:	6.3
Customer:		Cert. #:	U-1215-07002349	Wall Material:	Concrete (reinforced)

Street:	14th St. and Wisconsin St.	Project:	Hobart, IN
City:	Hobart, IN	GPS Northing:	0.0
Location:		GPS Easting:	0.0
Drain Area:	Southwest	GPS Accuracy:	Nearest Meter
Cover Shape:	Circular	Evidence of Surcharge:	No
Cover Size:	22.5	Potential for Runoff:	None
Comments:

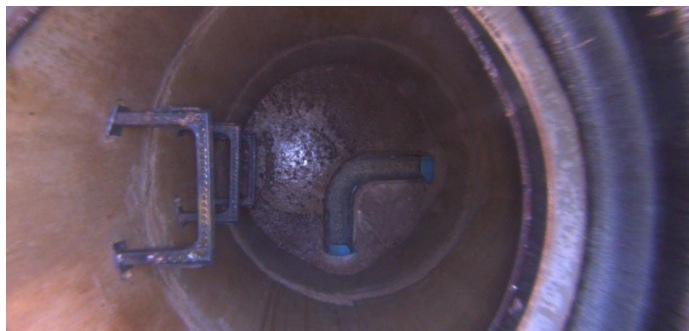
Code: **MGP**
Description: **General Photo**

Distance (ft): **.0**
Structural Grade: **0**
O&M Grade: **0**
Clock Start/From:
Clock To:
1st Value:
2nd Value:
Value Percent:
Step: **NO**
Remarks:

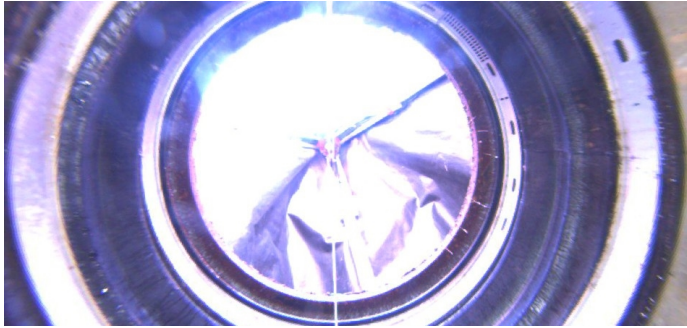
Code: **MGP**
Description: **General Photo**

Distance (ft): **2.2**
Structural Grade: **0**
O&M Grade: **0**
Clock Start/From:
Clock To:
1st Value:
2nd Value:
Value Percent:
Step: **NO**
Remarks:

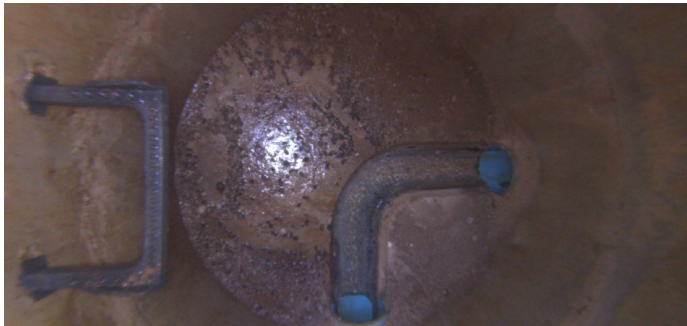
Code: **DSF**
Description: **Deposits Settled Fine**

Distance (ft): **2.7**
Structural Grade: **0**
O&M Grade: **2**
Clock Start/From: **12**
Clock To: **12**
1st Value:
2nd Value:
Value Percent: **10.000**
Step: **NO**
Remarks:

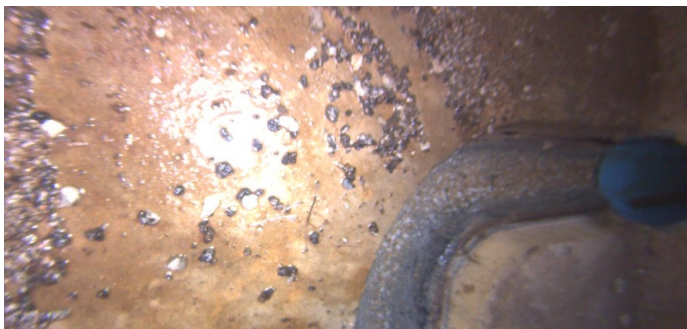
Code: **MGO**
Description: **General Observation**

Distance (ft): **4.9**
Structural Grade: **0**
O&M Grade: **0**
Clock Start/From:
Clock To:
1st Value:
2nd Value:
Value Percent:
Step: **NO**
Remarks: **Ins. Comp.**
