Manhole Inspection Report

Date:	10/07/2022	Weather:		Coding:	RZMACP
MH#:	M-603-010	Owner:	NA	Len. Surveyed:	7.3
P.O.#:		Surveyor:	Jen Costello	Rim to Invert:	7.9
Customer:		Cert. #:	U-907-5518	Wall Material:	Brick

Street:	176' East of Wisconsin St. 380' North	Project:	Hobart, IN
City:	Hobart, IN	GPS Northing:	2293924.001
Location:	Other	GPS Easting:	2901962.278
Drain Area:	Northwest	GPS Accuracy:	Sub-Meter
Cover Shape:	Circular	Evidence of Surcharge:	Yes
Cover Size:	24.0	Potential for Runoff:	None
Comments:

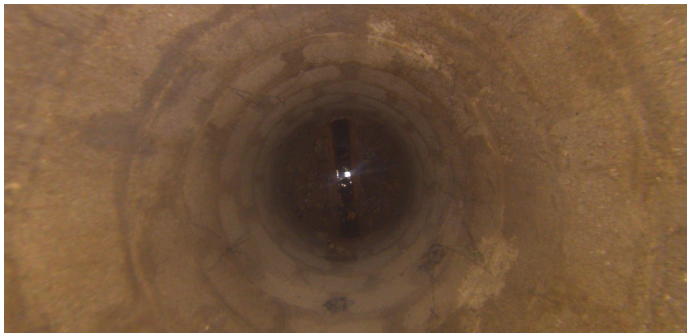
Code: **MGO**
Description: **General Observation**

Distance (ft): **.0**
Structural Grade: **0**
O&M Grade: **0**
Clock Start/From:
Clock To:
1st Value:
2nd Value:
Value Percent:
Step: **NO**
Remarks: **access mh**

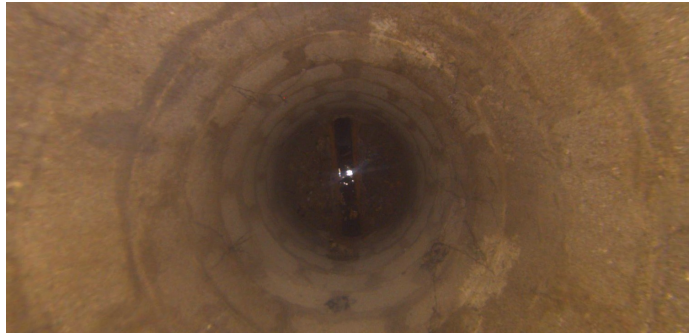
Code: **SRI**
Description: **Surface Roughness Increased**

Distance (ft): **.0**
Structural Grade: **1**
O&M Grade: **0**
Clock Start/From: **12**
Clock To: **12**
1st Value:
2nd Value:
Value Percent:
Step: **NO**
Remarks:

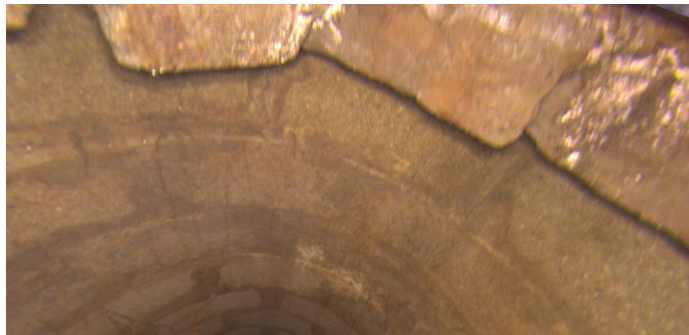
Code: **DB**
Description: **Displaced Brick**

Distance (ft): **.4**
Structural Grade: **3**
O&M Grade: **0**
Clock Start/From: **9**
Clock To: **3**
1st Value:
2nd Value:
Value Percent:
Step: **NO**
Remarks:

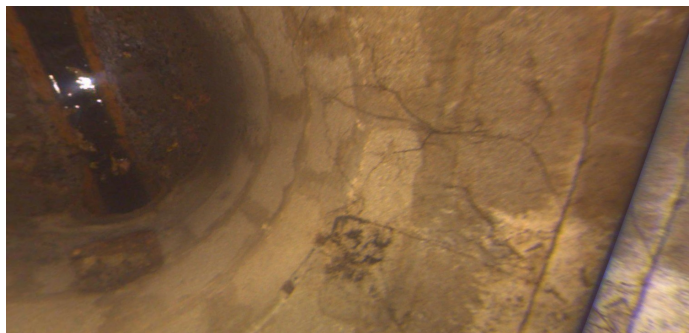
Code: **RFB**
Description: **Roots Fine Barrel**

Distance (ft): **2.7**
Structural Grade: **0**
O&M Grade: **2**
Clock Start/From: **1**
Clock To: **4**
1st Value:
2nd Value:
Value Percent:
Step: **NO**
Remarks:

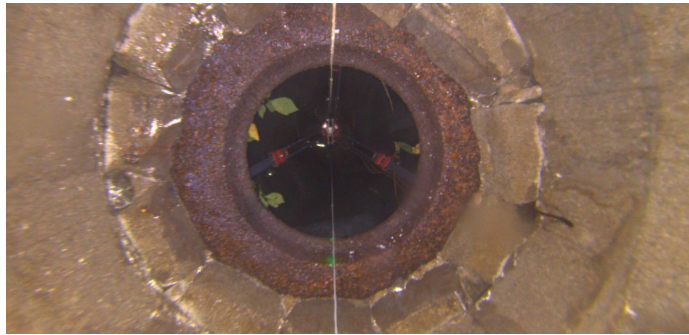
Code: **MGO**
Description: **General Observation**

Distance (ft): **2.7**
Structural Grade: **0**
O&M Grade: **0**
Clock Start/From:
Clock To:
1st Value:
2nd Value:
Value Percent:
Step: **NO**
Remarks: **underside of frame**

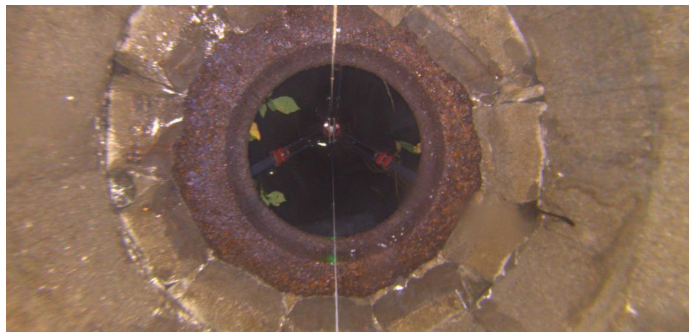
Code: **RFJ**
Description: **Roots Fine Joint**

Distance (ft): **2.7**
Structural Grade: **0**
O&M Grade: **1**
Clock Start/From: **3**
Clock To:
1st Value:
2nd Value:
Value Percent:
Step: **NO**
Remarks:

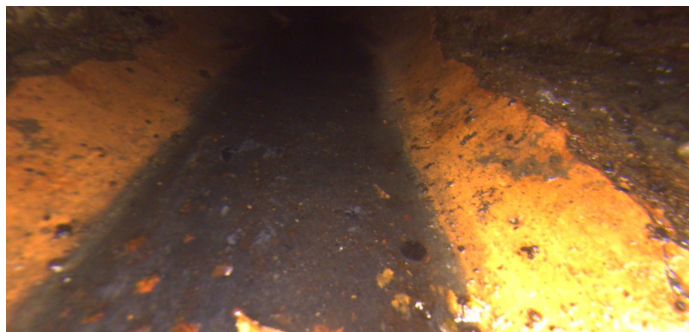
Code: **DSF**
Description: **Deposits Settled Fine**

Distance (ft): **7.3**
Structural Grade: **0**
O&M Grade: **2**
Clock Start/From: **12**
Clock To: **12**
1st Value:
2nd Value:
Value Percent: **5.000**
Step: **NO**
Remarks:

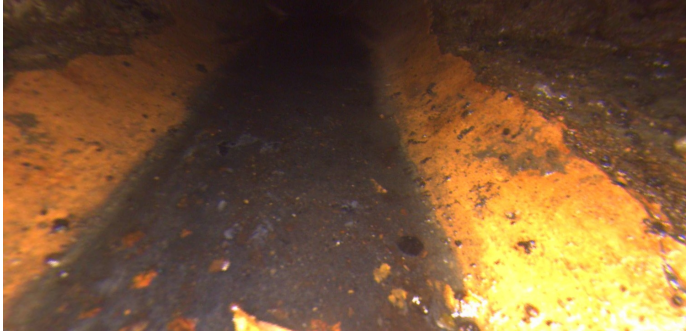
Code: **SRI**
Description: **Surface Roughness Increased**

Distance (ft): **7.3**
Structural Grade: **1**
O&M Grade: **0**
Clock Start/From: **12**
Clock To: **12**
1st Value:
2nd Value:
Value Percent:
Step: **NO**
Remarks:

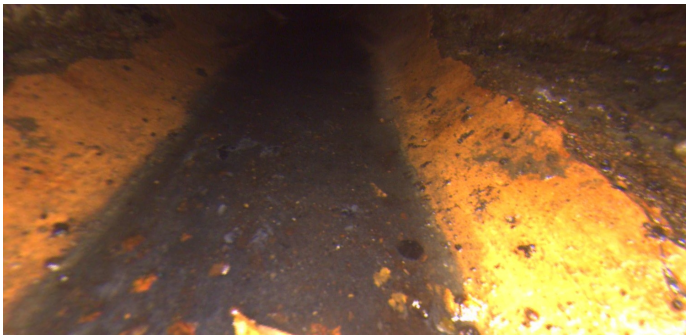
Code: **MGO**
Description: **General Observation**

Distance (ft): **7.3**
Structural Grade: **0**
O&M Grade: **0**
Clock Start/From:
Clock To:
1st Value:
2nd Value:
Value Percent:
Step: **NO**
Remarks: **end of survey**
