Manhole Inspection Report

Date:	04/12/2018	Weather:		Coding:	RZMACP
MH#:	M-603-021	Owner:	NA	Len. Surveyed:	3.5
P.O.#:		Surveyor:	John Kuglmaier	Rim to Invert:	3.8
Customer:		Cert. #:	U-1215-07002349	Wall Material:	Concrete (reinforced)

Street:	37th Ave. East of Wisconsin St.	Project:	Hobart, IN
City:	Hobart, IN	GPS Northing:	2902394.929
Location:		GPS Easting:	2902394.929
Drain Area:	Northwest	GPS Accuracy:	Sub-Meter
Cover Shape:	Circular	Evidence of Surcharge:	No
Cover Size:	23.0	Potential for Runoff:	None
Comments:

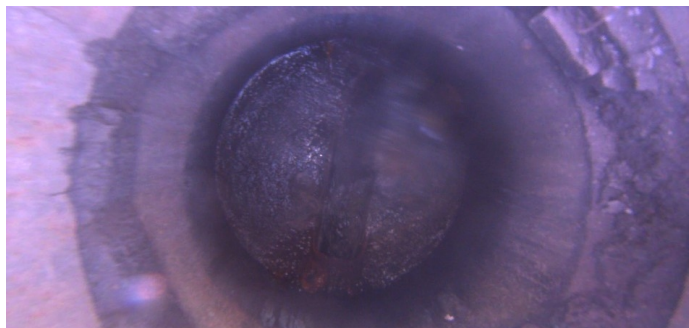
Code: **MGP**
Description: **General Photo**

Distance (ft): **.0**
Structural Grade: **0**
O&M Grade: **0**
Clock Start/From:
Clock To:
1st Value:
2nd Value:
Value Percent:
Step: **NO**
Remarks:

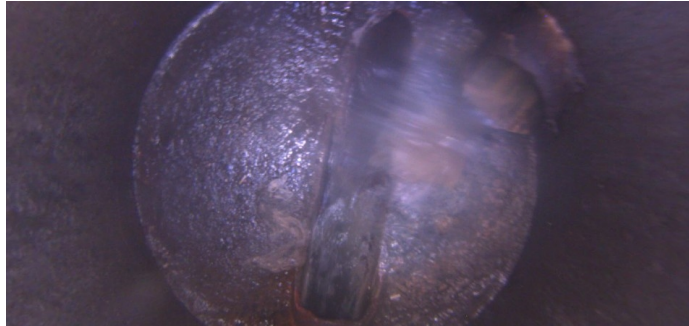
Code: **DSF**
Description: **Deposits Settled Fine**

Distance (ft): **1.5**
Structural Grade: **0**
O&M Grade: **2**
Clock Start/From: **12**
Clock To: **12**
1st Value:
2nd Value:
Value Percent: **5.000**
Step: **NO**
Remarks:

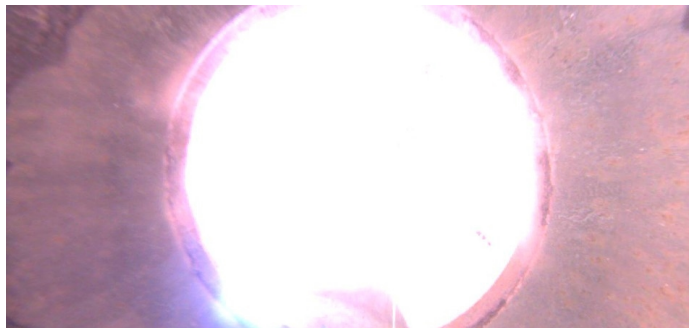
Code: **MGP**
Description: **General Photo**

Distance (ft): **1.8**
Structural Grade: **0**
O&M Grade: **0**
Clock Start/From:
Clock To:
1st Value:
2nd Value:
Value Percent:
Step: **NO**
Remarks:

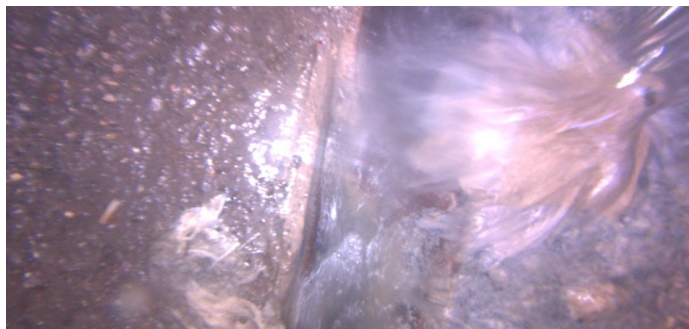
Code: **MGO**
Description: **General Observation**

Distance (ft): **3.0**
Structural Grade: **0**
O&M Grade: **0**
Clock Start/From:
Clock To:
1st Value:
2nd Value:
Value Percent:
Step: **NO**
Remarks: **Ins. Comp.**
