Manhole Inspection Report

Date:	04/11/2018	Weather:		Coding:	RZMACP
MH#:	M-603-023	Owner:	NA	Len. Surveyed:	4.7
P.O.#:		Surveyor:	John Kuglmaier	Rim to Invert:	5.8
Customer:		Cert. #:	U-1215-07002349	Wall Material:	Concrete (reinforced)

Street:	40th Place 185' East of Wisconsin St.	Project:	Hobart, IN
City:	Hobart, IN	GPS Northing:	0.0
Location:		GPS Easting:	0.0
Drain Area:	Northwest	GPS Accuracy:	Nearest Meter
Cover Shape:	Circular	Evidence of Surcharge:	No
Cover Size:	23.0	Potential for Runoff:	None
Comments:

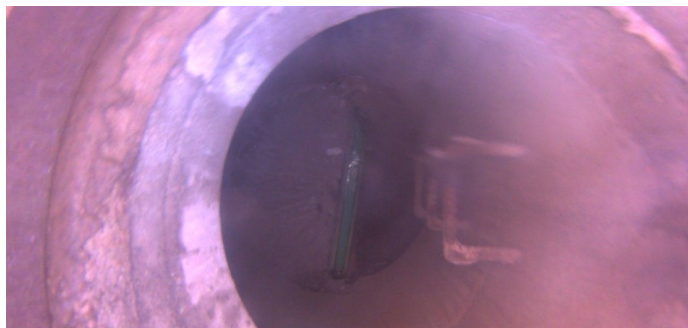
Code: **MGP**
Description: **General Photo**

Distance (ft): **.0**
Structural Grade: **0**
O&M Grade: **0**
Clock Start/From:
Clock To:
1st Value:
2nd Value:
Value Percent:
Step: **NO**
Remarks:

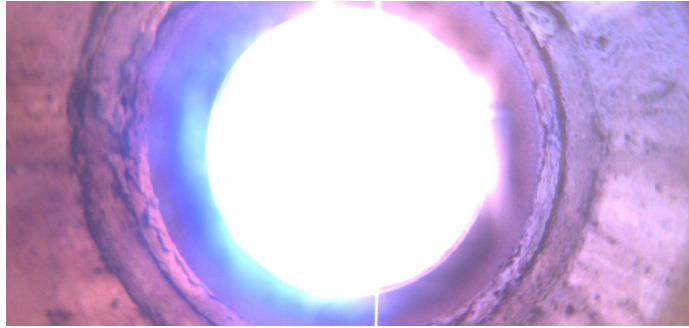
Code: **MGP**
Description: **General Photo**

Distance (ft): **2.0**
Structural Grade: **0**
O&M Grade: **0**
Clock Start/From:
Clock To:
1st Value:
2nd Value:
Value Percent:
Step: **NO**
Remarks:

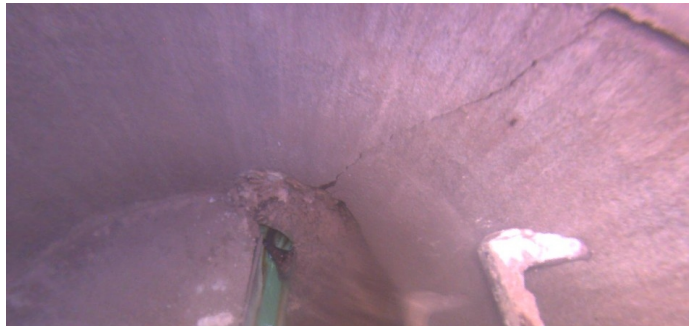
Code: **CS**
Description: **Crack Spiral**

Distance (ft): **2.5**
Structural Grade: **2**
O&M Grade: **0**
Clock Start/From: **1**
Clock To: **2**
1st Value:
2nd Value:
Value Percent:
Step: **NO**
Remarks:

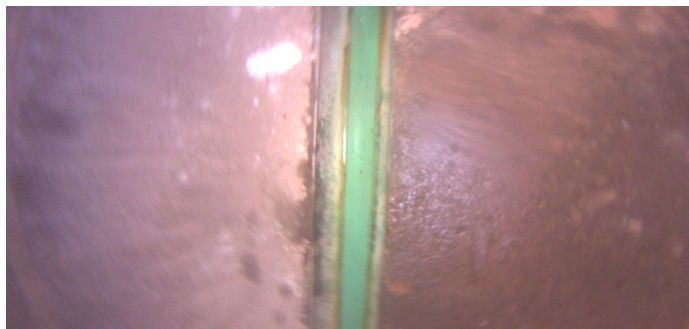
Code: **MGO**
Description: **General Observation**

Distance (ft): **4.0**
Structural Grade: **0**
O&M Grade: **0**
Clock Start/From:
Clock To:
1st Value:
2nd Value:
Value Percent:
Step: **NO**
Remarks: **Ins. Comp.**
