# Manhole Inspection Report

Date:	<b>04/11/2018</b>	Weather:		Coding:	<b>RZMACP</b>
MH#:	<b>M-603-024</b>	Owner:	<b>NA</b>	Len. Surveyed:	<b>1.7</b>
P.O.#:		Surveyor:	<b>John Kuglmaier</b>	Rim to Invert:	<b>2.3</b>
Customer:		Cert. #:	<b>U-1215-07002349</b>	Wall Material:	<b>Concrete (reinforced)</b>

Street:	<b>South of 40th Pl. West of YMCA. O</b>	Project:	<b>Hobart, IN</b>
City:	<b>Hobart, IN</b>	GPS Northing:	<b>2901985.262</b>
Location:		GPS Easting:	<b>2901985.262</b>
Drain Area:	<b>Northwest</b>	GPS Accuracy:	<b>Sub-Meter</b>
Cover Shape:	<b>Circular</b>	Evidence of Surcharge:	<b>No</b>
Cover Size:	<b>23.0</b>	Potential for Runoff:	<b>None</b>
Comments:

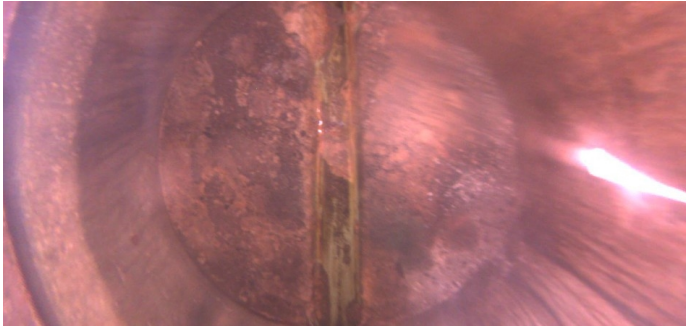
Code:	<b>DSF</b>
Description:	<b>Deposits Settled Fine</b>

Distance (ft):	<b>.1</b>
Structural Grade:	<b>0</b>
O&M Grade:	<b>2</b>
Clock Start/From:	<b>12</b>
Clock To:	<b>12</b>
1st Value:	
2nd Value:	
Value Percent:	<b>5.000</b>
Step:	<b>NO</b>
Remarks:

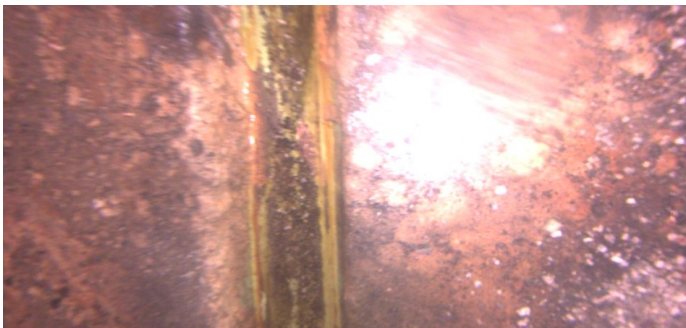
Code:	<b>MGO</b>
Description:	<b>General Observation</b>

Distance (ft):	<b>1.4</b>
Structural Grade:	<b>0</b>
O&M Grade:	<b>0</b>
Clock Start/From:	
Clock To:	
1st Value:	
2nd Value:	
Value Percent:	
Step:	<b>NO</b>
Remarks:	<b>Ins. Comp.</b>
