Manhole Inspection Report

Date:	04/11/2018	Weather:		Coding:	RZMACP
MH#:	M-603-025	Owner:	NA	Len. Surveyed:	8.2
P.O.#:		Surveyor:	John Kuglmaier	Rim to Invert:	10.0
Customer:		Cert. #:	U-1215-07002349	Wall Material:	Concrete (reinforced)

Street:	453' Southwest of 40th Pl. and Was	Project:	Hobart, IN
City:	Hobart, IN	GPS Northing:	2902620.277
Location:		GPS Easting:	2902620.277
Drain Area:	Northwest	GPS Accuracy:	Sub-Meter
Cover Shape:	Circular	Evidence of Surcharge:	No
Cover Size:	23.0	Potential for Runoff:	None
Comments:

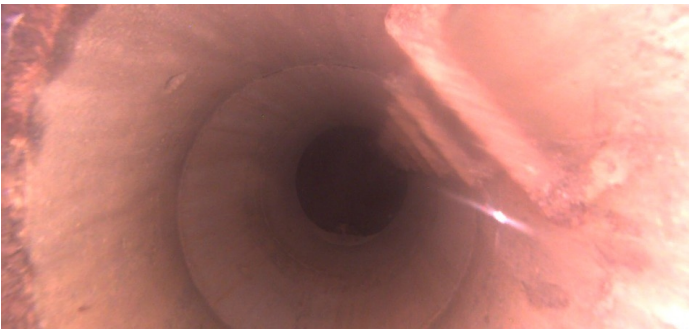
Code: **MGP**
Description: **General Photo**

Distance (ft): **.0**
Structural Grade: **0**
O&M Grade: **0**
Clock Start/From:
Clock To:
1st Value:
2nd Value:
Value Percent:
Step: **NO**
Remarks:

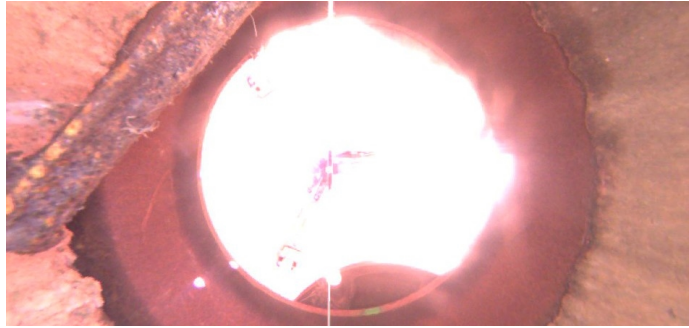
Code: **MGP**
Description: **General Photo**

Distance (ft): **1.7**
Structural Grade: **0**
O&M Grade: **0**
Clock Start/From:
Clock To:
1st Value:
2nd Value:
Value Percent:
Step: **NO**
Remarks:

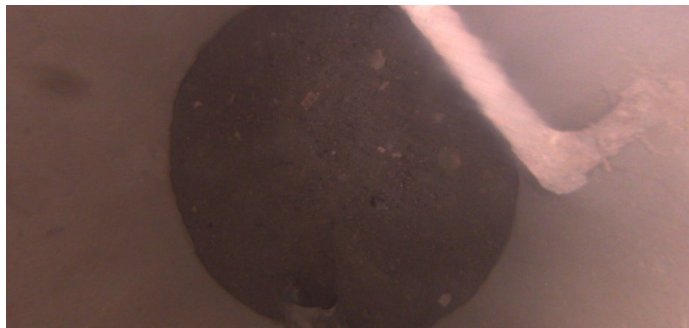
Code: **DSF**
Description: **Deposits Settled Fine**

Distance (ft): **6.8**
Structural Grade: **0**
O&M Grade: **3**
Clock Start/From: **12**
Clock To: **12**
1st Value:
2nd Value:
Value Percent: **15.000**
Step: **NO**
Remarks:

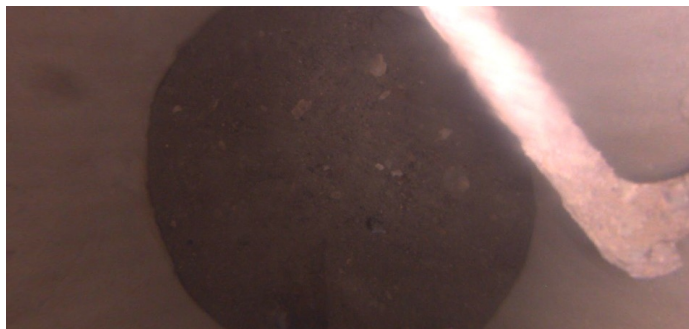
Code: **MGO**
Description: **General Observation**

Distance (ft): **7.2**
Structural Grade: **0**
O&M Grade: **0**
Clock Start/From:
Clock To:
1st Value:
2nd Value:
Value Percent:
Step: **NO**
Remarks: **Ins. Comp.**
