Manhole Inspection Report

Date:	04/11/2018	Weather:		Coding:	RZMACP
MH#:	M-603-026	Owner:	NA	Len. Surveyed:	5.3
P.O.#:		Surveyor:	John Kuglmaier	Rim to Invert:	6.5
Customer:		Cert. #:	U-1215-07002349	Wall Material:	Concrete (reinforced)

Street:	531' West of 40th Pl. and Washingto	Project:	Hobart, IN
City:	Hobart, IN	GPS Northing:	2902736.649
Location:		GPS Easting:	2902736.649
Drain Area:	Northwest	GPS Accuracy:	Sub-Meter
Cover Shape:	Circular	Evidence of Surcharge:	Yes
Cover Size:	23.0	Potential for Runoff:	None
Comments:

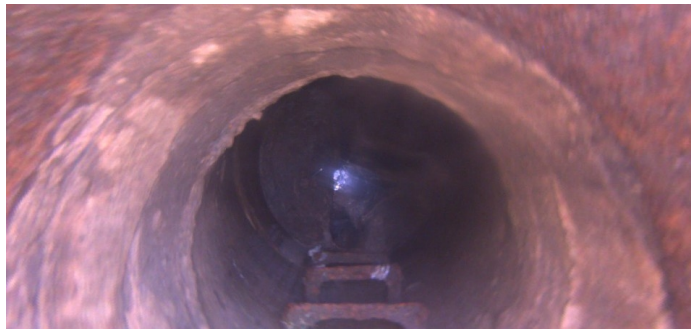
Code: **MGP**
Description: **General Photo**

Distance (ft): **.0**
Structural Grade: **0**
O&M Grade: **0**
Clock Start/From:
Clock To:
1st Value:
2nd Value:
Value Percent:
Step: **NO**
Remarks:

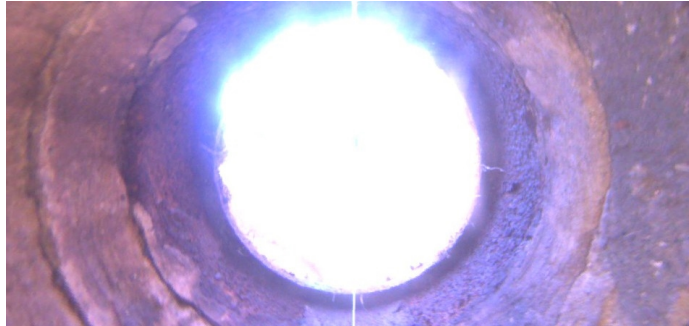
Code: **MGP**
Description: **General Photo**

Distance (ft): **2.1**
Structural Grade: **0**
O&M Grade: **0**
Clock Start/From:
Clock To:
1st Value:
2nd Value:
Value Percent:
Step: **NO**
Remarks:

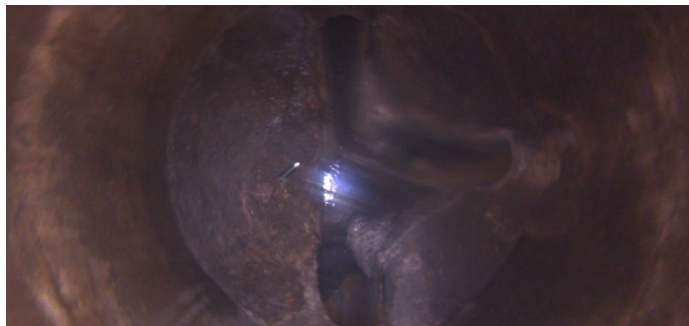
Code: **DSF**
Description: **Deposits Settled Fine**

Distance (ft): **3.0**
Structural Grade: **0**
O&M Grade: **2**
Clock Start/From: **12**
Clock To: **12**
1st Value:
2nd Value:
Value Percent: **10.000**
Step: **NO**
Remarks:

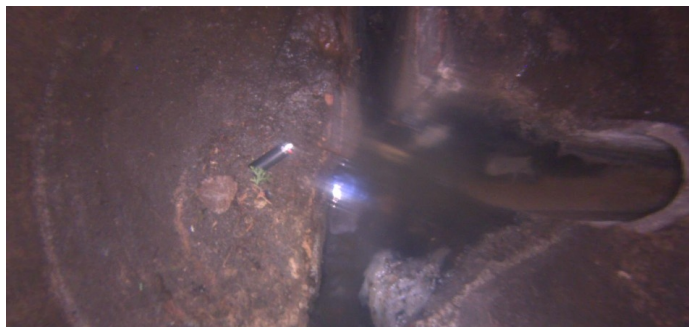
Code: **MGO**
Description: **General Observation**

Distance (ft): **4.4**
Structural Grade: **0**
O&M Grade: **0**
Clock Start/From:
Clock To:
1st Value:
2nd Value:
Value Percent:
Step: **NO**
Remarks: **Ins. Comp.**
