Manhole Inspection Report

Date:	04/11/2018	Weather:		Coding:	RZMACP
MH#:	M-603-028	Owner:	NA	Len. Surveyed:	4.4
P.O.#:		Surveyor:	John Kuglmaier	Rim to Invert:	5.8
Customer:		Cert. #:	U-1215-07002349	Wall Material:	Concrete (reinforced)

Street:	313' Northeast of 40th Pl. and Wash	Project:	Hobart, IN
City:	Hobart, IN	GPS Northing:	0.0
Location:		GPS Easting:	0.0
Drain Area:	Northwest	GPS Accuracy:	Nearest Meter
Cover Shape:	Circular	Evidence of Surcharge:	No
Cover Size:	23.0	Potential for Runoff:	None
Comments:

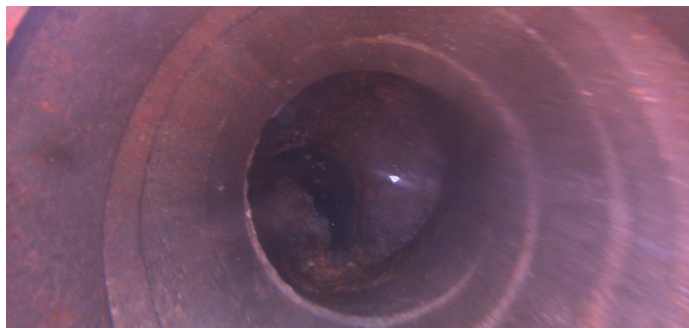
Code: **MGP**
Description: **General Photo**

Distance (ft): **.0**
Structural Grade: **0**
O&M Grade: **0**
Clock Start/From:
Clock To:
1st Value:
2nd Value:
Value Percent:
Step: **NO**
Remarks:

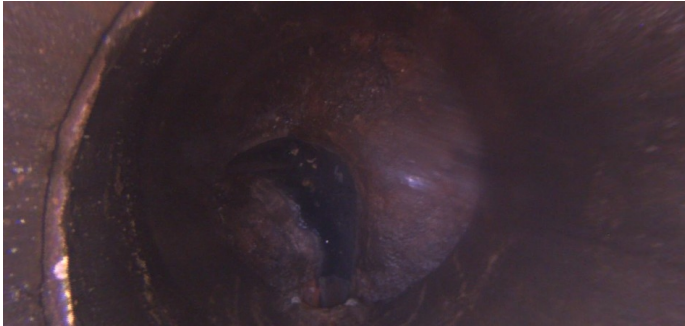
Code:	DAZ
Description:	Deposits Attached Other

Distance (ft):	1.5
Structural Grade:	0
O&M Grade:	3
Clock Start/From:	12
Clock To:	12
1st Value:	
2nd Value:	
Value Percent:	15.000
Step:	NO
Remarks:	Mixed materials

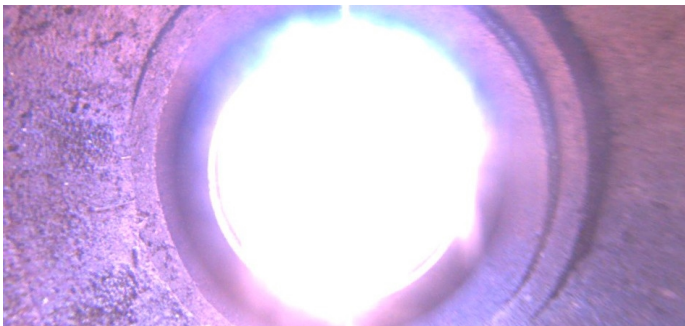
Code:	MGP
Description:	General Photo

Distance (ft):	2.4
Structural Grade:	0
O&M Grade:	0
Clock Start/From:	
Clock To:	
1st Value:	
2nd Value:	
Value Percent:	
Step:	NO
Remarks:

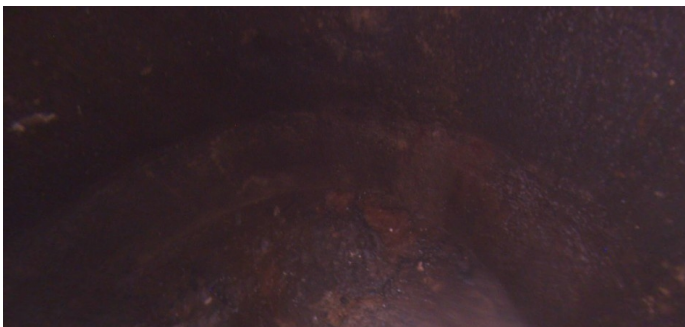
Code:	IS
Description:	Infil Stain

Distance (ft):	2.8
Structural Grade:	0
O&M Grade:	0
Clock Start/From:	1
Clock To:	
1st Value:	
2nd Value:	
Value Percent:	
Step:	NO
Remarks:

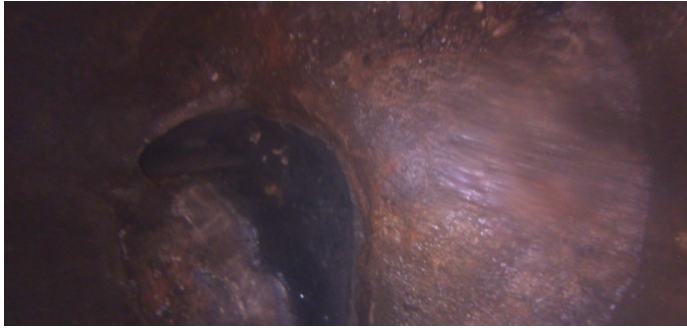
Code:	MGO
Description:	General Observation
Distance (ft):	3.6
Structural Grade:	0
O&M Grade:	0
Clock Start/From:	
Clock To:	
1st Value:	
2nd Value:	
Value Percent:	
Step:	NO
Remarks:	Ins. Comp.
