# Manhole Inspection Report

Date:	<b>04/11/2018</b>	Weather:		Coding:	<b>RZMACP</b>
MH#:	<b>M-603-028</b>	Owner:	<b>NA</b>	Len. Surveyed:	<b>4.9</b>
P.O.#:		Surveyor:	<b>John Kuglmaier</b>	Rim to Invert:	<b>6.0</b>
Customer:		Cert. #:	<b>U-1215-07002349</b>	Wall Material:	<b>Concrete (reinforced)</b>

Street:	<b>313' Northeast of 40th Pl. and Wash</b>	Project:	<b>Hobart, IN</b>
City:	<b>Hobart, IN</b>	GPS Northing:	<b>0.0</b>
Location:		GPS Easting:	<b>0.0</b>
Drain Area:	<b>Northwest</b>	GPS Accuracy:	<b>Nearest Meter</b>
Cover Shape:	<b>Circular</b>	Evidence of Surcharge:	<b>Yes</b>
Cover Size:	<b>23.0</b>	Potential for Runoff:	<b>None</b>
Comments:

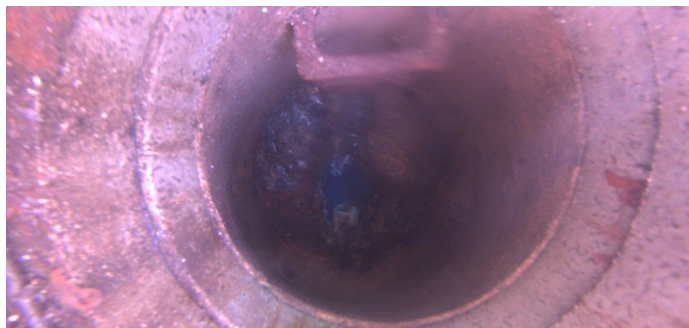
Code: **MGP**  
Description: **General Photo**

Distance (ft): **.0**  
Structural Grade: **0**  
O&M Grade: **0**  
Clock Start/From:  
Clock To:  
1st Value:  
2nd Value:  
Value Percent:  
Step: **NO**  
Remarks:

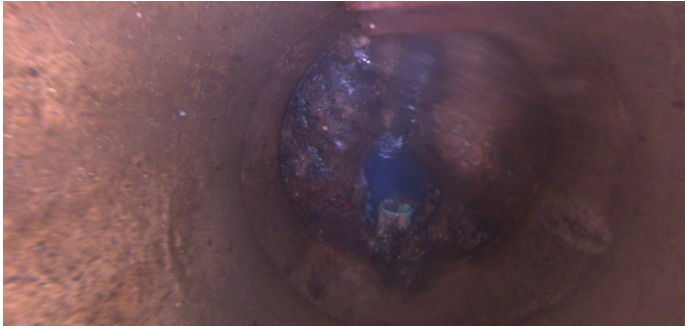
Code: **IS**  
Description: **Infil Stain**

Distance (ft): **1.6**  
Structural Grade: **0**  
O&M Grade: **0**  
Clock Start/From: **7**  
Clock To:  
1st Value:  
2nd Value:  
Value Percent:  
Step: **NO**  
Remarks:

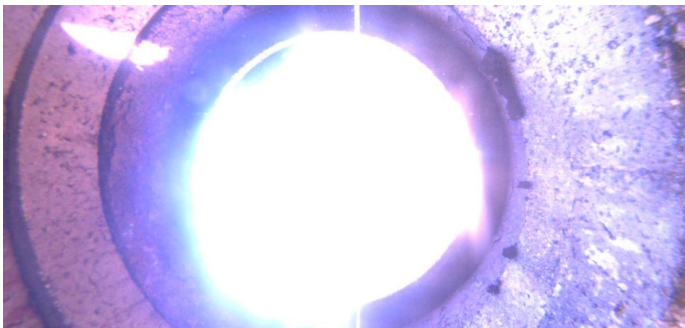
Code: **MGP**  
Description: **General Photo**

Distance (ft): **2.1**  
Structural Grade: **0**  
O&M Grade: **0**  
Clock Start/From:  
Clock To:  
1st Value:  
2nd Value:  
Value Percent:  
Step: **NO**  
Remarks:

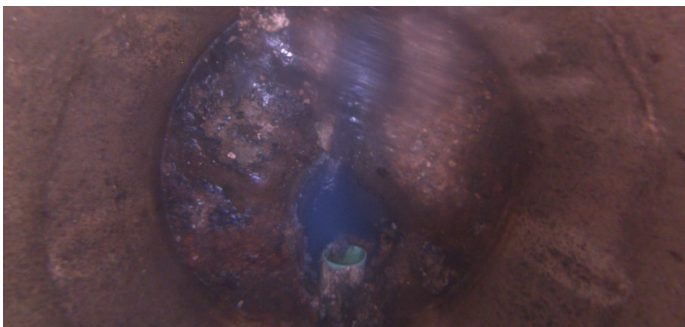
Code: **DAZ**  
Description: **Deposits Attached Other**

Distance (ft): **2.9**  
Structural Grade: **0**  
O&M Grade: **2**  
Clock Start/From: **12**  
Clock To: **12**  
1st Value:  
2nd Value:  
Value Percent: **10.000**  
Step: **NO**  
Remarks: **Mixed materials**

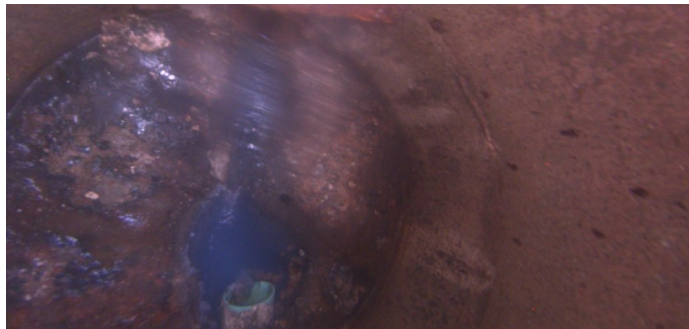
Code: **IS**  
Description: **Infil Stain**

Distance (ft): **2.9**  
Structural Grade: **0**  
O&M Grade: **0**  
Clock Start/From: **4**  
Clock To:  
1st Value:  
2nd Value:  
Value Percent:  
Step: **NO**  
Remarks:

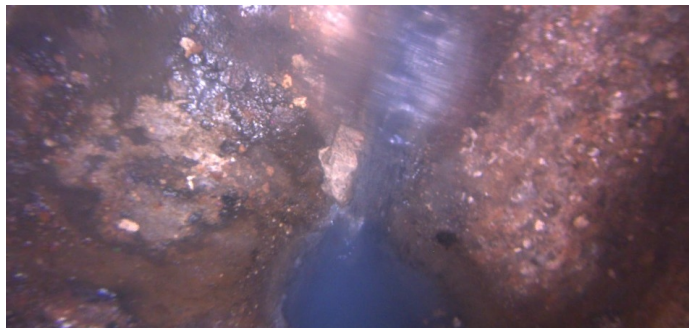
Code: **MGO**  
Description: **General Observation**

Distance (ft): **4.4**  
Structural Grade: **0**  
O&M Grade: **0**  
Clock Start/From:  
Clock To:  
1st Value:  
2nd Value:  
Value Percent:  
Step: **NO**  
Remarks: **Ins. Comp.**
