Manhole Inspection Report

Date:	04/11/2018	Weather:		Coding:	RZMACP
MH#:	M-603-029	Owner:	NA	Len. Surveyed:	4.4
P.O.#:		Surveyor:	John Kuglmaier	Rim to Invert:	5.4
Customer:		Cert. #:	U-1215-07002349	Wall Material:	Concrete (reinforced)

Street:	39th Pl. Between Wisconsin St. and	Project:	Hobart, IN
City:	Hobart, IN	GPS Northing:	2902052.358
Location:		GPS Easting:	2902052.358
Drain Area:	Northwest	GPS Accuracy:	Sub-Meter
Cover Shape:	Circular	Evidence of Surcharge:	Yes
Cover Size:	23.0	Potential for Runoff:	None
Comments:

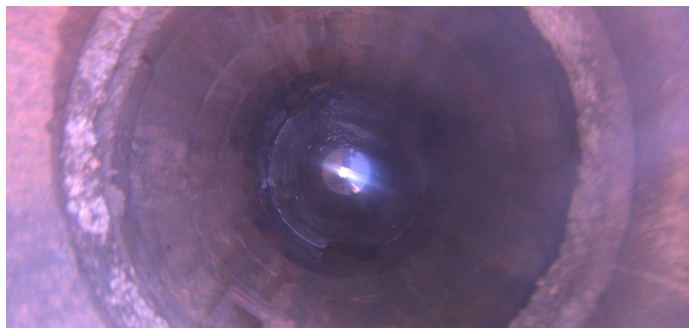
Code: **MGP**
Description: **General Photo**

Distance (ft): **.0**
Structural Grade: **0**
O&M Grade: **0**
Clock Start/From:
Clock To:
1st Value:
2nd Value:
Value Percent:
Step: **NO**
Remarks:

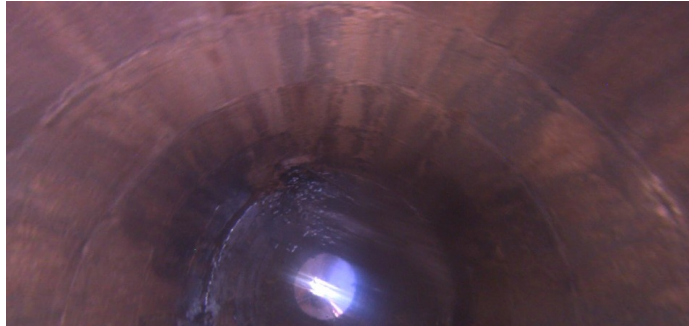
Code: **IS**
Description: **Infil Stain**

Distance (ft): **1.6**
Structural Grade: **0**
O&M Grade: **0**
Clock Start/From: **10**
Clock To: **2**
1st Value:
2nd Value:
Value Percent:
Step: **NO**
Remarks:

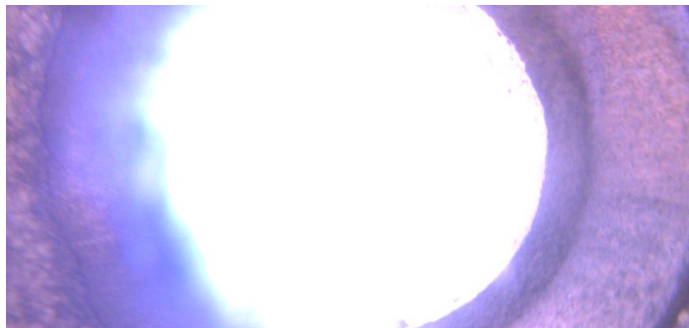
Code: **MGP**
Description: **General Photo**

Distance (ft): **1.9**
Structural Grade: **0**
O&M Grade: **0**
Clock Start/From:
Clock To:
1st Value:
2nd Value:
Value Percent:
Step: **NO**
Remarks:

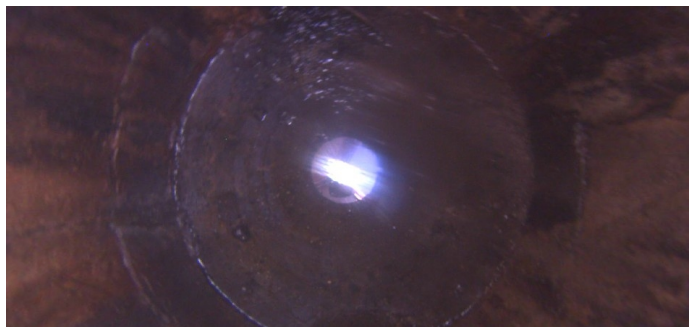
Code: **MGO**
Description: **General Observation**

Distance (ft): **2.9**
Structural Grade: **0**
O&M Grade: **0**
Clock Start/From:
Clock To:
1st Value:
2nd Value:
Value Percent:
Step: **NO**
Remarks: **Surcharge**

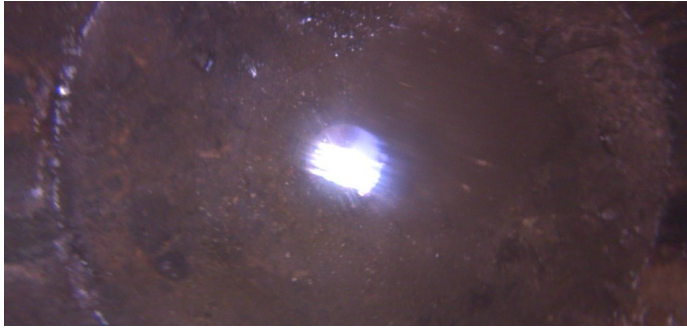
Code:	MGO
Description:	General Observation
Distance (ft):	3.8
Structural Grade:	0
O&M Grade:	0
Clock Start/From:	
Clock To:	
1st Value:	
2nd Value:	
Value Percent:	
Step:	NO
Remarks:	Ins. Comp.
