Manhole Inspection Report

Date:	04/08/2018	Weather:		Coding:	RZMACP
MH#:	M-603-033	Owner:	NA	Len. Surveyed:	6.0
P.O.#:		Surveyor:	John Kuglmaier	Rim to Invert:	7.5
Customer:		Cert. #:	U-1215-07002349	Wall Material:	Concrete (reinforced)

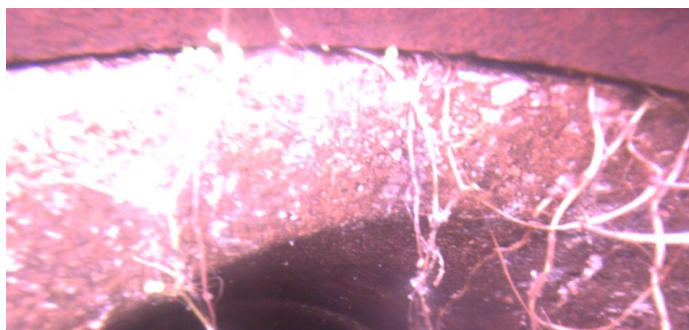
Code: **RFJ**
Description: **Roots Fine Joint**

Distance (ft): **.0**
Structural Grade: **0**
O&M Grade: **1**
Clock Start/From: **12**
Clock To: **3**
1st Value:
2nd Value:
Value Percent:
Step: **NO**
Remarks:

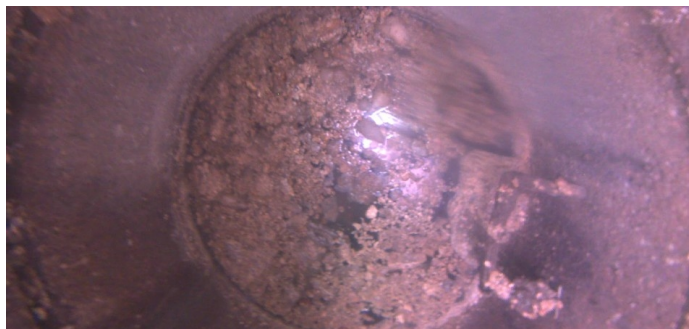
Code: **MGO**
Description: **General Observation**

Distance (ft): **3.5**
Structural Grade: **0**
O&M Grade: **0**
Clock Start/From:
Clock To:
1st Value:
2nd Value:
Value Percent:
Step: **NO**
Remarks: **Surcharge**

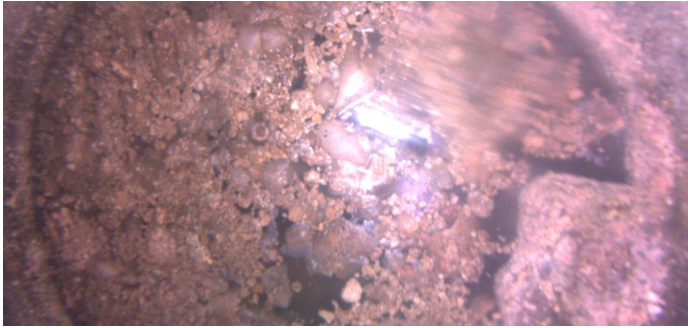
Code:	MSA
Description:	Abandoned Survey
Distance (ft):	5.1
Structural Grade:	0
O&M Grade:	0
Clock Start/From:	
Clock To:	
1st Value:	
2nd Value:	
Value Percent:	
Step:	NO
Remarks:	Surcharge
