Manhole Inspection Report

Date:	04/08/2018	Weather:		Coding:	RZMACP
MH#:	M-603-034	Owner:	NA	Len. Surveyed:	3.6
P.O.#:		Surveyor:	John Kuglmaier	Rim to Invert:	4.5
Customer:		Cert. #:	U-1215-07002349	Wall Material:	Concrete (reinforced)

Street:	223' South of Hwy 6. East of Wiscon	Project:	Hobart, IN
City:	Hobart, IN	GPS Northing:	2902054.389
Location:		GPS Easting:	2902054.389
Drain Area:	Northwest	GPS Accuracy:	Sub-Meter
Cover Shape:	Circular	Evidence of Surcharge:	Yes
Cover Size:	23.0	Potential for Runoff:	None
Comments:

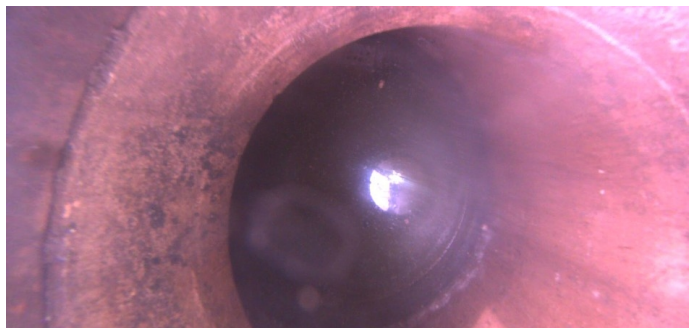
Code: **MGP**
Description: **General Photo**

Distance (ft): **.0**
Structural Grade: **0**
O&M Grade: **0**
Clock Start/From:
Clock To:
1st Value:
2nd Value:
Value Percent:
Step: **NO**
Remarks:

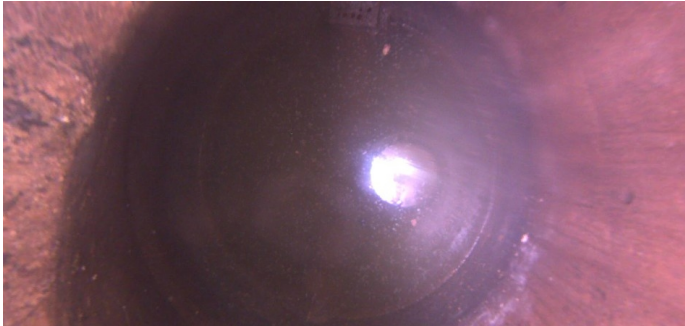
Code:	MGO
Description:	General Observation

Distance (ft):	.9
Structural Grade:	0
O&M Grade:	0
Clock Start/From:	
Clock To:	
1st Value:	
2nd Value:	
Value Percent:	
Step:	NO
Remarks:	Surcharge

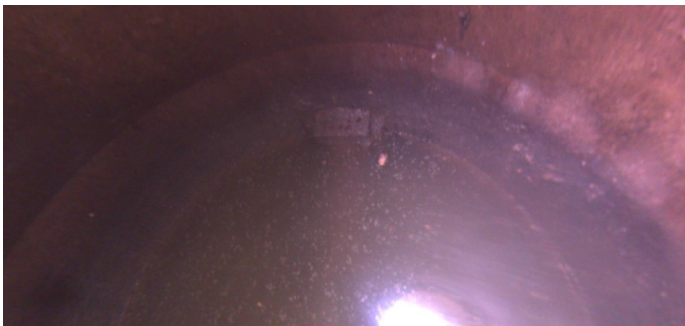
Code:	OBB
Description:	Obstacle Brick

Distance (ft):	1.8
Structural Grade:	0
O&M Grade:	2
Clock Start/From:	12
Clock To:	
1st Value:	
2nd Value:	
Value Percent:	5.000
Step:	NO
Remarks:

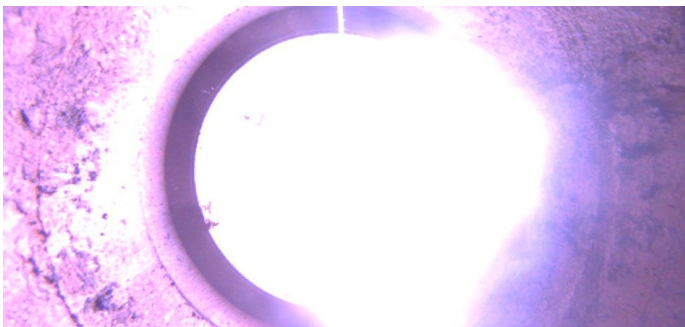
Code:	MGP
Description:	General Photo

Distance (ft):	2.0
Structural Grade:	0
O&M Grade:	0
Clock Start/From:	
Clock To:	
1st Value:	
2nd Value:	
Value Percent:	
Step:	NO
Remarks:

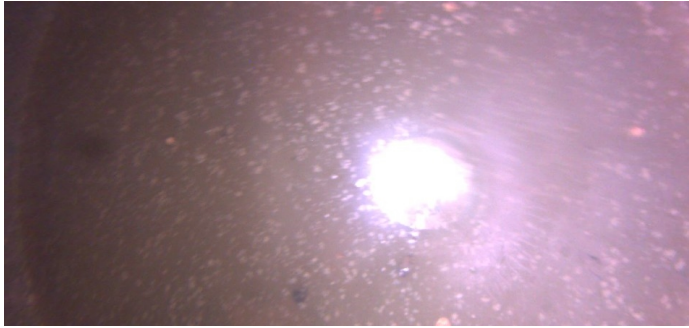
Code:	MSA
Description:	Abandoned Survey
Distance (ft):	2.9
Structural Grade:	0
O&M Grade:	0
Clock Start/From:	
Clock To:	
1st Value:	
2nd Value:	
Value Percent:	
Step:	NO
Remarks:	Surcharge
