# Manhole Inspection Report

Date:	<b>04/08/2018</b>	Weather:		Coding:	<b>RZMACP</b>
MH#:	<b>M-603-035</b>	Owner:	<b>NA</b>	Len. Surveyed:	<b>2.0</b>
P.O.#:		Surveyor:	<b>John Kuglmaier</b>	Rim to Invert:	<b>2.7</b>
Customer:		Cert. #:	<b>U-1215-07002349</b>	Wall Material:	<b>Concrete (reinforced)</b>

Street:	<b>South of Hwy 6 and 500' East of Wis</b>	Project:	<b>Hobart, IN</b>
City:	<b>Hobart, IN</b>	GPS Northing:	<b>2902254.845</b>
Location:		GPS Easting:	<b>2902254.845</b>
Drain Area:	<b>Northwest</b>	GPS Accuracy:	<b>Sub-Meter</b>
Cover Shape:	<b>Circular</b>	Evidence of Surcharge:	<b>No</b>
Cover Size:	<b>23.0</b>	Potential for Runoff:	<b>None</b>
Comments:

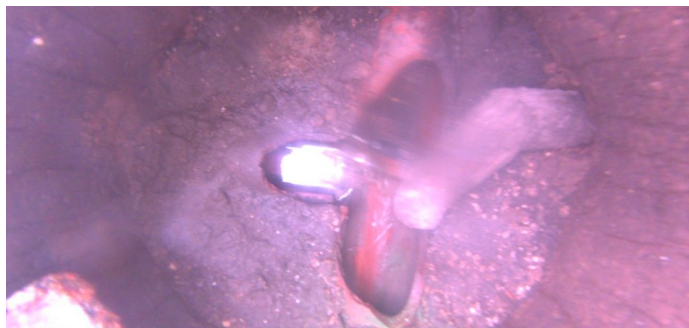
Code: **MGP**  
Description: **General Photo**

Distance (ft): **.0**  
Structural Grade: **0**  
O&M Grade: **0**  
Clock Start/From:  
Clock To:  
1st Value:  
2nd Value:  
Value Percent:  
Step: **NO**  
Remarks:

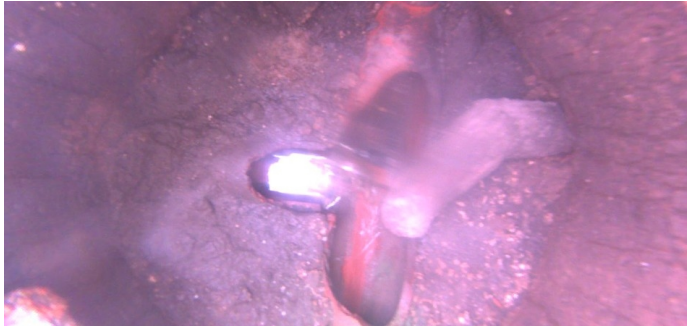
Code:	<b>DSF</b>
Description:	<b>Deposits Settled Fine</b>
Distance (ft):	<b>.0</b>
Structural Grade:	<b>0</b>
O&M Grade:	<b>3</b>
Clock Start/From:	<b>12</b>
Clock To:	<b>12</b>
1st Value:	
2nd Value:	
Value Percent:	<b>20.000</b>
Step:	<b>NO</b>
Remarks:

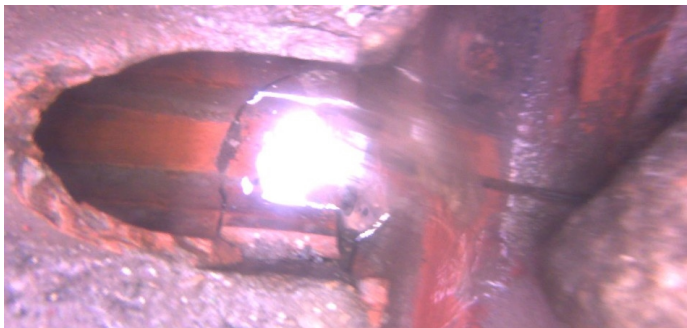
Code:	<b>MGO</b>
Description:	<b>General Observation</b>
Distance (ft):	<b>1.7</b>
Structural Grade:	<b>0</b>
O&M Grade:	<b>0</b>
Clock Start/From:	
Clock To:	
1st Value:	
2nd Value:	
Value Percent:	
Step:	<b>NO</b>
Remarks:	<b>Ins. Comp.</b>
