# Manhole Inspection Report

Date:	<b>04/29/2018</b>	Weather:		Coding:	<b>RZMACP</b>
MH#:	<b>M-604-000</b>	Owner:	<b>NA</b>	Len. Surveyed:	<b>6.4</b>
P.O.#:		Surveyor:	<b>Jen Costello</b>	Rim to Invert:	<b>7.1</b>
Customer:		Cert. #:	<b>U-907-5518</b>	Wall Material:	<b>Brick</b>

Street:	<b>West Side of Lake Park Ave North of</b>	Project:	<b>Hobart, IN</b>
City:	<b>Hobart, IN</b>	GPS Northing:	<b>2904433.106</b>
Location:		GPS Easting:	<b>2904433.106</b>
Drain Area:	<b>North</b>	GPS Accuracy:	<b>Sub-Meter</b>
Cover Shape:	<b>Circular</b>	Evidence of Surcharge:	<b>No</b>
Cover Size:	<b>22.5</b>	Potential for Runoff:	<b>None</b>
Comments:

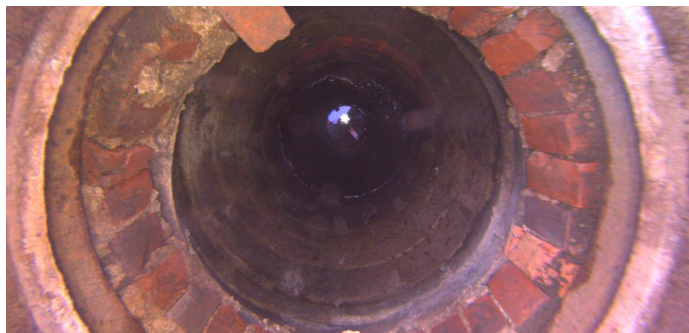
Code: **MGO**  
Description: **General Observation**

Distance (ft): **.0**  
Structural Grade: **0**  
O&M Grade: **0**  
Clock Start/From:  
Clock To:  
1st Value:  
2nd Value:  
Value Percent:  
Step: **NO**  
Remarks: **ACCESS MH**

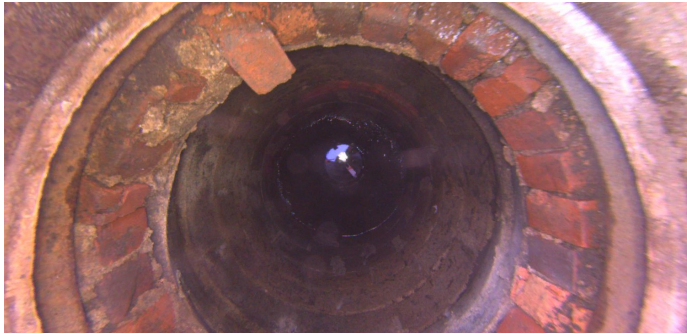
Code: **DB**  
Description: **Displaced Brick**

Distance (ft): **.0**  
Structural Grade: **3**  
O&M Grade: **0**  
Clock Start/From: **11**  
Clock To:  
1st Value:  
2nd Value:  
Value Percent:  
Step: **NO**  
Remarks:

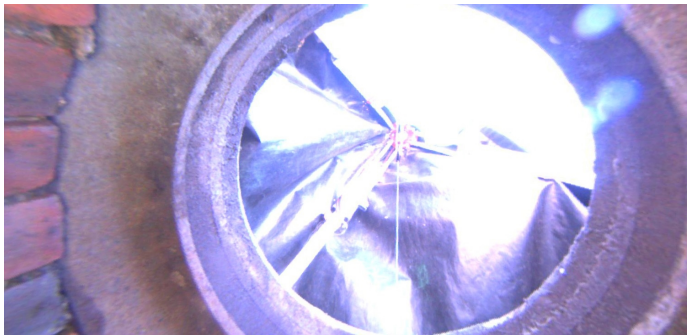
Code: **MGP**  
Description: **General Photo**

Distance (ft): **1.6**  
Structural Grade: **0**  
O&M Grade: **0**  
Clock Start/From:  
Clock To:  
1st Value:  
2nd Value:  
Value Percent:  
Step: **NO**  
Remarks: **UNDERSIDE OF FRAME**

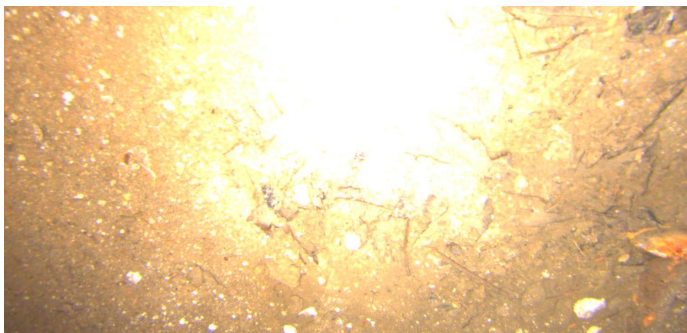
Code: **MGO**  
Description: **General Observation**

Distance (ft): **6.4**  
Structural Grade: **0**  
O&M Grade: **0**  
Clock Start/From:  
Clock To:  
1st Value:  
2nd Value:  
Value Percent:  
Step: **NO**  
Remarks: **END SURVEY BENCH IS SUBMERGED**
