# Manhole Inspection Report

Date:	05/01/2018	Weather:		Coding:	RZMACP
MH#:	M-604-001	Owner:	NA	Len. Surveyed:	4.5
P.O.#:		Surveyor:	Jen Costello	Rim to Invert:	4.8
Customer:		Cert. #:	U-907-5518	Wall Material:	Concrete (reinforced)

Street:	Intersection of Lake Park Ave. and CI	Project:	Hobart, IN
City:	Hobart, IN	GPS Northing:	41.5362854
Location:		GPS Easting:	-87.25980377
Drain Area:	West	GPS Accuracy:	Nearest Meter
Cover Shape:	Circular	Evidence of Surcharge:	No
Cover Size:	22.5	Potential for Runoff:	None
Comments:

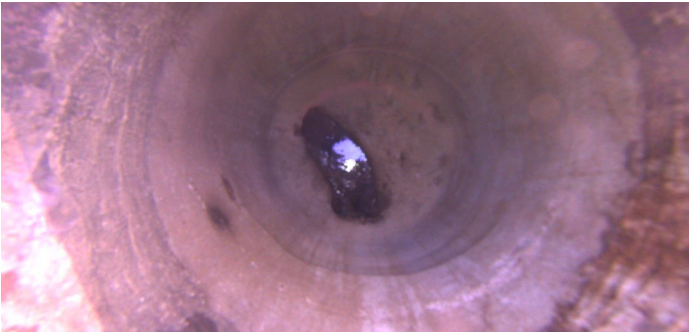
Code: **MGP**  
Description: **General Photo**

Distance (ft): **.0**  
Structural Grade: **0**  
O&M Grade: **0**  
Clock Start/From:  
Clock To:  
1st Value:  
2nd Value:  
Value Percent:  
Step: **NO**  
Remarks: **access mh**

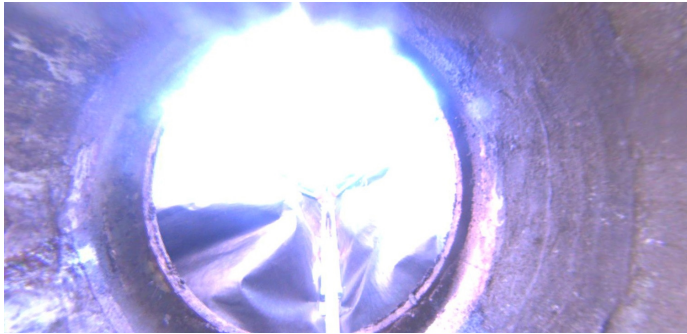
Code: **MGO**  
Description: **General Observation**

Distance (ft): **2.1**  
Structural Grade: **0**  
O&M Grade: **0**  
Clock Start/From:  
Clock To:  
1st Value:  
2nd Value:  
Value Percent:  
Step: **NO**  
Remarks: **underside of frame**

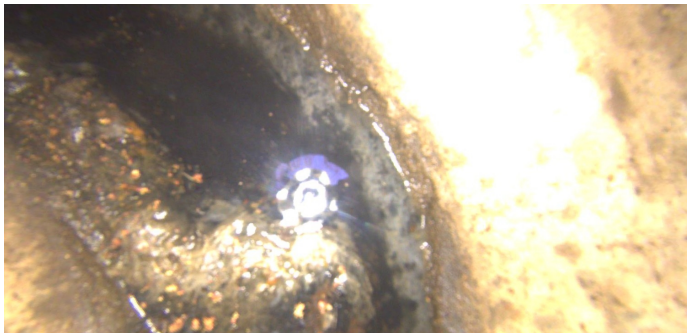
Code: **DSZ**  
Description: **Deposits Settled Other**

Distance (ft): **4.5**  
Structural Grade: **0**  
O&M Grade: **4**  
Clock Start/From: **6**  
Clock To: **9**  
1st Value:  
2nd Value:  
Value Percent: **30.000**  
Step: **NO**  
Remarks: **misc**

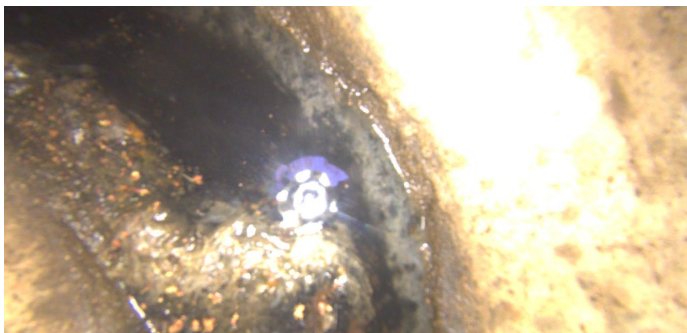
Code: **MGO**  
Description: **General Observation**

Distance (ft): **4.5**  
Structural Grade: **0**  
O&M Grade: **0**  
Clock Start/From:  
Clock To:  
1st Value:  
2nd Value:  
Value Percent:  
Step: **NO**  
Remarks: **end survey**
