Manhole Inspection Report

Date:	05/01/2018	Weather:		Coding:	RZMACP
MH#:	M-604-002	Owner:	NA	Len. Surveyed:	5.6
P.O.#:		Surveyor:	Jen Costello	Rim to Invert:	5.8
Customer:		Cert. #:	U-907-5518	Wall Material:	Concrete (reinforced)

Street:	Cleveland Ave. 98' East of Beverly Ln	Project:	Hobart, IN
City:	Hobart, IN	GPS Northing:	41.53626251
Location:		GPS Easting:	-87.26044464
Drain Area:	West	GPS Accuracy:	Nearest Meter
Cover Shape:	Circular	Evidence of Surcharge:	No
Cover Size:	22.5	Potential for Runoff:	None
Comments:

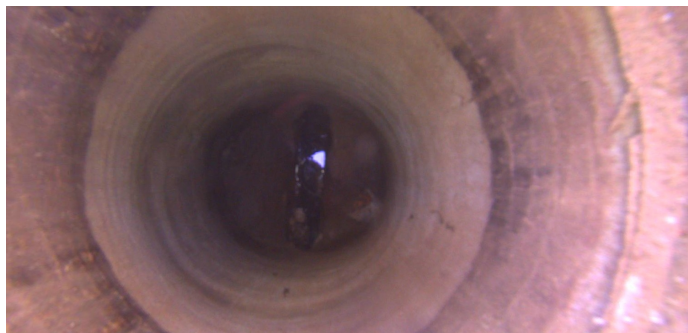
Code: **MGP**
Description: **General Photo**

Distance (ft): **.0**
Structural Grade: **0**
O&M Grade: **0**
Clock Start/From:
Clock To:
1st Value:
2nd Value:
Value Percent:
Step: **NO**
Remarks: **ACCESS MH**

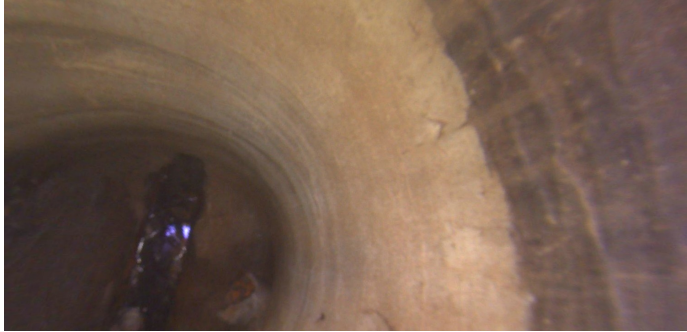
Code: **CL**
Description: **Crack Longitudinal**

Distance (ft): **1.2**
Structural Grade: **2**
O&M Grade: **0**
Clock Start/From: **2**
Clock To:
1st Value:
2nd Value:
Value Percent:
Step: **NO**
Remarks:

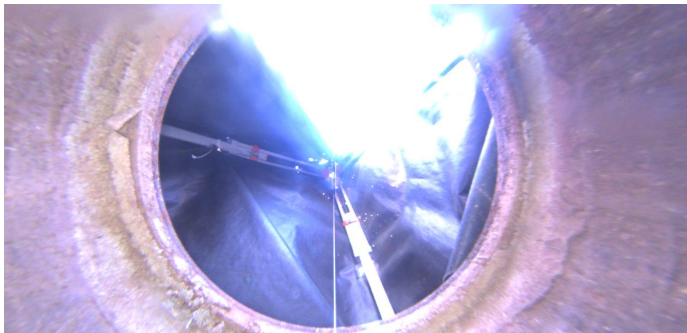
Code: **MGO**
Description: **General Observation**

Distance (ft): **1.8**
Structural Grade: **0**
O&M Grade: **0**
Clock Start/From:
Clock To:
1st Value:
2nd Value:
Value Percent:
Step: **NO**
Remarks: **UNDERSIDE OF FRAME**

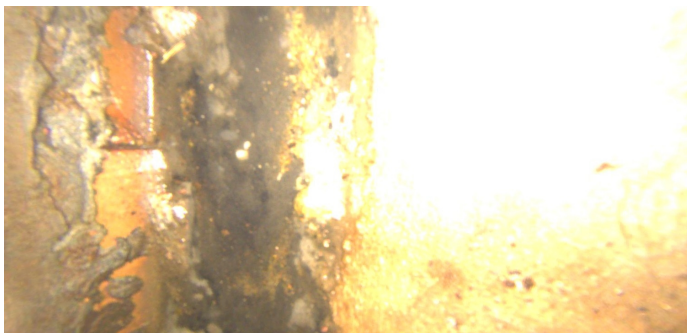
Code: **MGO**
Description: **General Observation**

Distance (ft): **5.6**
Structural Grade: **0**
O&M Grade: **0**
Clock Start/From:
Clock To:
1st Value:
2nd Value:
Value Percent:
Step: **NO**
Remarks: **END SURVEY**
