Manhole Inspection Report

Date:	05/01/2018	Weather:		Coding:	RZMACP
MH#:	M-604-004	Owner:	NA	Len. Surveyed:	7.0
P.O.#:		Surveyor:	Jen Costello	Rim to Invert:	7.5
Customer:		Cert. #:	U-907-5518	Wall Material:	Concrete (reinforced)

Street:	Intersection of Cleveland Ave. and	Project:	Hobart, IN
City:	Hobart, IN	GPS Northing:	41.53628159
Location:		GPS Easting:	-87.26189423
Drain Area:	West	GPS Accuracy:	Nearest Meter
Cover Shape:	Circular	Evidence of Surcharge:	No
Cover Size:	22.5	Potential for Runoff:	None
Comments:

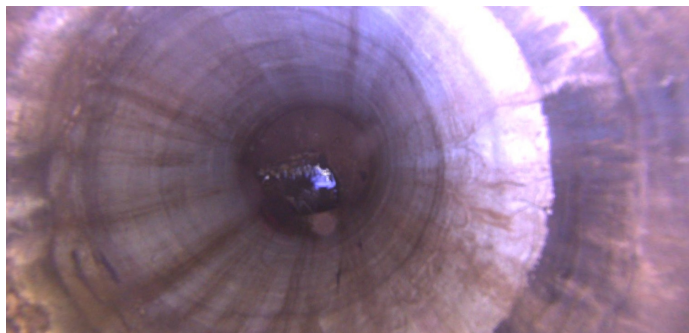
Code: **MGO**
Description: **General Observation**

Distance (ft): **.0**
Structural Grade: **0**
O&M Grade: **0**
Clock Start/From:
Clock To:
1st Value:
2nd Value:
Value Percent:
Step: **NO**
Remarks: **access MH**

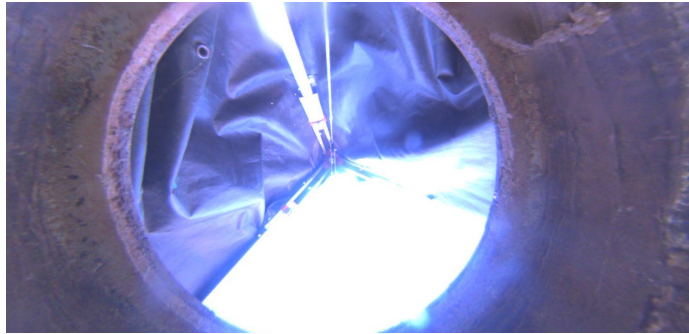
Code: **MGO**
Description: **General Observation**

Distance (ft): **1.3**
Structural Grade: **0**
O&M Grade: **0**
Clock Start/From:
Clock To:
1st Value:
2nd Value:
Value Percent:
Step: **NO**
Remarks: **UNDERSIDE OF FRAME**

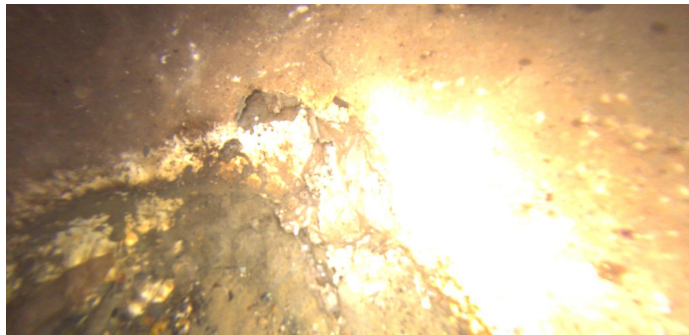
Code: **B**
Description: **Broken**

Distance (ft): **7.0**
Structural Grade: **3**
O&M Grade: **0**
Clock Start/From: **12**
Clock To:
1st Value:
2nd Value:
Value Percent:
Step: **NO**
Remarks:

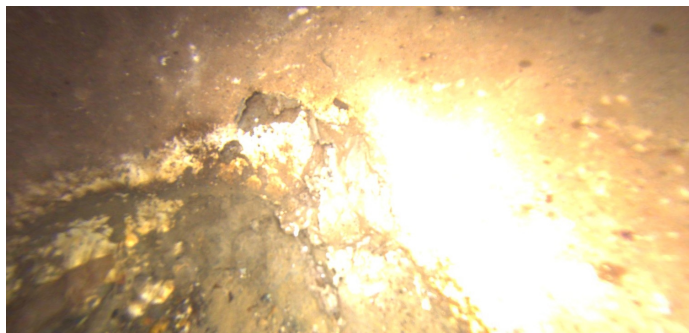
Code: **MGO**
Description: **General Observation**

Distance (ft): **7.0**
Structural Grade: **0**
O&M Grade: **0**
Clock Start/From:
Clock To:
1st Value:
2nd Value:
Value Percent:
Step: **NO**
Remarks: **END SURVEY**
