Manhole Inspection Report

Date:	05/01/2018	Weather:		Coding:	RZMACP
MH#:	M-604-004	Owner:	NA	Len. Surveyed:	6.1
P.O.#:		Surveyor:	Jen Costello	Rim to Invert:	6.7
Customer:		Cert. #:	U-907-5518	Wall Material:	Brick

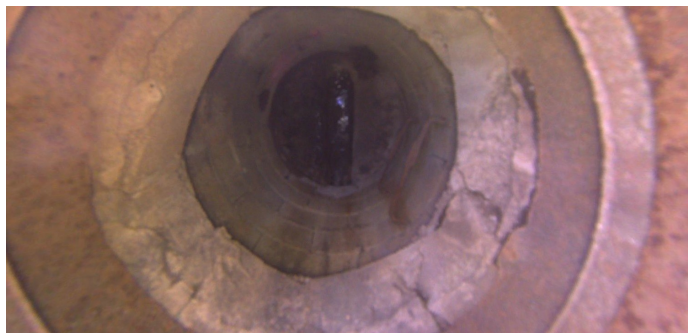
Code: **MGP**
Description: **General Photo**

Distance (ft): **.0**
Structural Grade: **0**
O&M Grade: **0**
Clock Start/From:
Clock To:
1st Value:
2nd Value:
Value Percent:
Step: **NO**
Remarks: **access MH**

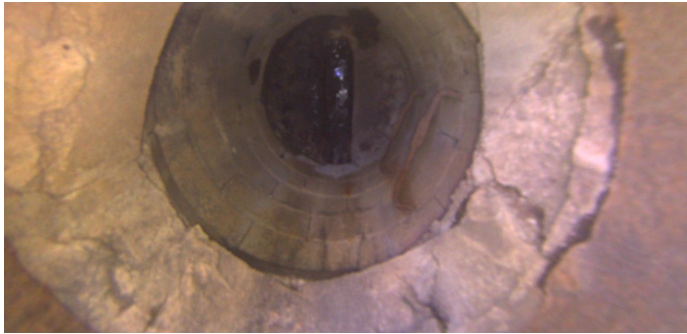
Code: **FM**
Description: **Fracture Multiple**

Distance (ft): **.4**
Structural Grade: **4**
O&M Grade: **0**
Clock Start/From: **3**
Clock To: **9**
1st Value:
2nd Value:
Value Percent:
Step: **NO**
Remarks:

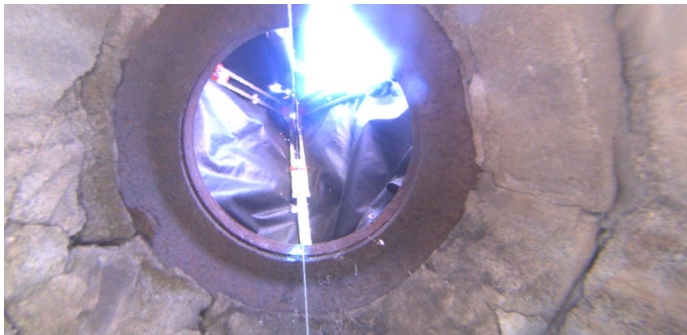
Code: **MGO**
Description: **General Observation**

Distance (ft): **2.9**
Structural Grade: **0**
O&M Grade: **0**
Clock Start/From:
Clock To:
1st Value:
2nd Value:
Value Percent:
Step: **NO**
Remarks: **UNDERSIDE OF FRAME**

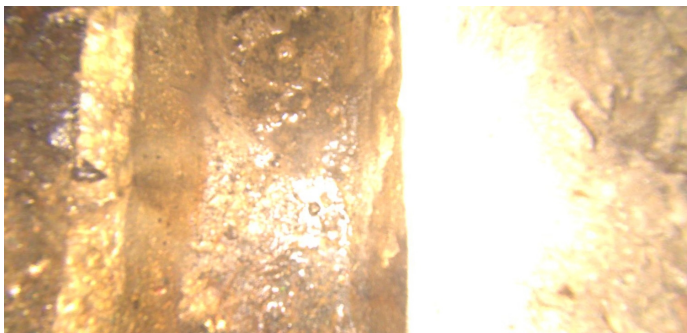
Code: **MGO**
Description: **General Observation**

Distance (ft): **6.1**
Structural Grade: **0**
O&M Grade: **0**
Clock Start/From:
Clock To:
1st Value:
2nd Value:
Value Percent:
Step: **NO**
Remarks: **END SURVEY**
