Manhole Inspection Report

Date:	10/13/2022	Weather:		Coding:	RZMACP
MH#:	M-604-005	Owner:	NA	Len. Surveyed:	6.2
P.O.#:		Surveyor:	Todd Machine	Rim to Invert:	6.9
Customer:		Cert. #:	P0038859-082022	Wall Material:	Concrete (cast in place)

Street:	Willow Pl. 318' North of Cleveland A	Project:	Hobart, IN
City:	Hobart, IN	GPS Northing:	2290761.26
Location:	Local Rural Streets	GPS Easting:	2903850.16
Drain Area:	West	GPS Accuracy:	Sub-Meter
Cover Shape:	Circular	Evidence of Surcharge:	No
Cover Size:	24.0	Potential for Runoff:	None
Comments:

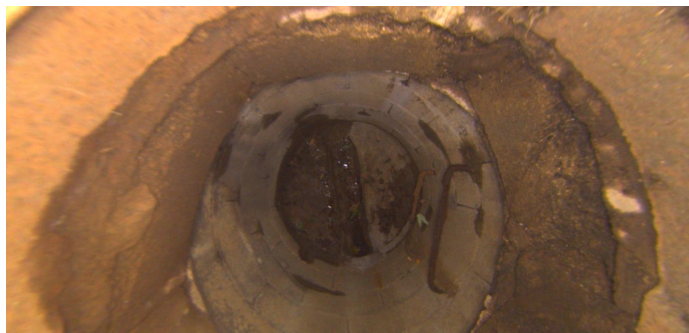
Code: **MGO**
Description: **General Observation**

Distance (ft): **.0**
Structural Grade: **0**
O&M Grade: **0**
Clock Start/From:
Clock To:
1st Value:
2nd Value:
Value Percent:
Step: **NO**
Remarks: **access mh**

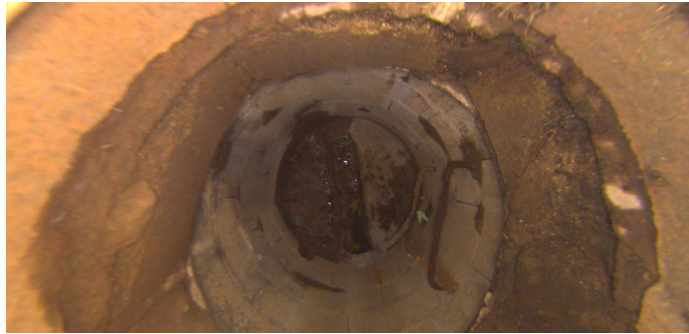
Code: **SRI**
Description: **Surface Roughness Increased**

Distance (ft): **.0**
Structural Grade: **1**
O&M Grade: **0**
Clock Start/From: **12**
Clock To: **12**
1st Value:
2nd Value:
Value Percent:
Step: **NO**
Remarks:

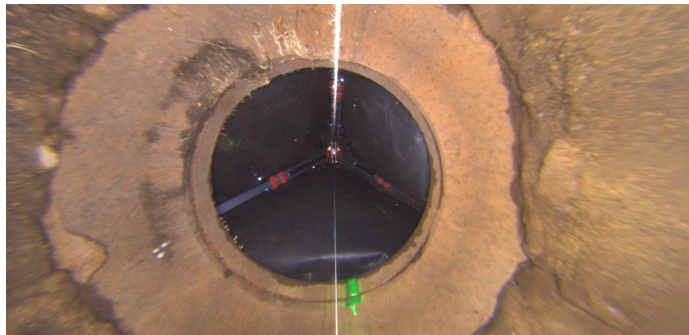
Code: **RFJ**
Description: **Roots Fine Joint**

Distance (ft): **1.9**
Structural Grade: **0**
O&M Grade: **1**
Clock Start/From: **12**
Clock To: **12**
1st Value:
2nd Value:
Value Percent:
Step: **NO**
Remarks:

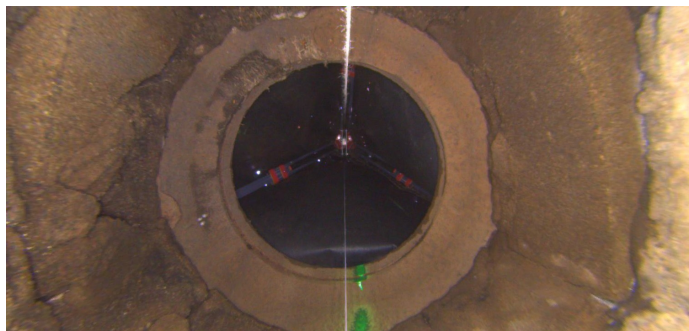
Code: **MGO**
Description: **General Observation**

Distance (ft): **2.8**
Structural Grade: **0**
O&M Grade: **0**
Clock Start/From:
Clock To:
1st Value:
2nd Value:
Value Percent:
Step: **NO**
Remarks: **Underside Of Frame**

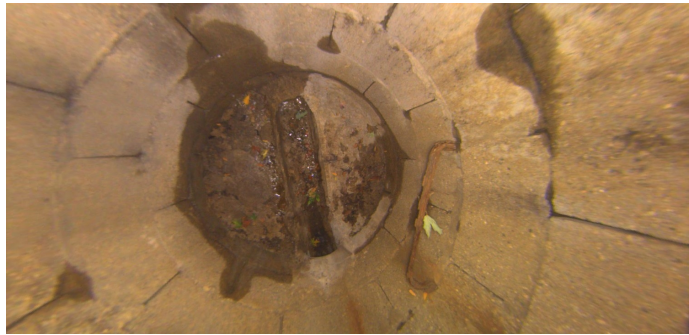
Code: **IW**
Description: **Infil Weeper**

Distance (ft): **3.1**
Structural Grade: **0**
O&M Grade: **2**
Clock Start/From: **12**
Clock To: **12**
1st Value:
2nd Value:
Value Percent:
Step: **NO**
Remarks:

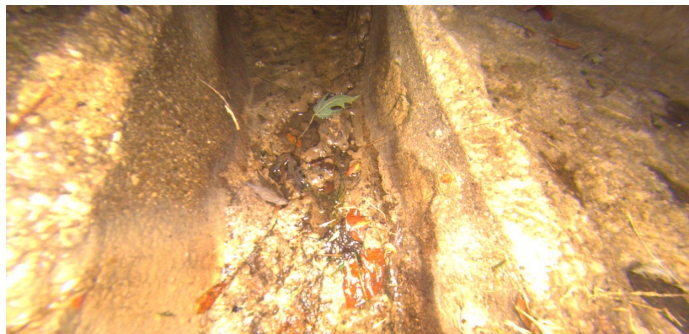
Code: **SRI**
Description: **Surface Roughness Increased**

Distance (ft): **6.2**
Structural Grade: **1**
O&M Grade: **0**
Clock Start/From: **12**
Clock To: **12**
1st Value:
2nd Value:
Value Percent:
Step: **NO**
Remarks:

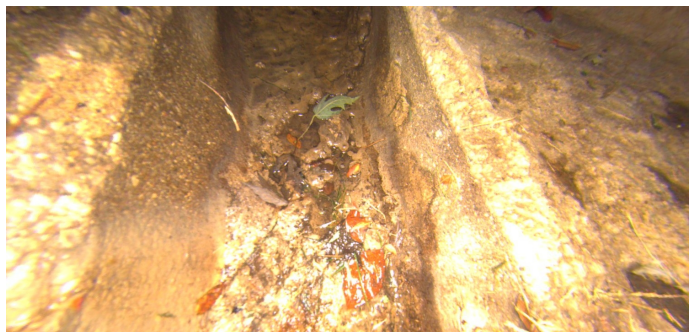
Code: **SAV**
Description: **Surface Aggregate Visible**

Distance (ft): **6.2**
Structural Grade: **3**
O&M Grade: **0**
Clock Start/From: **3**
Clock To: **9**
1st Value:
2nd Value:
Value Percent:
Step: **NO**
Remarks:

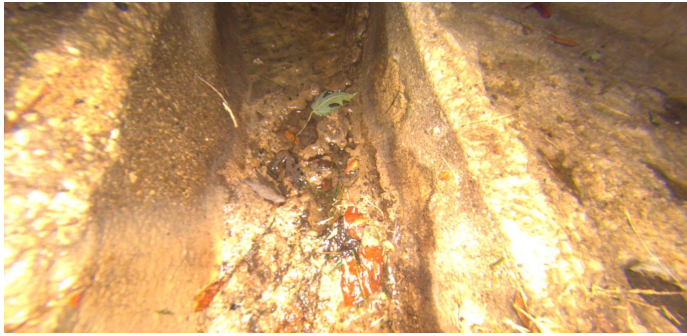
Code: **DSF**
Description: **Deposits Settled Fine**

Distance (ft): **6.2**
Structural Grade: **0**
O&M Grade: **2**
Clock Start/From: **5**
Clock To: **7**
1st Value:
2nd Value:
Value Percent: **10.000**
Step: **NO**
Remarks:

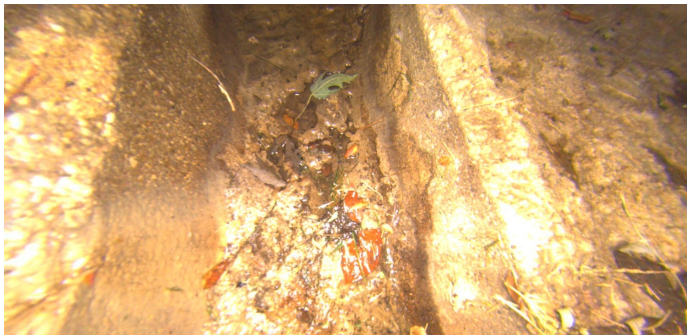
Code: **SRI**
Description: **Surface Roughness Increased**

Distance (ft): **6.2**
Structural Grade: **1**
O&M Grade: **0**
Clock Start/From: **12**
Clock To: **12**
1st Value:
2nd Value:
Value Percent:
Step: **NO**
Remarks:

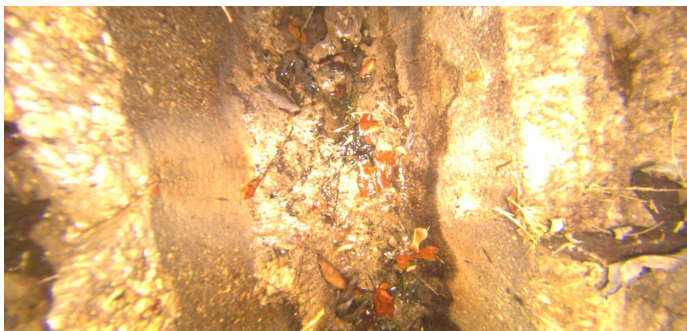
Code: **MGO**
Description: **General Observation**

Distance (ft): **6.2**
Structural Grade: **0**
O&M Grade: **0**
Clock Start/From:
Clock To:
1st Value:
2nd Value:
Value Percent:
Step: **NO**
Remarks: **End Of Survey**
