Manhole Inspection Report

Date:	04/28/2018	Weather:		Coding:	RZMACP
MH#:	M-604-010	Owner:	NA	Len. Surveyed:	18.6
P.O.#:		Surveyor:	Jen Costello	Rim to Invert:	18.3
Customer:		Cert. #:	U-907-5518	Wall Material:	Concrete (reinforced)

Street:	Old Ridge Rd. and Lake Park Ave. To	Project:	Hobart, IN
City:	Hobart, IN	GPS Northing:	41.53735352
Location:		GPS Easting:	-87.25989532
Drain Area:	Northwest	GPS Accuracy:	Nearest Meter
Cover Shape:	Circular	Evidence of Surcharge:	No
Cover Size:	22.5	Potential for Runoff:	None
Comments:

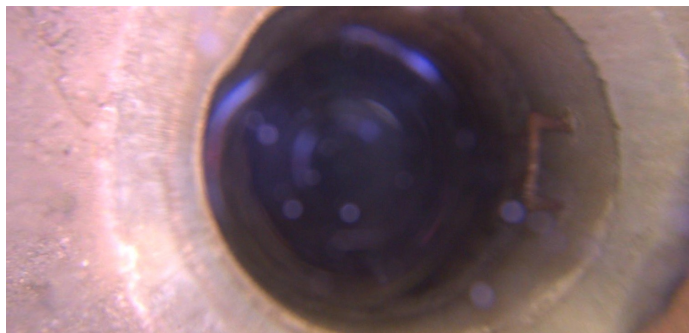
Code: **MGO**
Description: **General Observation**

Distance (ft): **.0**
Structural Grade: **0**
O&M Grade: **0**
Clock Start/From:
Clock To:
1st Value:
2nd Value:
Value Percent:
Step: **NO**
Remarks: **END SURVEY**

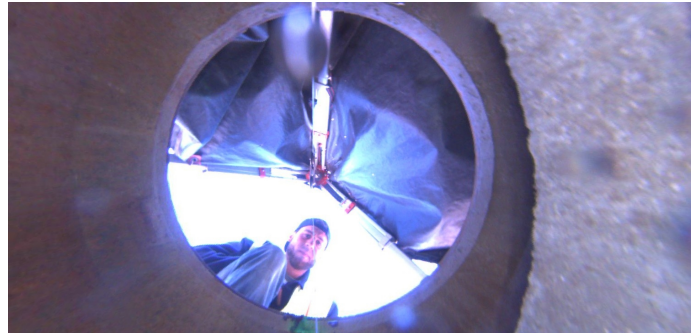
Code:	MGP
Description:	General Photo
Distance (ft):	1.4
Structural Grade:	0
O&M Grade:	0
Clock Start/From:	
Clock To:	
1st Value:	
2nd Value:	
Value Percent:	
Step:	NO
Remarks:	UNDERSIDE OF FRAME

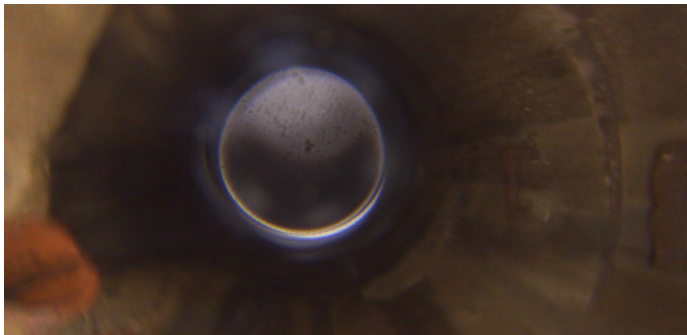
Code:	IW
Description:	Infil Weeper
Distance (ft):	5.7
Structural Grade:	0
O&M Grade:	2
Clock Start/From:	12
Clock To:	12
1st Value:	
2nd Value:	
Value Percent:	
Step:	NO
Remarks:
