# Manhole Inspection Report

Date:	<b>05/13/2018</b>	Weather:		Coding:	<b>RZMACP</b>
MH#:	<b>M-604-017</b>	Owner:	<b>NA</b>	Len. Surveyed:	<b>4.4</b>
P.O.#:		Surveyor:	<b>Jen Costello</b>	Rim to Invert:	<b>4.6</b>
Customer:		Cert. #:	<b>U-907-5518</b>	Wall Material:	<b>Concrete (reinforced)</b>

Street:	<b>Intersection of Ridge Rd. and Ash St.</b>	Project:	<b>Hobart, IN</b>
City:	<b>Hobart, IN</b>	GPS Northing:	<b>2903560.723</b>
Location:		GPS Easting:	<b>2903560.723</b>
Drain Area:	<b>Northwest</b>	GPS Accuracy:	<b>Sub-Meter</b>
Cover Shape:	<b>Circular</b>	Evidence of Surcharge:	<b>No</b>
Cover Size:	<b>22.5</b>	Potential for Runoff:	<b>None</b>
Comments:

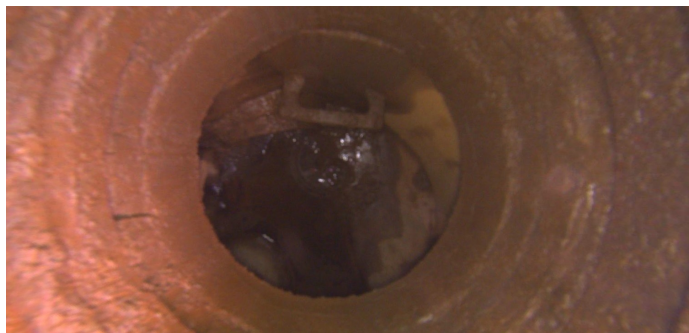
Code: **MGP**  
Description: **General Photo**

Distance (ft): **.0**  
Structural Grade: **0**  
O&M Grade: **0**  
Clock Start/From:  
Clock To:  
1st Value:  
2nd Value:  
Value Percent:  
Step: **NO**  
Remarks: **ACCESS MH**

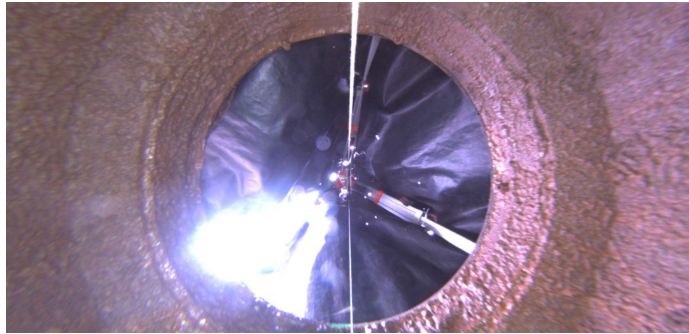
Code: **MGO**  
Description: **General Observation**

Distance (ft): **1.6**  
Structural Grade: **0**  
O&M Grade: **0**  
Clock Start/From:  
Clock To:  
1st Value:  
2nd Value:  
Value Percent:  
Step: **NO**  
Remarks: **UNDERSIDE OF FRAME**

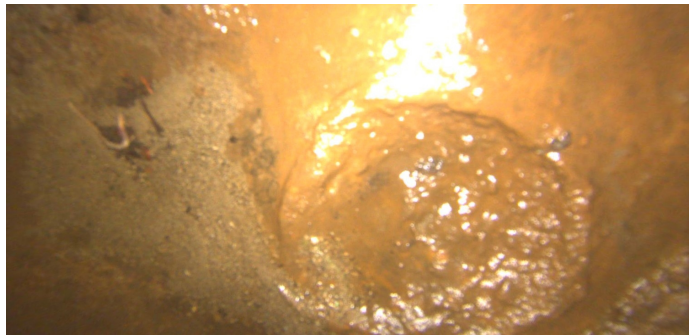
Code: **MGO**  
Description: **General Observation**

Distance (ft): **4.4**  
Structural Grade: **0**  
O&M Grade: **0**  
Clock Start/From:  
Clock To:  
1st Value:  
2nd Value:  
Value Percent:  
Step: **NO**  
Remarks: **END SURVEY**
