Manhole Inspection Report

Date:	05/13/2018	Weather:		Coding:	RZMACP
MH#:	M-604-019	Owner:	NA	Len. Surveyed:	9.8
P.O.#:		Surveyor:	Jen Costello	Rim to Invert:	14.2
Customer:		Cert. #:	U-907-5518	Wall Material:	Concrete (reinforced)

Street:	Intersection of Connecticut St. and R	Project:	Hobart, IN
City:	Hobart, IN	GPS Northing:	2902744.139
Location:		GPS Easting:	2902744.139
Drain Area:	Northwest	GPS Accuracy:	Sub-Meter
Cover Shape:	Circular	Evidence of Surcharge:	No
Cover Size:	22.5	Potential for Runoff:	None
Comments:

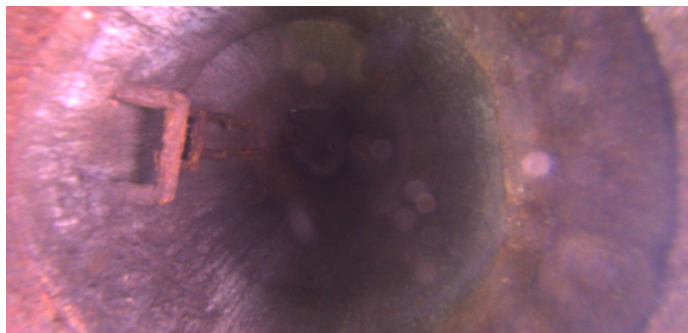
Code: **MGP**
Description: **General Photo**

Distance (ft): **.0**
Structural Grade: **0**
O&M Grade: **0**
Clock Start/From:
Clock To:
1st Value:
2nd Value:
Value Percent:
Step: **NO**
Remarks: **access mh**

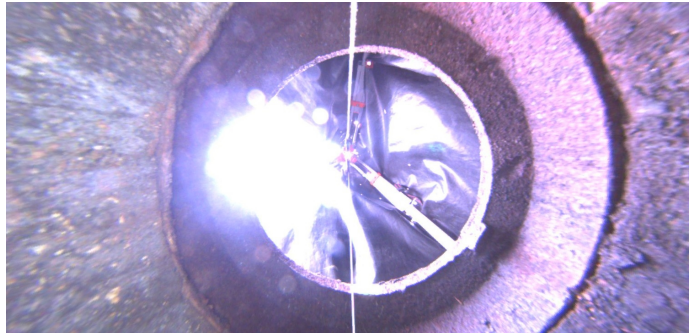
Code: **MGO**
Description: **General Observation**

Distance (ft): **1.9**
Structural Grade: **0**
O&M Grade: **0**
Clock Start/From:
Clock To:
1st Value:
2nd Value:
Value Percent:
Step: **NO**
Remarks: **underside of frame**

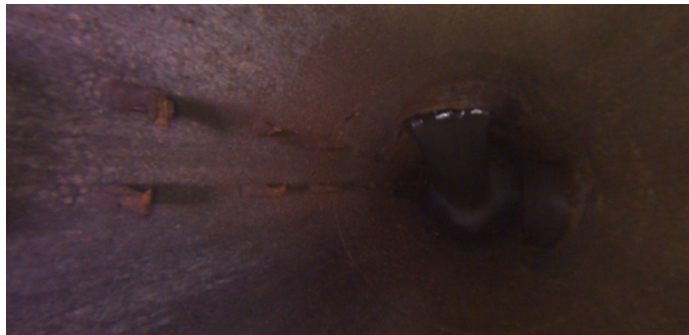
Code: **MGO**
Description: **General Observation**

Distance (ft): **3.6**
Structural Grade: **0**
O&M Grade: **0**
Clock Start/From:
Clock To:
1st Value:
2nd Value:
Value Percent:
Step: **NO**
Remarks: **broken steps**

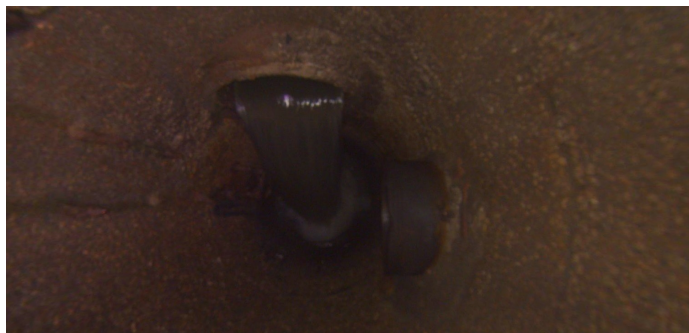
Code: **SAP**
Description: **Surface Aggregate Projecting**

Distance (ft): **6.1**
Structural Grade: **3**
O&M Grade: **0**
Clock Start/From: **12**
Clock To: **12**
1st Value:
2nd Value:
Value Percent:
Step: **NO**
Remarks:

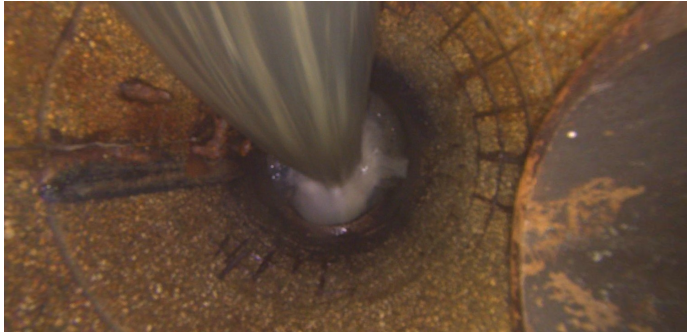
Code: **IW**
Description: **Infil Weeper**

Distance (ft): **9.8**
Structural Grade: **0**
O&M Grade: **2**
Clock Start/From: **9**
Clock To:
1st Value:
2nd Value:
Value Percent:
Step: **NO**
Remarks:

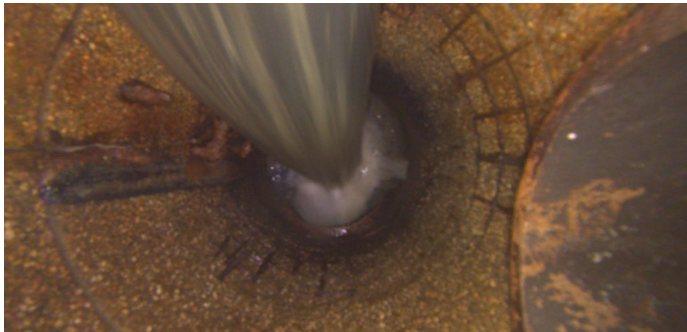
Code: **SRV**
Description: **Surface Reinforcement Visible**

Distance (ft): **9.8**
Structural Grade: **5**
O&M Grade: **0**
Clock Start/From: **12**
Clock To: **12**
1st Value:
2nd Value:
Value Percent:
Step: **NO**
Remarks:

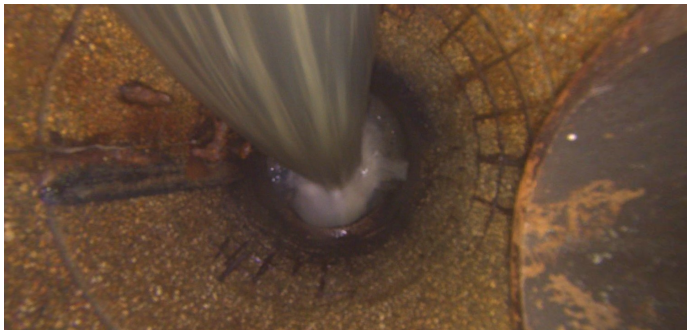
Code: **MSA**
Description: **Abandoned Survey**

Distance (ft): **9.8**
Structural Grade: **0**
O&M Grade: **0**
Clock Start/From:
Clock To:
1st Value:
2nd Value:
Value Percent:
Step: **NO**
Remarks: **intruding line**
