Manhole Inspection Report

Date:	05/14/2018	Weather:		Coding:	RZMACP
MH#:	M-604-030	Owner:	NA	Len. Surveyed:	6.0
P.O.#:		Surveyor:	Jen Costello	Rim to Invert:	6.4
Customer:		Cert. #:	U-907-5518	Wall Material:	Concrete (reinforced)

Street:	Intersection of Lake Park Ave. and L	Project:	Hobart, IN
City:	Hobart, IN	GPS Northing:	2904421.601
Location:		GPS Easting:	2904421.601
Drain Area:	North	GPS Accuracy:	Sub-Meter
Cover Shape:	Circular	Evidence of Surcharge:	No
Cover Size:	22.5	Potential for Runoff:	None
Comments:

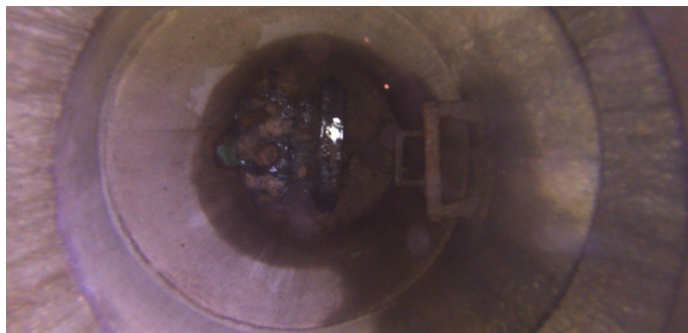
Code: **MGP**
Description: **General Photo**

Distance (ft): **.0**
Structural Grade: **0**
O&M Grade: **0**
Clock Start/From:
Clock To:
1st Value:
2nd Value:
Value Percent:
Step: **NO**
Remarks: **access MH**

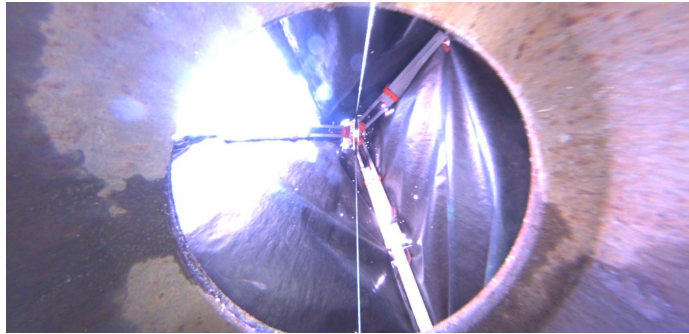
Code: **MGO**
Description: **General Observation**

Distance (ft): **1.3**
Structural Grade: **0**
O&M Grade: **0**
Clock Start/From:
Clock To:
1st Value:
2nd Value:
Value Percent:
Step: **NO**
Remarks: **UNDERSIDE OF FRAME**

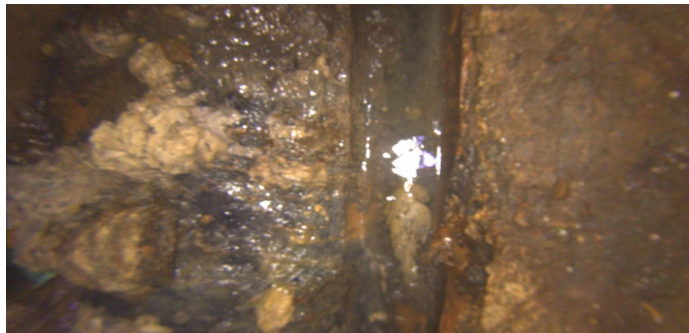
Code: **DSZ**
Description: **Deposits Settled Other**

Distance (ft): **4.8**
Structural Grade: **0**
O&M Grade: **2**
Clock Start/From: **7**
Clock To: **11**
1st Value:
2nd Value:
Value Percent: **10.000**
Step: **NO**
Remarks: **PAPER PRODUCTS**

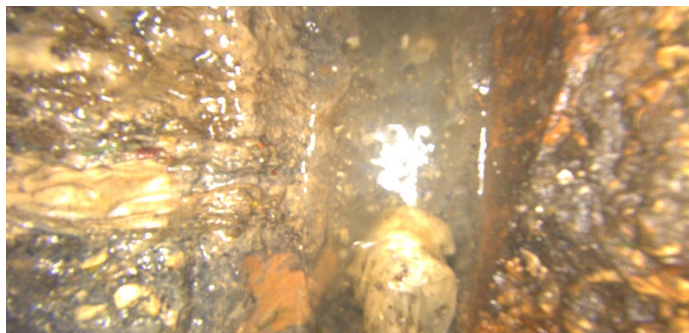
Code: **MGO**
Description: **General Observation**

Distance (ft): **6.0**
Structural Grade: **0**
O&M Grade: **0**
Clock Start/From:
Clock To:
1st Value:
2nd Value:
Value Percent:
Step: **NO**
Remarks: **END SURVEY**
