# Manhole Inspection Report

Date:	<b>05/14/2018</b>	Weather:		Coding:	<b>RZMACP</b>
MH#:	<b>M-604-031</b>	Owner:	<b>NA</b>	Len. Surveyed:	<b>6.2</b>
P.O.#:		Surveyor:	<b>Jen Costello</b>	Rim to Invert:	<b>6.7</b>
Customer:		Cert. #:	<b>U-907-5518</b>	Wall Material:	<b>Concrete (reinforced)</b>

Street:	<b>Lake Park Ave. 461'. North of Shore</b>	Project:	<b>Hobart, IN</b>
City:	<b>Hobart, IN</b>	GPS Northing:	<b>41.54294586</b>
Location:		GPS Easting:	<b>-87.2598114</b>
Drain Area:	<b>North</b>	GPS Accuracy:	<b>Nearest Meter</b>
Cover Shape:	<b>Circular</b>	Evidence of Surcharge:	<b>No</b>
Cover Size:	<b>22.5</b>	Potential for Runoff:	<b>None</b>
Comments:

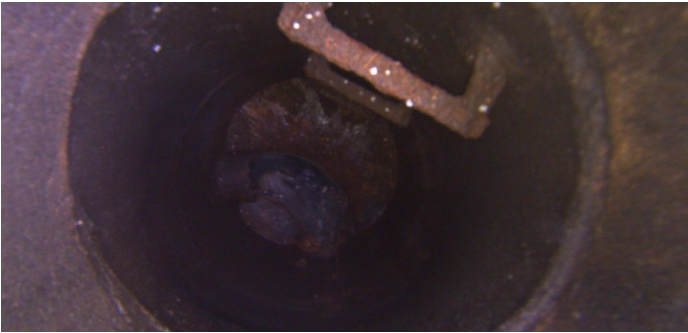
Code:

MGP

Description:

General Photo

Distance (ft):

.0

Remarks:

ACCESS MH

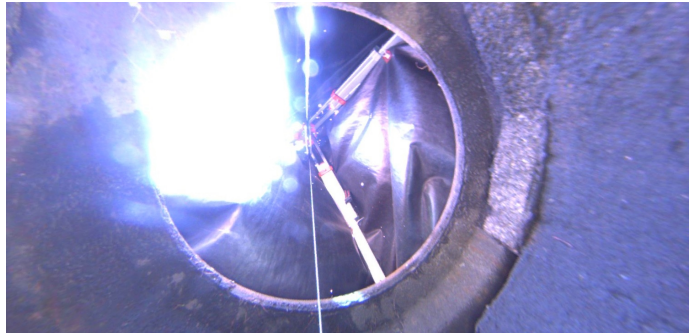
Code:	<b>MGO</b>
Description:	<b>General Observation</b>
Distance (ft):	<b>1.3</b>
Structural Grade:	<b>0</b>
O&M Grade:	<b>0</b>
Clock Start/From:	
Clock To:	
1st Value:	
2nd Value:	
Value Percent:	
Step:	<b>NO</b>
Remarks:	<b>UNDERSIDE OF FRAME</b>

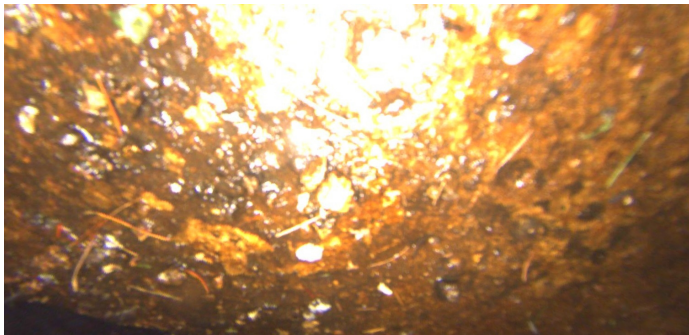
Code:	<b>MGO</b>
Description:	<b>General Observation</b>
Distance (ft):	<b>6.2</b>
Structural Grade:	<b>0</b>
O&M Grade:	<b>0</b>
Clock Start/From:	
Clock To:	
1st Value:	
2nd Value:	
Value Percent:	
Step:	<b>NO</b>
Remarks:	<b>END SURVEY</b>
