Manhole Inspection Report

Date:	10/10/2022	Weather:		Coding:	RZMACP
MH#:	M-604-033	Owner:	NA	Len. Surveyed:	6.0
P.O.#:		Surveyor:	Jen Costello	Rim to Invert:	7.0
Customer:		Cert. #:	U-907-5518	Wall Material:	Concrete (cast in place)

Street:	Lake Park Ave. 615' South of Hidden	Project:	Hobart, IN
City:	Hobart, IN	GPS Northing:	2292825.852
Location:	Other	GPS Easting:	2904438.996
Drain Area:	North	GPS Accuracy:	Sub-Meter
Cover Shape:	Circular	Evidence of Surcharge:	No
Cover Size:	24.0	Potential for Runoff:	None
Comments:

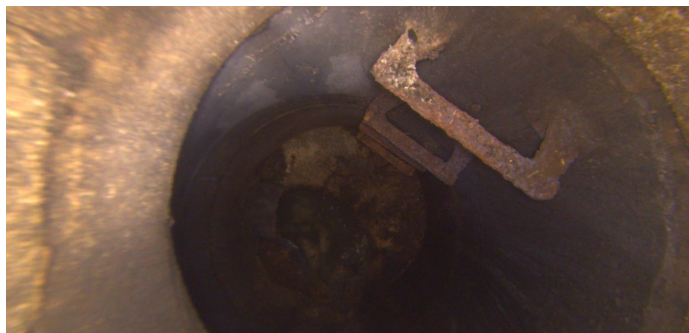
Code: **MGO**
Description: **General Observation**

Distance (ft): **.0**
Structural Grade: **0**
O&M Grade: **0**
Clock Start/From:
Clock To:
1st Value:
2nd Value:
Value Percent:
Step: **NO**
Remarks: **access mh**

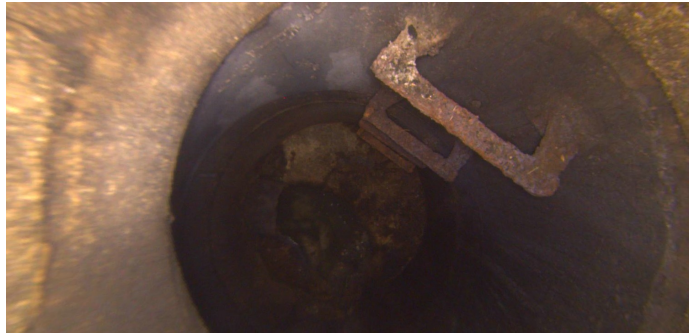
Code: **SRI**
Description: **Surface Roughness Increased**

Distance (ft): **.0**
Structural Grade: **1**
O&M Grade: **0**
Clock Start/From: **12**
Clock To: **12**
1st Value:
2nd Value:
Value Percent:
Step: **NO**
Remarks:

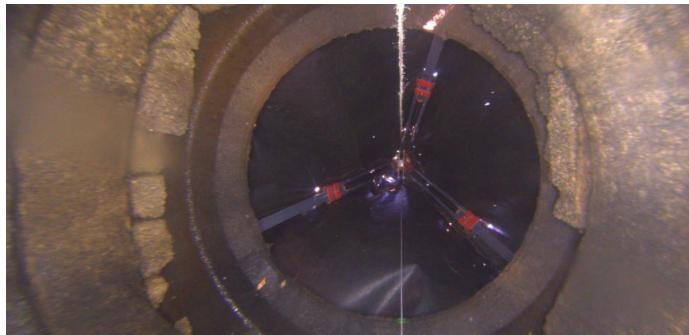
Code: **B**
Description: **Broken**

Distance (ft): **1.8**
Structural Grade: **5**
O&M Grade: **0**
Clock Start/From: **12**
Clock To: **12**
1st Value:
2nd Value:
Value Percent:
Step: **NO**
Remarks:

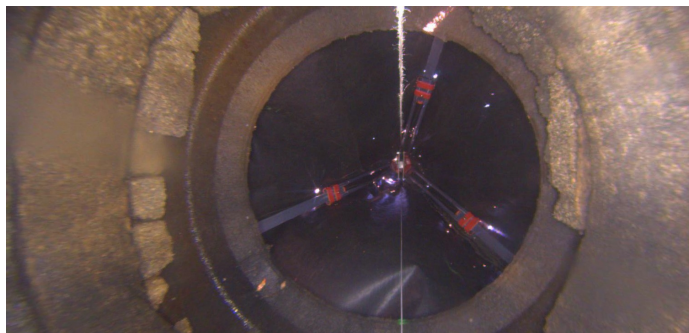
Code: **MGO**
Description: **General Observation**

Distance (ft): **1.8**
Structural Grade: **0**
O&M Grade: **0**
Clock Start/From:
Clock To:
1st Value:
2nd Value:
Value Percent:
Step: **NO**
Remarks: **underside of frame**

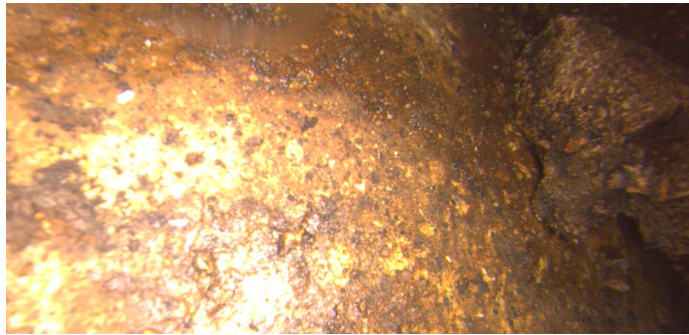
Code: **OBR**
Description: **Obstacle Rocks**

Distance (ft): **5.9**
Structural Grade: **0**
O&M Grade: **2**
Clock Start/From: **1**
Clock To: **2**
1st Value:
2nd Value:
Value Percent: **10.000**
Step: **NO**
Remarks:

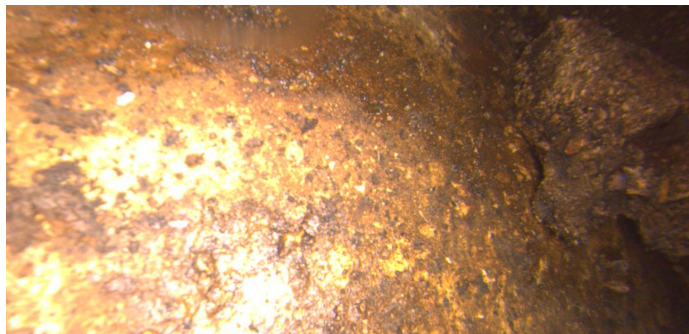
Code: **SAV**
Description: **Surface Aggregate Visible**

Distance (ft): **5.9**
Structural Grade: **3**
O&M Grade: **0**
Clock Start/From: **12**
Clock To: **12**
1st Value:
2nd Value:
Value Percent:
Step: **NO**
Remarks:

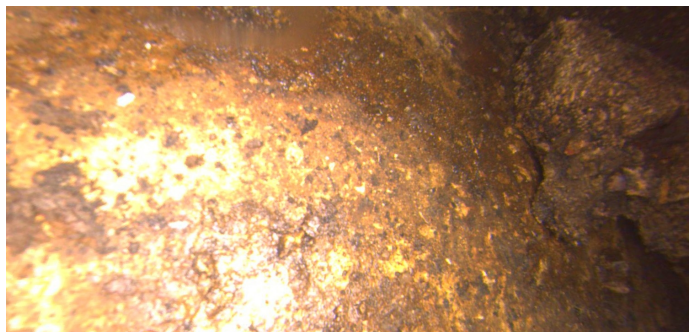
Code: **SRI**
Description: **Surface Roughness Increased**

Distance (ft): **5.9**
Structural Grade: **1**
O&M Grade: **0**
Clock Start/From: **12**
Clock To: **12**
1st Value:
2nd Value:
Value Percent:
Step: **NO**
Remarks:

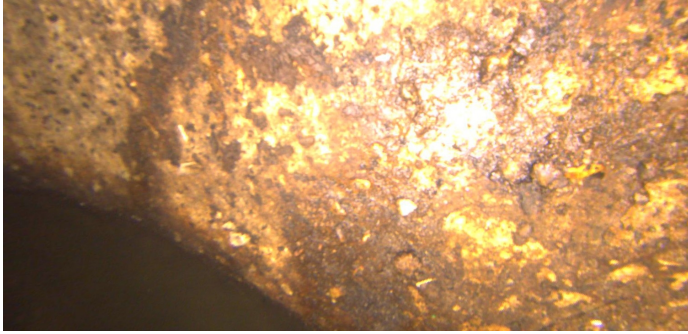
Code:	MGO
Description:	General Observation
Distance (ft):	5.9
Structural Grade:	0
O&M Grade:	0
Clock Start/From:	
Clock To:	
1st Value:	
2nd Value:	
Value Percent:	
Step:	NO
Remarks:	end of survey
