Manhole Inspection Report

Date:	05/14/2018	Weather:		Coding:	RZMACP
MH#:	M-604-034	Owner:	NA	Len. Surveyed:	3.7
P.O.#:		Surveyor:	Jen Costello	Rim to Invert:	4.0
Customer:		Cert. #:	U-907-5518	Wall Material:	Concrete (reinforced)

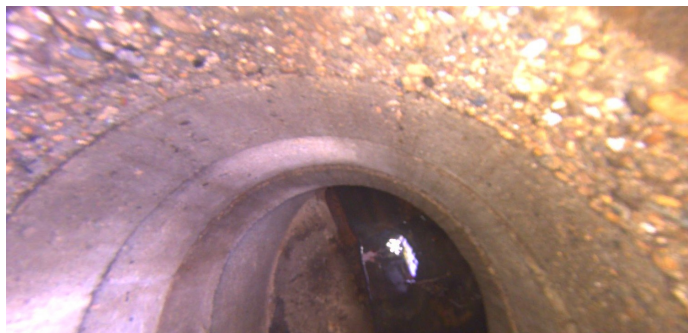
Code: **MGP**
Description: **General Photo**

Distance (ft): **.0**
Structural Grade: **0**
O&M Grade: **0**
Clock Start/From:
Clock To:
1st Value:
2nd Value:
Value Percent:
Step: **NO**
Remarks: **ACCESS MH**

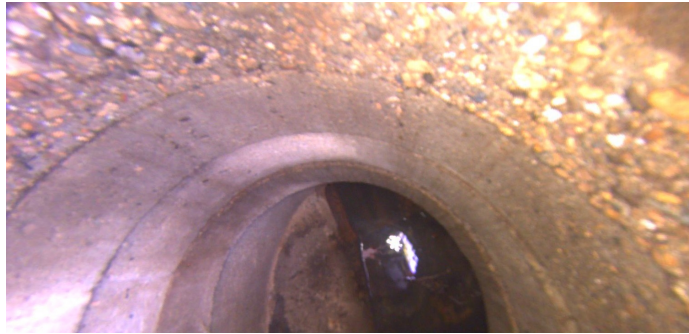
Code: **SAP**
Description: **Surface Aggregate Projecting**

Distance (ft): **.0**
Structural Grade: **3**
O&M Grade: **0**
Clock Start/From: **12**
Clock To: **12**
1st Value:
2nd Value:
Value Percent:
Step: **NO**
Remarks:

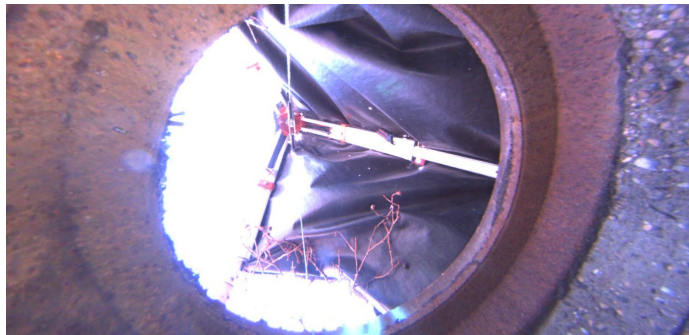
Code: **MGO**
Description: **General Observation**

Distance (ft): **.8**
Structural Grade: **0**
O&M Grade: **0**
Clock Start/From:
Clock To:
1st Value:
2nd Value:
Value Percent:
Step: **NO**
Remarks: **UNDERSIDE OF FRAME**

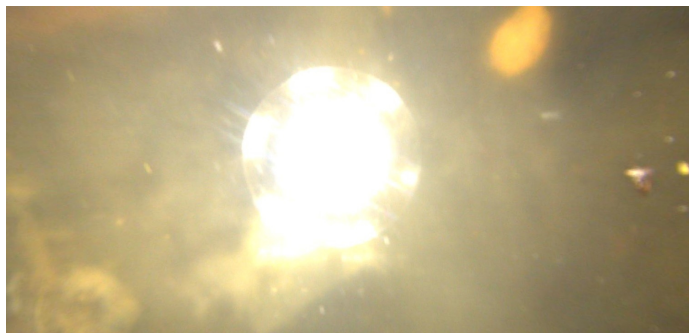
Code: **MGO**
Description: **General Observation**

Distance (ft): **3.7**
Structural Grade: **0**
O&M Grade: **0**
Clock Start/From:
Clock To:
1st Value:
2nd Value:
Value Percent:
Step: **NO**
Remarks: **END SURVEY**
