Manhole Inspection Report

Date:	05/14/2018	Weather:		Coding:	RZMACP
MH#:	M-604-035	Owner:	NA	Len. Surveyed:	2.9
P.O.#:		Surveyor:	Jen Costello	Rim to Invert:	3.2
Customer:		Cert. #:	U-907-5518	Wall Material:	Concrete (reinforced)

Street:	738' Southwest of Lake Park Ave. an	Project:	Hobart, IN
City:	Hobart, IN	GPS Northing:	2904088.474
Location:		GPS Easting:	2904088.474
Drain Area:	North	GPS Accuracy:	Sub-Meter
Cover Shape:	Circular	Evidence of Surcharge:	No
Cover Size:	22.5	Potential for Runoff:	None
Comments:

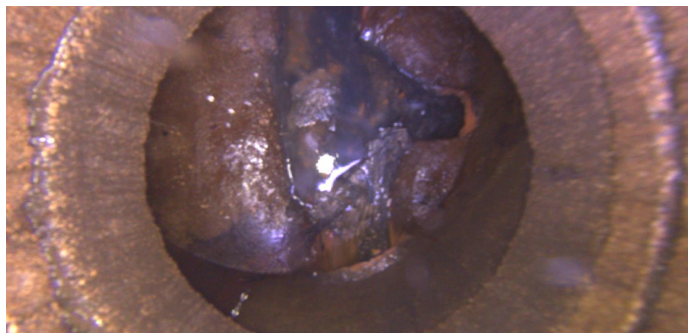
Code: **MGP**
Description: **General Photo**

Distance (ft): **.0**
Structural Grade: **0**
O&M Grade: **0**
Clock Start/From:
Clock To:
1st Value:
2nd Value:
Value Percent:
Step: **NO**
Remarks: **ACCESS MH**

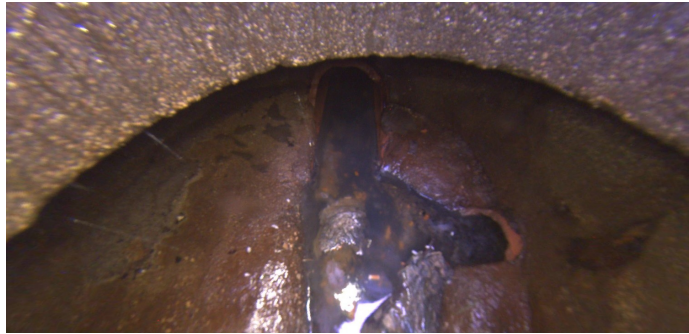
Code: **SAV**
Description: **Surface Aggregate Visible**

Distance (ft): **.9**
Structural Grade: **3**
O&M Grade: **0**
Clock Start/From: **12**
Clock To: **12**
1st Value:
2nd Value:
Value Percent:
Step: **NO**
Remarks:

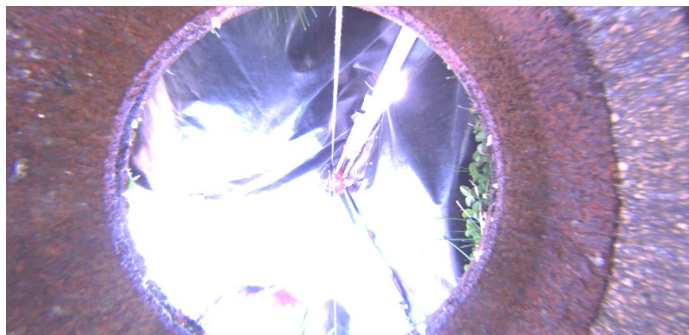
Code: **MGO**
Description: **General Observation**

Distance (ft): **1.1**
Structural Grade: **0**
O&M Grade: **0**
Clock Start/From:
Clock To:
1st Value:
2nd Value:
Value Percent:
Step: **NO**
Remarks: **END SURVEY**

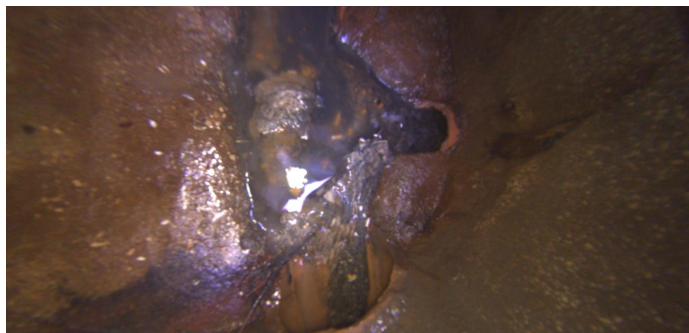
Code: **IW**
Description: **Infil Weeper**

Distance (ft): **1.3**
Structural Grade: **0**
O&M Grade: **2**
Clock Start/From: **3**
Clock To:
1st Value:
2nd Value:
Value Percent:
Step: **NO**
Remarks:

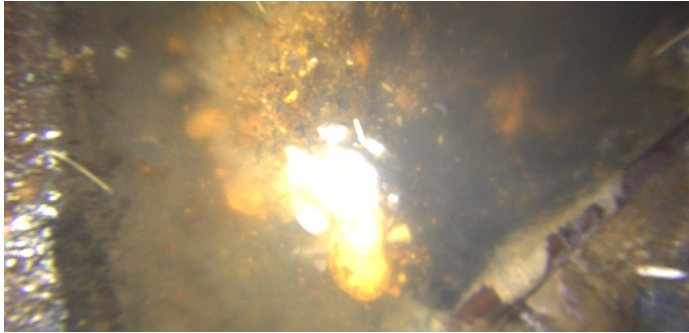
Code:	MGO
Description:	General Observation
Distance (ft):	2.9
Structural Grade:	0
O&M Grade:	0
Clock Start/From:	
Clock To:	
1st Value:	
2nd Value:	
Value Percent:	
Step:	NO
Remarks:	END SURVEY
