Manhole Inspection Report

Date:	04/11/2018	Weather:		Coding:	RZMACP
MH#:	M-604-039	Owner:	NA	Len. Surveyed:	2.8
P.O.#:		Surveyor:	John Kuglmaier	Rim to Invert:	4.0
Customer:		Cert. #:	U-1215-07002349	Wall Material:	Concrete (reinforced)

Street:	376' Southwest of Lake Park Ave. an	Project:	Hobart, IN
City:	Hobart, IN	GPS Northing:	2904237.098
Location:		GPS Easting:	2904237.098
Drain Area:	North	GPS Accuracy:	Sub-Meter
Cover Shape:	Circular	Evidence of Surcharge:	Yes
Cover Size:	23.0	Potential for Runoff:	None
Comments:

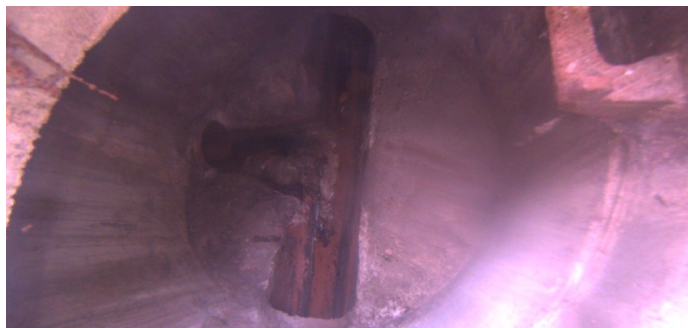
Code: **MGP**
Description: **General Photo**

Distance (ft): **.0**
Structural Grade: **0**
O&M Grade: **0**
Clock Start/From:
Clock To:
1st Value:
2nd Value:
Value Percent:
Step: **NO**
Remarks:

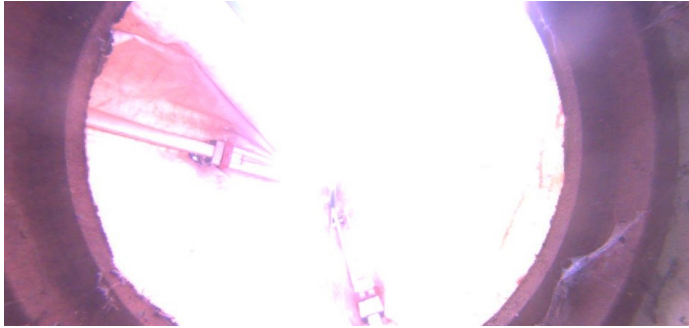
Code:	MGP
Description:	General Photo
Distance (ft):	.9
Structural Grade:	0
O&M Grade:	0
Clock Start/From:	
Clock To:	
1st Value:	
2nd Value:	
Value Percent:	
Step:	NO
Remarks:

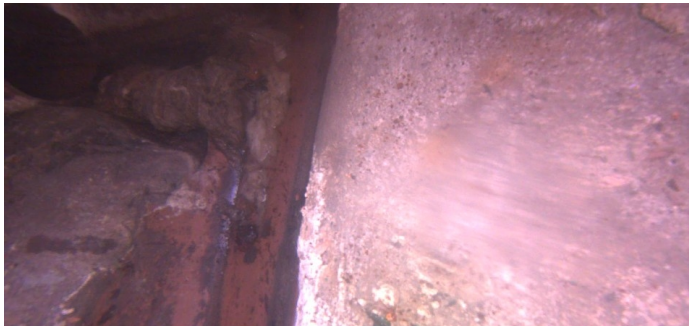
Code:	MGO
Description:	General Observation
Distance (ft):	2.3
Structural Grade:	0
O&M Grade:	0
Clock Start/From:	
Clock To:	
1st Value:	
2nd Value:	
Value Percent:	
Step:	NO
Remarks:	Ins. Comp.
