Manhole Inspection Report

Date:	04/11/2018	Weather:		Coding:	RZMACP
MH#:	M-604-040	Owner:	NA	Len. Surveyed:	2.1
P.O.#:		Surveyor:	John Kuglmaier	Rim to Invert:	3.0
Customer:		Cert. #:	U-1215-07002349	Wall Material:	Concrete (reinforced)

Street:	306' Southwest of Lake Park Ave. an	Project:	Hobart, IN
City:	Hobart, IN	GPS Northing:	2904240.645
Location:		GPS Easting:	2904240.645
Drain Area:	North	GPS Accuracy:	Sub-Meter
Cover Shape:	Circular	Evidence of Surcharge:	No
Cover Size:	23.0	Potential for Runoff:	None
Comments:

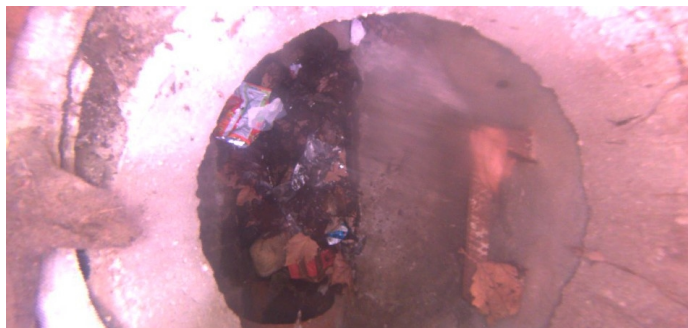
Code: **MGP**
Description: **General Photo**

Distance (ft): **.0**
Structural Grade: **0**
O&M Grade: **0**
Clock Start/From:
Clock To:
1st Value:
2nd Value:
Value Percent:
Step: **NO**
Remarks:

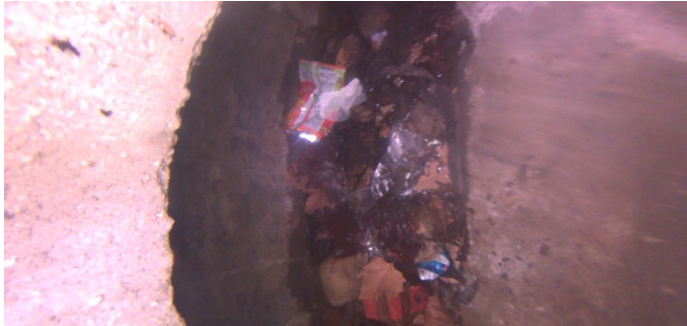
Code:	DAZ
Description:	Deposits Attached Other
Distance (ft):	.8
Structural Grade:	0
O&M Grade:	5
Clock Start/From:	3
Clock To:	9
1st Value:	
2nd Value:	
Value Percent:	50.000
Step:	NO
Remarks:	Mixed materials

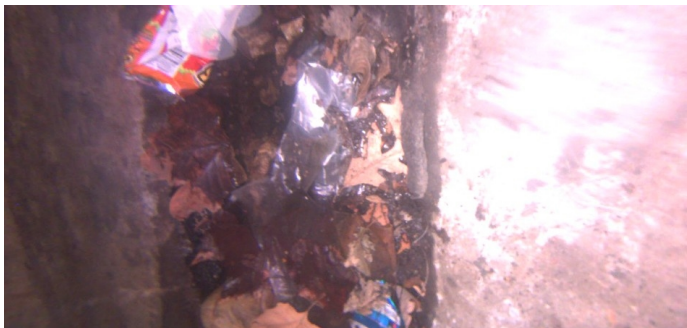
Code:	MGO
Description:	General Observation
Distance (ft):	1.9
Structural Grade:	0
O&M Grade:	0
Clock Start/From:	
Clock To:	
1st Value:	
2nd Value:	
Value Percent:	
Step:	NO
Remarks:	Ins. Comp.
