# Manhole Inspection Report

Date:	<b>05/13/2018</b>	Weather:		Coding:	<b>RZMACP</b>
MH#:	<b>M-604-042</b>	Owner:	<b>NA</b>	Len. Surveyed:	<b>4.8</b>
P.O.#:		Surveyor:	<b>Jen Costello</b>	Rim to Invert:	<b>4.8</b>
Customer:		Cert. #:	<b>U-907-5518</b>	Wall Material:	<b>Concrete (reinforced)</b>

Street:	<b>Ash St. 188' North of Ridge Rd.</b>	Project:	<b>Hobart, IN</b>
City:	<b>Hobart, IN</b>	GPS Northing:	<b>2903112.072</b>
Location:		GPS Easting:	<b>2903112.072</b>
Drain Area:	<b>Northwest</b>	GPS Accuracy:	<b>Sub-Meter</b>
Cover Shape:	<b>Circular</b>	Evidence of Surcharge:	<b>No</b>
Cover Size:	<b>22.5</b>	Potential for Runoff:	<b>None</b>
Comments:

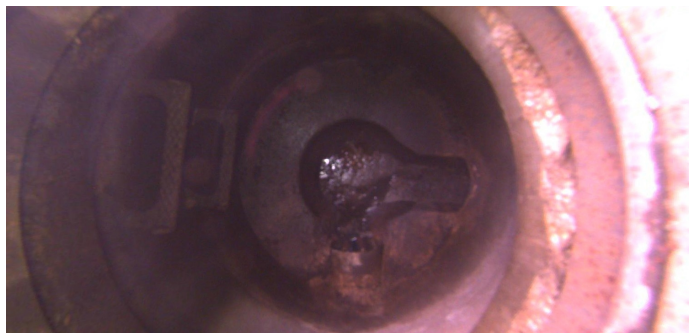
Code: **MGP**  
Description: **General Photo**

Distance (ft): **.0**  
Structural Grade: **0**  
O&M Grade: **0**  
Clock Start/From:  
Clock To:  
1st Value:  
2nd Value:  
Value Percent:  
Step: **NO**  
Remarks: **ACCESS MH**

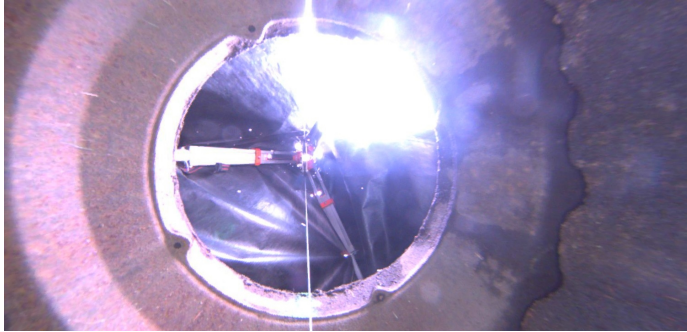
Code:	<b>MGO</b>
Description:	<b>General Observation</b>
Distance (ft):	<b>2.0</b>
Structural Grade:	<b>0</b>
O&M Grade:	<b>0</b>
Clock Start/From:	
Clock To:	
1st Value:	
2nd Value:	
Value Percent:	
Step:	<b>NO</b>
Remarks:	<b>UNDERSIDE OF FRAME</b>

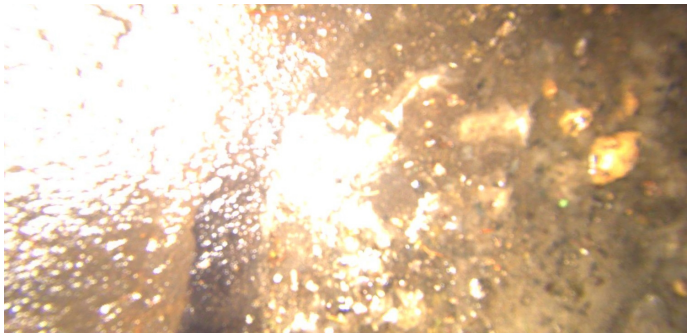
Code:	<b>MGO</b>
Description:	<b>General Observation</b>
Distance (ft):	<b>4.8</b>
Structural Grade:	<b>0</b>
O&M Grade:	<b>0</b>
Clock Start/From:	
Clock To:	
1st Value:	
2nd Value:	
Value Percent:	
Step:	<b>NO</b>
Remarks:	<b>END SURVEY</b>
