Manhole Inspection Report

| Date: | 05/13/2018 | Weather: | | Coding: | RZMACP |

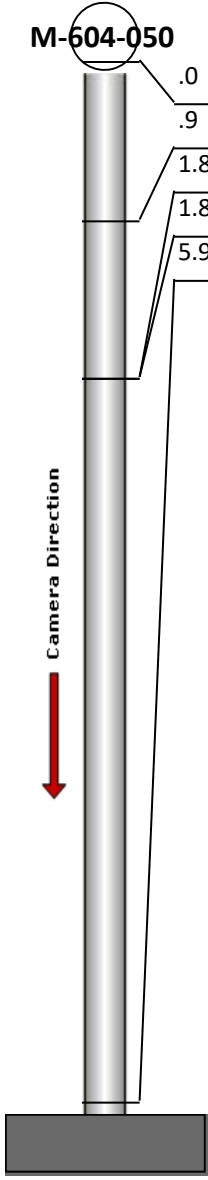
| | Position | Code | Observation | Video (sec) | Grade |
|--|---|---|---|---|---|
| | .0 | MGP | General Photo | 10 | NA |

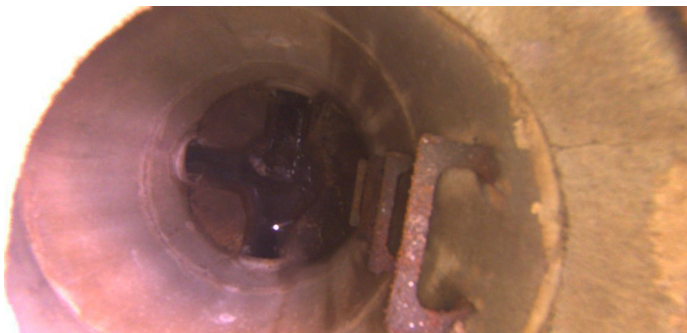
Code: **MGP**
Description: **General Photo**

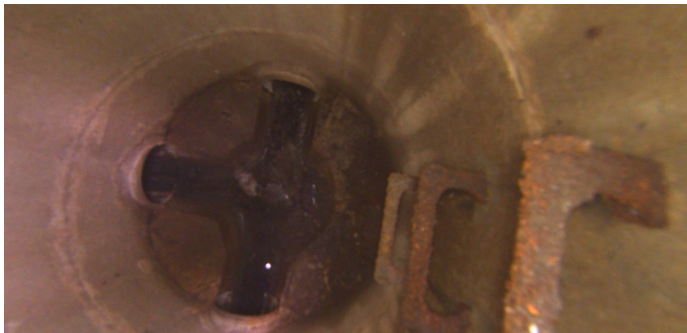
| Remarks: | UNDERSIDE OF FRAME |
