Manhole Inspection Report

Date:	05/13/2018	Weather:		Coding:	RZMACP
MH#:	M-604-053	Owner:	NA	Len. Surveyed:	5.5
P.O.#:		Surveyor:	Jen Costello	Rim to Invert:	6.2
Customer:		Cert. #:	U-907-5518	Wall Material:	Concrete (reinforced)

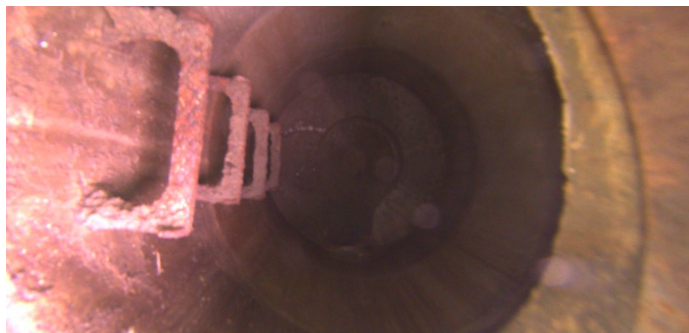
Code: **MGP**
Description: **General Photo**

Distance (ft): **.0**
Structural Grade: **0**
O&M Grade: **0**
Clock Start/From:
Clock To:
1st Value:
2nd Value:
Value Percent:
Step: **NO**
Remarks: **ACCESS MH**

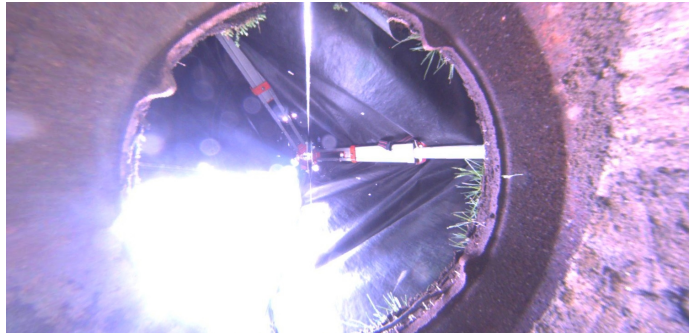
Code: **MGO**
Description: **General Observation**

Distance (ft): **1.2**
Structural Grade: **0**
O&M Grade: **0**
Clock Start/From:
Clock To:
1st Value:
2nd Value:
Value Percent:
Step: **NO**
Remarks: **END SURVEY**

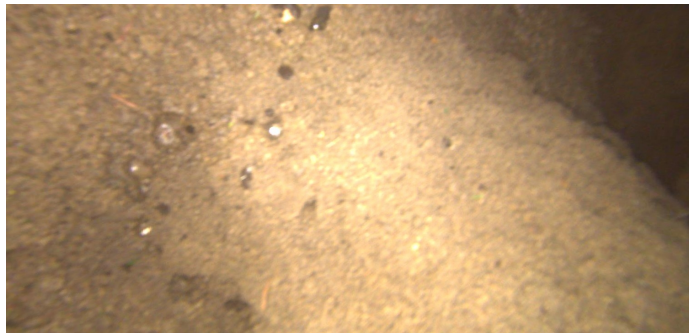
Code: **DSF**
Description: **Deposits Settled Fine**

Distance (ft): **5.5**
Structural Grade: **0**
O&M Grade: **2**
Clock Start/From: **12**
Clock To: **12**
1st Value:
2nd Value:
Value Percent: **5.000**
Step: **NO**
Remarks:

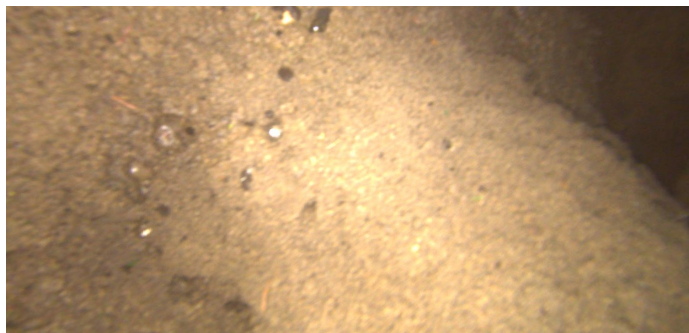
Code: **MGO**
Description: **General Observation**

Distance (ft): **5.5**
Structural Grade: **0**
O&M Grade: **0**
Clock Start/From:
Clock To:
1st Value:
2nd Value:
Value Percent:
Step: **NO**
Remarks: **END SURVEY**
