Manhole Inspection Report

Date:	05/13/2018	Weather:		Coding:	RZMACP
MH#:	M-604-057	Owner:	NA	Len. Surveyed:	7.9
P.O.#:		Surveyor:	Jen Costello	Rim to Invert:	8.5
Customer:		Cert. #:	U-907-5518	Wall Material:	Concrete (reinforced)

Street:	Connecticut St. 163' South of Old Ri	Project:	Hobart, IN
City:	Hobart, IN	GPS Northing:	2902803.823
Location:		GPS Easting:	2902803.823
Drain Area:	West	GPS Accuracy:	Sub-Meter
Cover Shape:	Circular	Evidence of Surcharge:	No
Cover Size:	22.5	Potential for Runoff:	None
Comments:

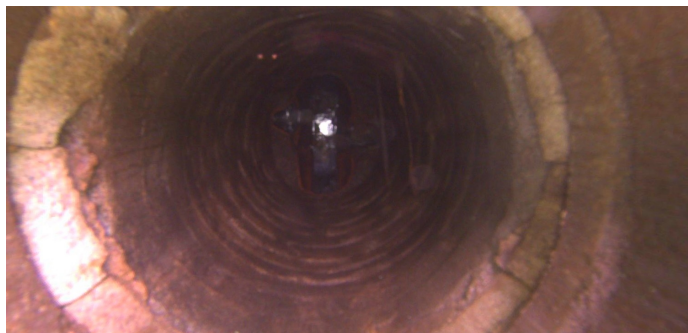
Code: **MGP**
Description: **General Photo**

Distance (ft): **.0**
Structural Grade: **0**
O&M Grade: **0**
Clock Start/From:
Clock To:
1st Value:
2nd Value:
Value Percent:
Step: **NO**
Remarks: **ACCESS MH**

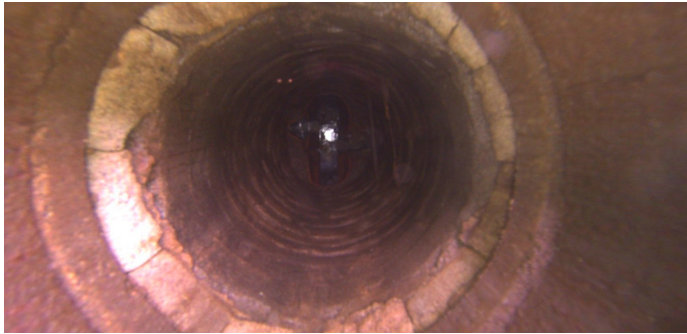
Code: **B**
Description: **Broken**

Distance (ft): **.0**
Structural Grade: **5**
O&M Grade: **0**
Clock Start/From: **12**
Clock To: **12**
1st Value:
2nd Value:
Value Percent:
Step: **NO**
Remarks:

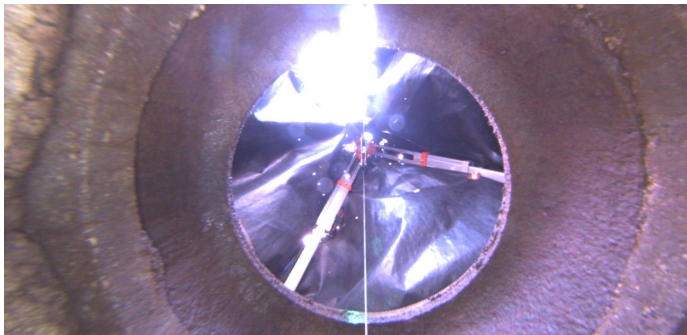
Code: **MGO**
Description: **General Observation**

Distance (ft): **1.8**
Structural Grade: **0**
O&M Grade: **0**
Clock Start/From:
Clock To:
1st Value:
2nd Value:
Value Percent:
Step: **NO**
Remarks: **UNDERSIDE OF FRAME**

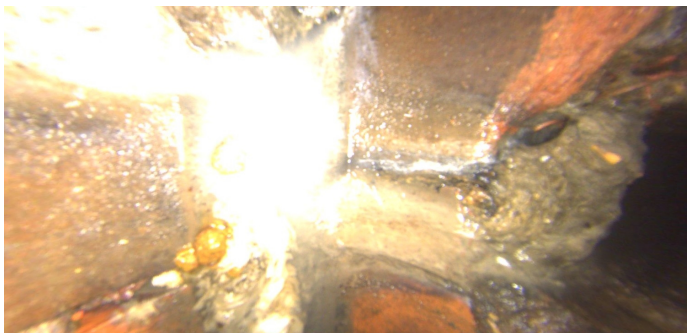
Code: **MGO**
Description: **General Observation**

Distance (ft): **7.9**
Structural Grade: **0**
O&M Grade: **0**
Clock Start/From:
Clock To:
1st Value:
2nd Value:
Value Percent:
Step: **NO**
Remarks: **END SURVEY**
