Manhole Inspection Report

Date:	04/29/2018	Weather:		Coding:	RZMACP
MH#:	M-604-064	Owner:	NA	Len. Surveyed:	3.7
P.O.#:		Surveyor:	Jen Costello	Rim to Invert:	4.3
Customer:		Cert. #:	U-907-5518	Wall Material:	Brick

Street:	Intersection of 1st St. and Pennsylv	Project:	Hobart, IN
City:	Hobart, IN	GPS Northing:	2902474.696
Location:		GPS Easting:	2902474.696
Drain Area:	West	GPS Accuracy:	Sub-Meter
Cover Shape:	Circular	Evidence of Surcharge:	No
Cover Size:	24.0	Potential for Runoff:	None
Comments:

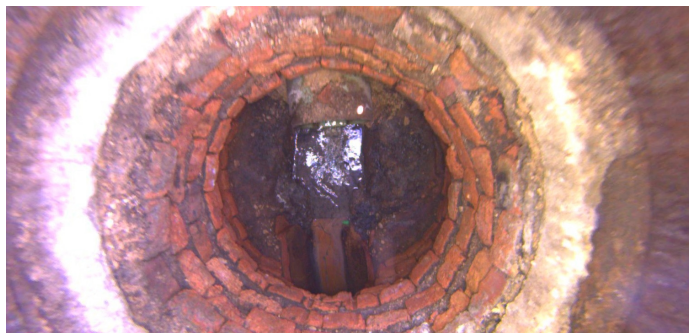
Code: **MGP**
Description: **General Photo**

Distance (ft): **.0**
Structural Grade: **0**
O&M Grade: **0**
Clock Start/From:
Clock To:
1st Value:
2nd Value:
Value Percent:
Step: **NO**
Remarks: **ACCESS MH**

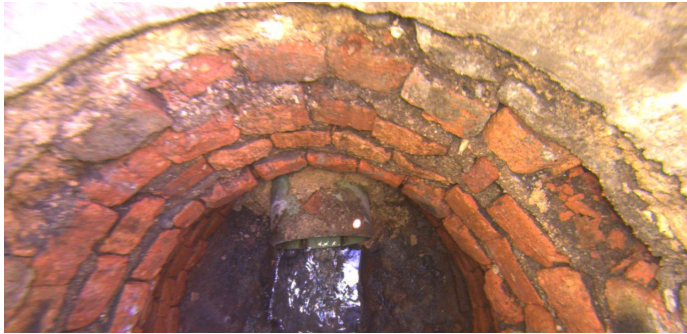
Code:	DAE
Description:	Deposits Attached Encrustation
Distance (ft):	.5
Structural Grade:	0
O&M Grade:	2
Clock Start/From:	12
Clock To:	12
1st Value:	
2nd Value:	
Value Percent:	5.000
Step:	NO
Remarks:

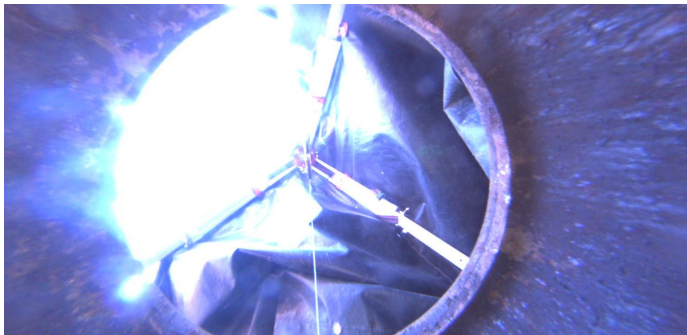
Code:	MGO
Description:	General Observation
Distance (ft):	1.1
Structural Grade:	0
O&M Grade:	0
Clock Start/From:	
Clock To:	
1st Value:	
2nd Value:	
Value Percent:	
Step:	NO
Remarks:	UNDERSIDE OF FRAME

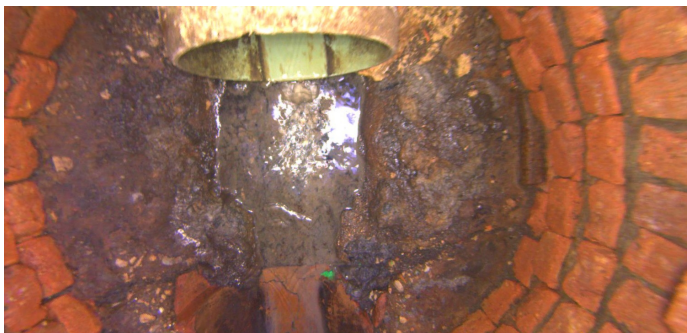
Code:	DSF
Description:	Deposits Settled Fine
Distance (ft):	2.1
Structural Grade:	0
O&M Grade:	2
Clock Start/From:	12
Clock To:	12
1st Value:	
2nd Value:	
Value Percent:	5.000
Step:	NO
Remarks:

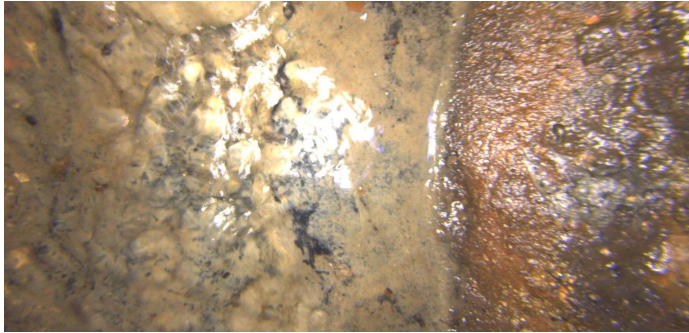
Code:	MGO
Description:	General Observation
Distance (ft):	3.7
Structural Grade:	0
O&M Grade:	0
Clock Start/From:	
Clock To:	
1st Value:	
2nd Value:	
Value Percent:	
Step:	NO
Remarks:	END SURVEY
