Manhole Inspection Report

Date:	04/29/2018	Weather:		Coding:	RZMACP
MH#:	M-604-067	Owner:	NA	Len. Surveyed:	7.0
P.O.#:		Surveyor:	Jen Costello	Rim to Invert:	7.4
Customer:		Cert. #:	U-907-5518	Wall Material:	Brick

Street:	Intersection of Home Ave. and Penn	Project:	Hobart, IN
City:	Hobart, IN	GPS Northing:	2902467.311
Location:		GPS Easting:	2902467.311
Drain Area:	West	GPS Accuracy:	Sub-Meter
Cover Shape:	Circular	Evidence of Surcharge:	No
Cover Size:	24.0	Potential for Runoff:	None
Comments:

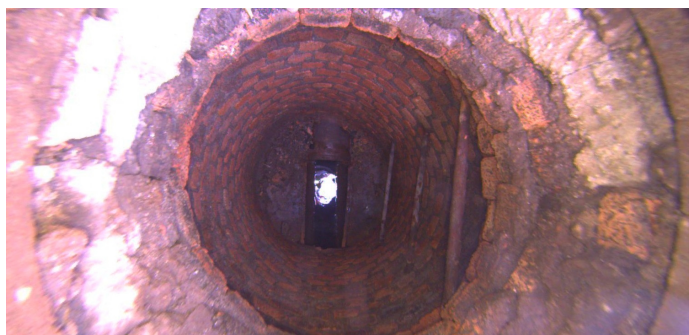
Code: **MGP**
 Description: **General Photo**

Distance (ft): **.0**
 Structural Grade: **0**
 O&M Grade: **0**
 Clock Start/From:
 Clock To:
 1st Value:
 2nd Value:
 Value Percent:
 Step: **NO**
 Remarks: **ACCESS MH**

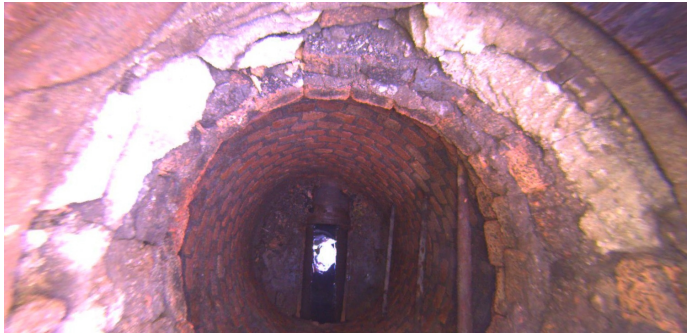
Code: **DB**
Description: **Displaced Brick**

Distance (ft): **.0**
Structural Grade: **3**
O&M Grade: **0**
Clock Start/From: **9**
Clock To: **3**
1st Value:
2nd Value:
Value Percent:
Step: **NO**
Remarks:

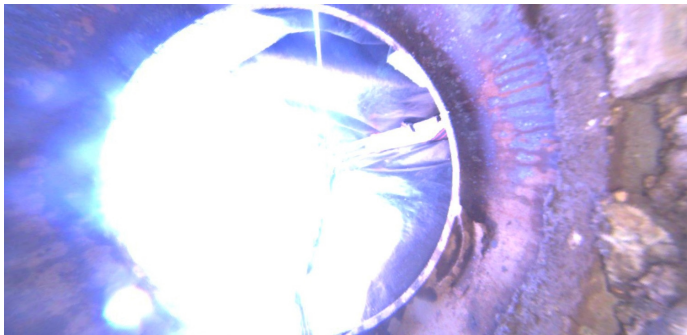
Code: **MGO**
Description: **General Observation**

Distance (ft): **1.4**
Structural Grade: **0**
O&M Grade: **0**
Clock Start/From:
Clock To:
1st Value:
2nd Value:
Value Percent:
Step: **NO**
Remarks: **UNDERSIDE OF FRAME**

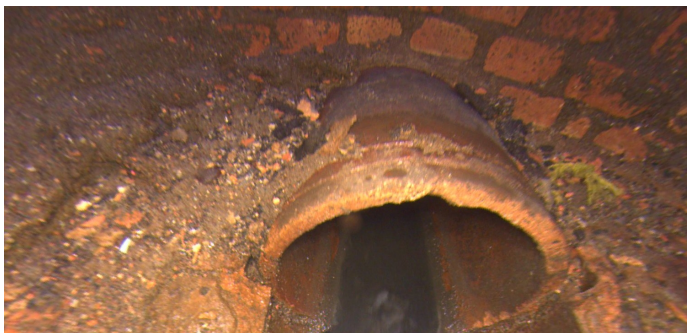
Code: **DSGV**
Description: **Deposits Settled Gravel**

Distance (ft): **6.0**
Structural Grade: **0**
O&M Grade: **2**
Clock Start/From: **10**
Clock To: **2**
1st Value:
2nd Value:
Value Percent: **5.000**
Step: **NO**
Remarks:

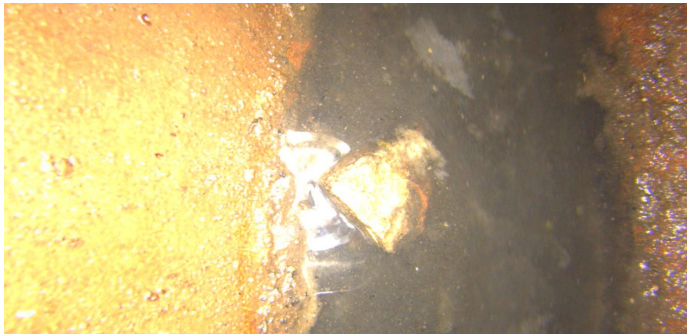
Code:	MGO
Description:	General Observation
Distance (ft):	7.0
Structural Grade:	0
O&M Grade:	0
Clock Start/From:	
Clock To:	
1st Value:	
2nd Value:	
Value Percent:	
Step:	NO
Remarks:	END SURVEY
