Manhole Inspection Report

Date:	05/13/2018	Weather:		Coding:	RZMACP
MH#:	M-604-068	Owner:	NA	Len. Surveyed:	7.8
P.O.#:		Surveyor:	Jen Costello	Rim to Invert:	7.9
Customer:		Cert. #:	U-907-5518	Wall Material:	Concrete (reinforced)

Street:	Pennsylvania St. 163' South of Old R	Project:	Hobart, IN
City:	Hobart, IN	GPS Northing:	2902477.367
Location:		GPS Easting:	2902477.367
Drain Area:	West	GPS Accuracy:	Sub-Meter
Cover Shape:	Circular	Evidence of Surcharge:	No
Cover Size:	22.5	Potential for Runoff:	None
Comments:

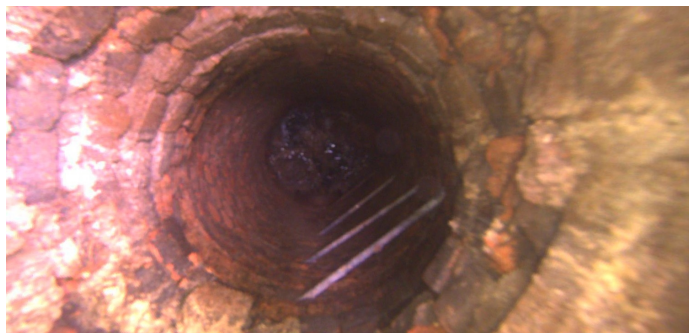
Code: **MGO**
Description: **General Observation**

Distance (ft): **.0**
Structural Grade: **0**
O&M Grade: **0**
Clock Start/From:
Clock To:
1st Value:
2nd Value:
Value Percent:
Step: **NO**
Remarks: **underside of frame**

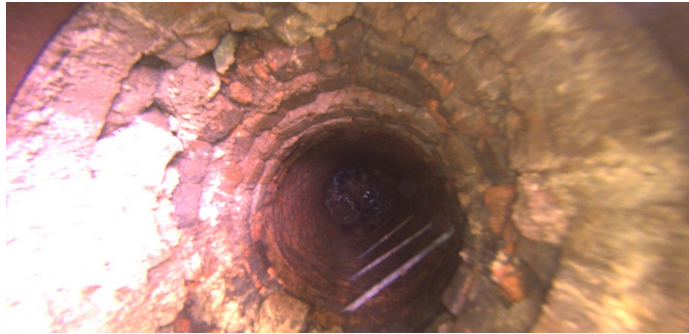
Code: **DB**
Description: **Displaced Brick**

Distance (ft): **.0**
Structural Grade: **3**
O&M Grade: **0**
Clock Start/From: **12**
Clock To: **12**
1st Value:
2nd Value:
Value Percent:
Step: **NO**
Remarks:

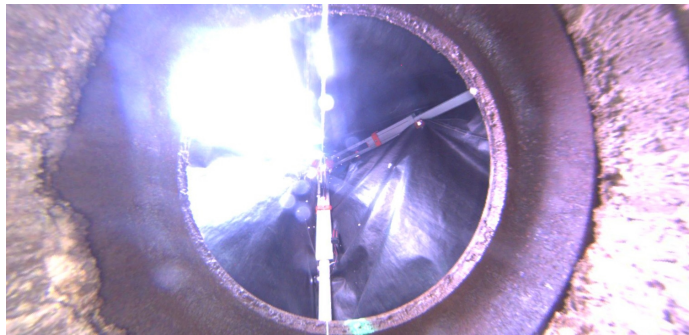
Code: **MGO**
Description: **General Observation**

Distance (ft): **1.3**
Structural Grade: **0**
O&M Grade: **0**
Clock Start/From:
Clock To:
1st Value:
2nd Value:
Value Percent:
Step: **NO**
Remarks: **underside of frame**

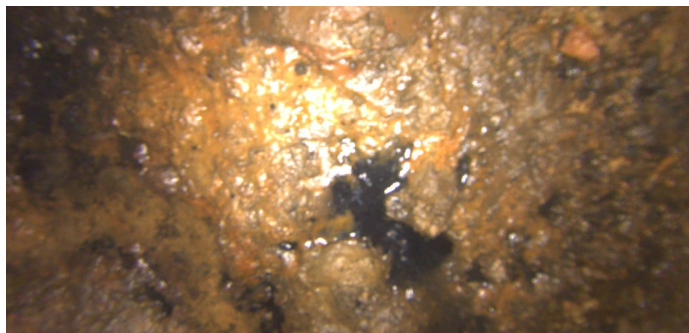
Code: **MGO**
Description: **General Observation**

Distance (ft): **7.8**
Structural Grade: **0**
O&M Grade: **0**
Clock Start/From:
Clock To:
1st Value:
2nd Value:
Value Percent:
Step: **NO**
Remarks: **end survey**
