# Manhole Inspection Report

Date:	05/14/2018	Weather:		Coding:	RZMACP
MH#:	M-604-074	Owner:	NA	Len. Surveyed:	11.5
P.O.#:		Surveyor:	Jen Costello	Rim to Invert:	11.3
Customer:		Cert. #:	U-907-5518	Wall Material:	Concrete (reinforced)

Street:	Washington St. 229' North of Home	Project:	Hobart, IN
City:	Hobart, IN	GPS Northing:	2902115.044
Location:		GPS Easting:	2902115.044
Drain Area:	West	GPS Accuracy:	Sub-Meter
Cover Shape:	Circular	Evidence of Surcharge:	No
Cover Size:	22.5	Potential for Runoff:	None
Comments:

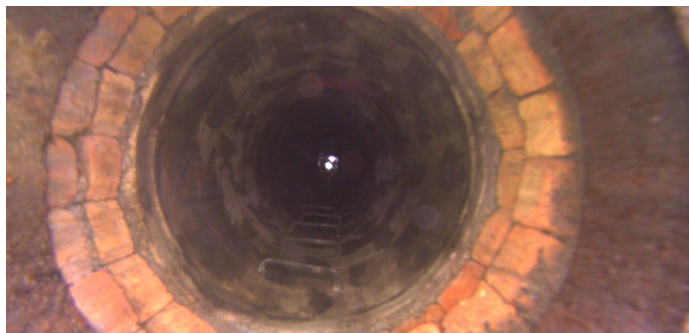
Code: **MGP**  
Description: **General Photo**

Distance (ft): **.0**  
Structural Grade: **0**  
O&M Grade: **0**  
Clock Start/From:  
Clock To:  
1st Value:  
2nd Value:  
Value Percent:  
Step: **NO**  
Remarks: **ACCESS MH**

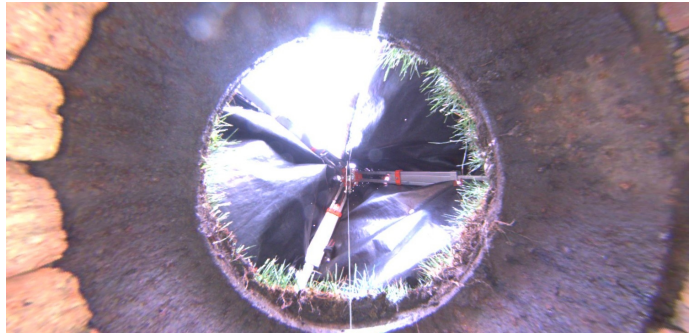
Code: **MGO**  
Description: **General Observation**

Distance (ft): **1.7**  
Structural Grade: **0**  
O&M Grade: **0**  
Clock Start/From:  
Clock To:  
1st Value:  
2nd Value:  
Value Percent:  
Step: **NO**  
Remarks: **UNDERSIDE OF FRAME**

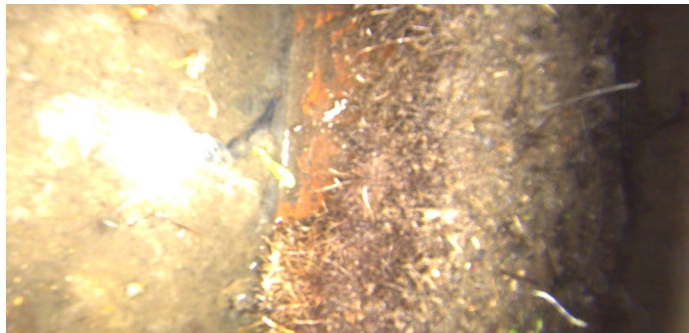
Code: **RMB**  
Description: **Roots Medium Barrel**

Distance (ft): **11.5**  
Structural Grade: **0**  
O&M Grade: **4**  
Clock Start/From: **2**  
Clock To: **4**  
1st Value:  
2nd Value:  
Value Percent: **5.000**  
Step: **NO**  
Remarks:

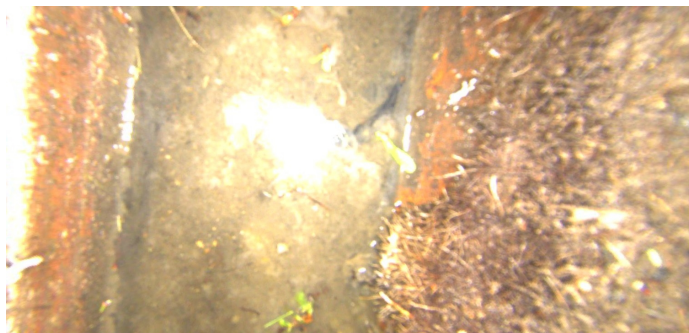
Code: **MGO**  
Description: **General Observation**

Distance (ft): **11.5**  
Structural Grade: **0**  
O&M Grade: **0**  
Clock Start/From:  
Clock To:  
1st Value:  
2nd Value:  
Value Percent:  
Step: **NO**  
Remarks: **END SURVEY**
